**RE: MUNICIPAL Water Use N7L3-0714
CLASS B - MUNICIPAL
Kudlak Lake**

MUNICIPAL WATER USE INSPECTION REPORT

LICENCE #:	N7L3-0714	EXPIRY DATE:	November 20, 2013
LICENCEE:	Incorporated Hamlet of Tuktoyaktuk	PREVIOUS INSPECTION:	September 8, 2011
COMPANY REP:	Emma Wolki, A/SAO	INSPECTION DATE:	August 27, 2013

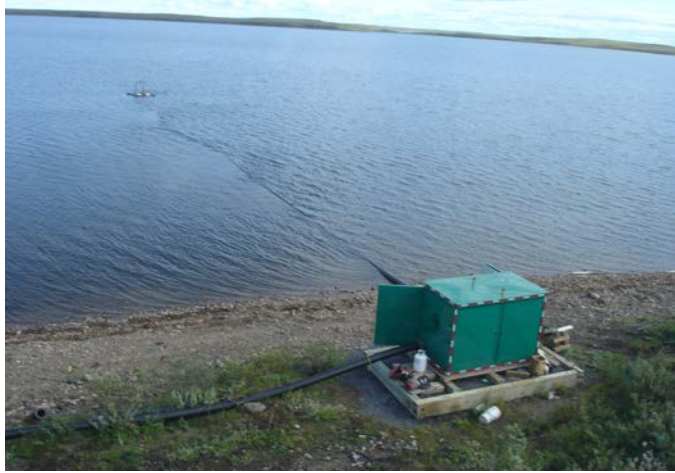
Figure 1

- Kudlak Lake Intake Facility was acceptable and appeared open to be preparing for pumping and refilling the Freshwater Reservoir.
- This is an Annual event. The site appeared clean and in order.
- Oil and other waste containers were on site. Ensure these are properly disposed of prior to securing the site. Keep in mind any waste materials/service related fluids or even spills will ultimately end up in the Hamlet's Water Supply if left on site.
- Propane tanks are on site as the source of fuel for water pumping operations, since in the past there were issues with diesel fuel leaking from the site.

Kudlak Lake Water Intake Facility including floating intake.

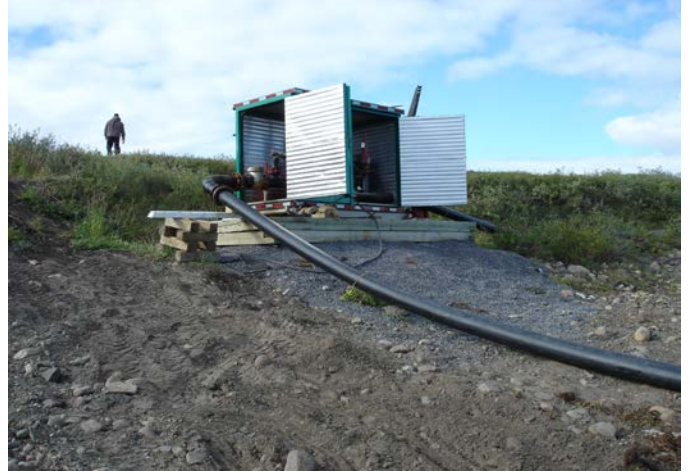
Figure 2

- There was a concern of the ground access by ATV down the bank to the intake facility/pumping station which was disturbing/ripping up the ground. This could be minimized if the ATV(s) were parked at the top of the bank by the propane fuel tanks and Hamlet staff walked down to the pump station. This would minimize impacts to the environment not to mention the soil erosion just ends up getting worse and soil eroding into the lake. The area then has long term effects that may need reclamation and further work later on.
- The actual water intake was in the lake and hooked up to the pipe leading to the pumping station.
- No spills or other issues were evident. Kudlak Lake Intake Facility site was acceptable.

Front of pumping station and disturbance to bank of lake and sand.

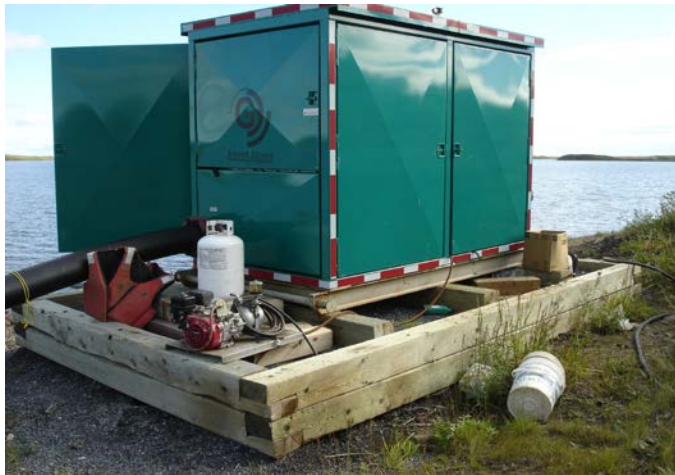
Figure 3

Behind of pumping station.

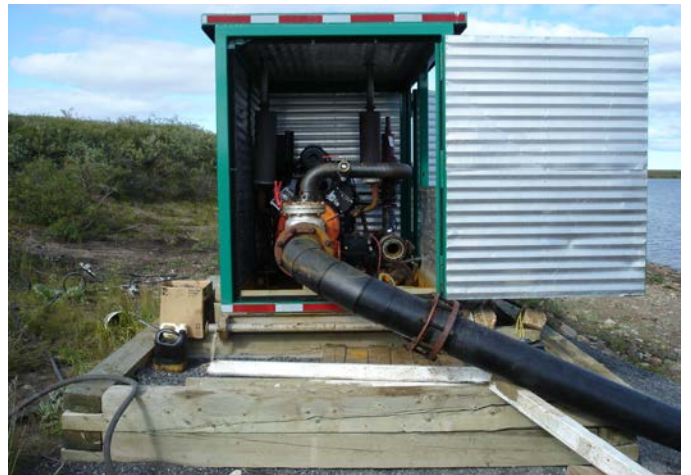
Figure 4

Pump itself and various service related fluids

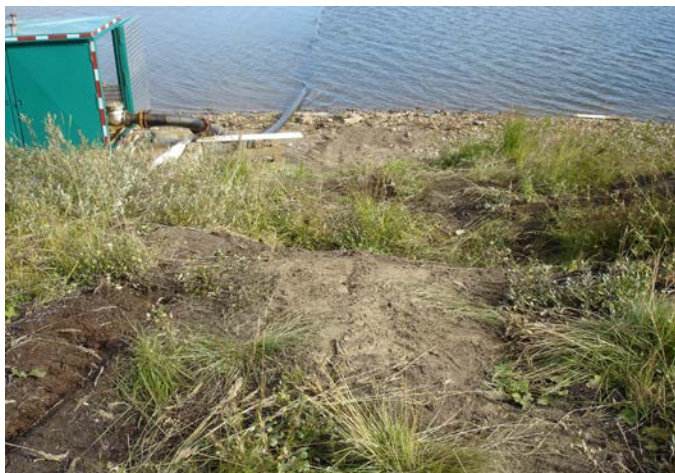
Figure 5

Disturbance to bank of Kudlak Lake due to ATV going up and down the bank.

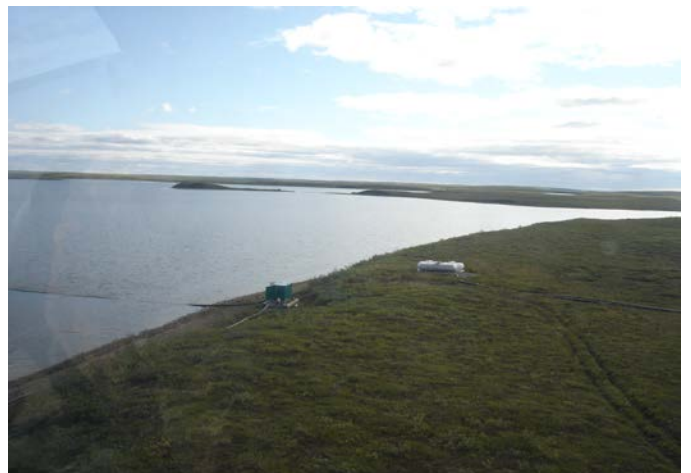
Figure 6

Water Intake Facility and associated propane tanks.
