**RE: Municipal Water Licence (N7L3-1619)**

An inspection was conducted of the Municipal Water Supply and Waste Disposal Facilities on September 14, 2010. Enclosed is a copy of the Municipal Water Licence Inspection Report.

## WATER LICENCE INSPECTION FORM

<b>DATE:</b>	September 14, 2010	<b>COMPANY REP:</b>	Debbie Gordon-Ruben
<b>LICENCEE:</b>	Hamlet of Paulatuk	<b>LICENCE #:</b>	N7L3-1619

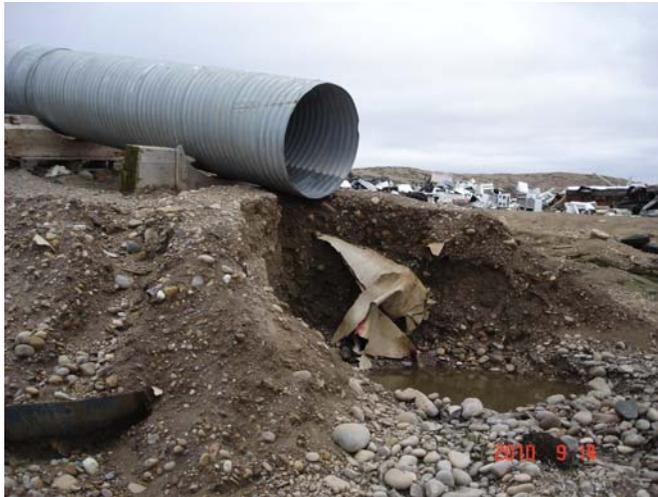
**Figure 1**

1. Large amount of erosion from the back of the sewage discharge chute (see Figure 1). This material that is being eroded away is being deposited back into the sewage lagoon which decreases efficiency and costs the Hamlet to repair it and material to replace it. Sewage discharge chute needs to be extended. Great work by Hamlet staff on the front to line it up and utilize tire stops to decrease sewage bypassing the front of the discharge chute.

Large amount of erosion from the back of the sewage discharge chute. The chute needs to be extended as this material is going into the sewage lagoon and can decrease its efficiency, while costing the Hamlet to replace/repair it.

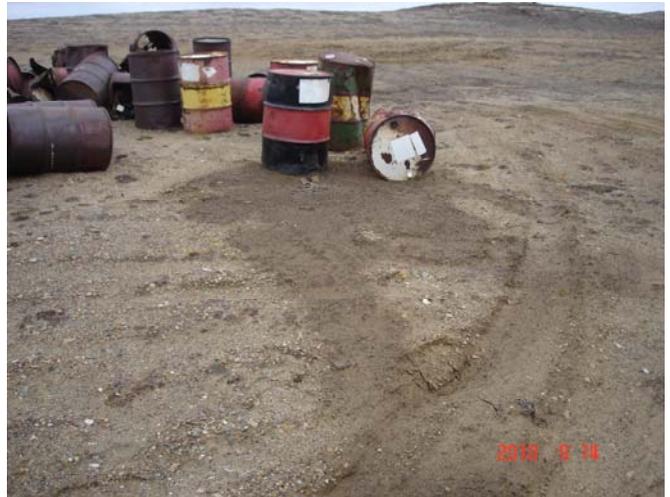
**Figure 2**

2. There is a clear indication that many drums/containers are leaking. There needs to be regular checks at the Solid Waste Disposal Facility (SWDF) for leaks and subsequent repairs including containment of leaking containers/materials to prevent spills and further contamination of the environment (see Figure 2). Ensure drums and fuel tanks are secure, contained, properly segregated and fluids are unable to leak from containers (strong drum/tank, bung in place, no holes). If required, fluids should be transferred to secure and approved containers.

There needs to be regular checks at the Solid Waste Disposal Facility (SWDF) for leaks and subsequent repairs including containment of leaking containers/materials to prevent spills and further contamination of the environment.

Currently there are many barrels and batteries present at the SWDF that need to be in a bermed temporary storage area as per Part D: Conditions Applying to Waste Disposal, Section 9, of the Water Licence.. It might be prudent for Hamlet Staff to build a berm around the few large groups of hazardous waste such as barrels, batteries etc. and contain them where they are as this material is located throughout the landfill. This would save on time and work involved to move

all the material. In the containment/storage areas these materials need to be collected, consolidated, prepared and either shipped to an approved facility for disposal or burned in approved equipment. This will ultimately maintain the SWDF in a well managed state that encourages public participation and assistance.

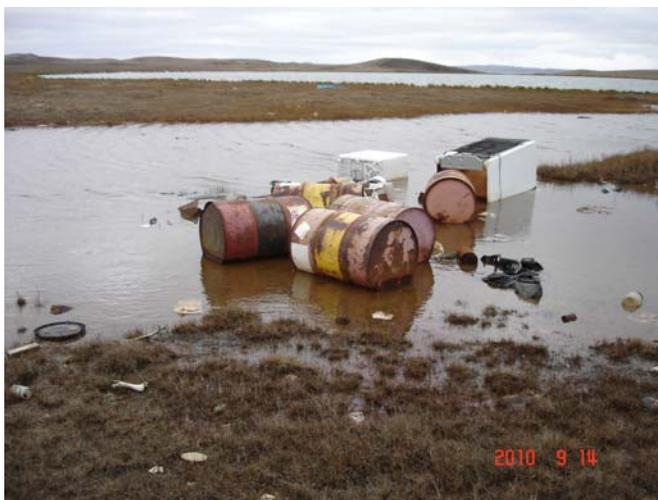
**Figure 3**

3. Drums and waste vehicles located in the water and in amongst the drainage areas provides a source of contamination (see Figure 3). There was also erosion noted throughout the Solid Waste Disposal Facility. Waste especially those with possible contaminants present need to be moved away from the water, erosion and drainage areas.

Drums and waste vehicles located in the water and in amongst the drainage areas provides a source of contamination

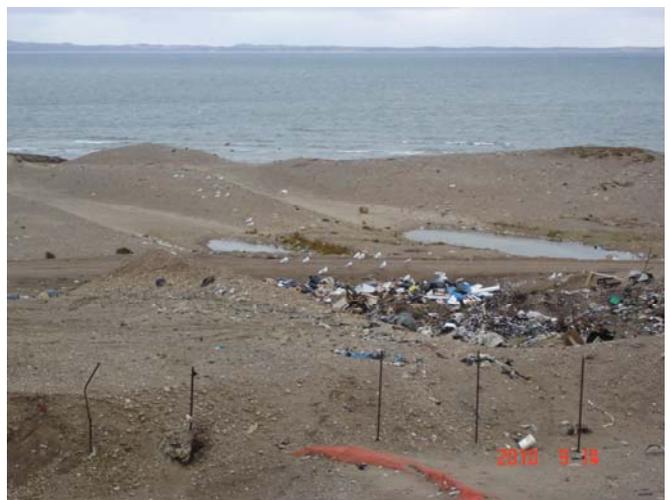
**Figure 4**

10. To prevent water ponding on the surface of the SWDF cells, contouring is needed and this will also help against water contamination and leachate issues (see Figure 4).

To prevent water ponding on the surface of the SWDF cells, contouring is needed and this will also help against water contamination and leachate issues.
