INDUSTRIAL WATER LICENCE INSPECTION REPORT

DATE:	January 13, 2004	COMPANY REP:	Sam Mahood
LICENSEE:	EnCana Corporation	LICENCE #:	N7L1-1797

List of Figures for Industrial Water Licence Inspection Report

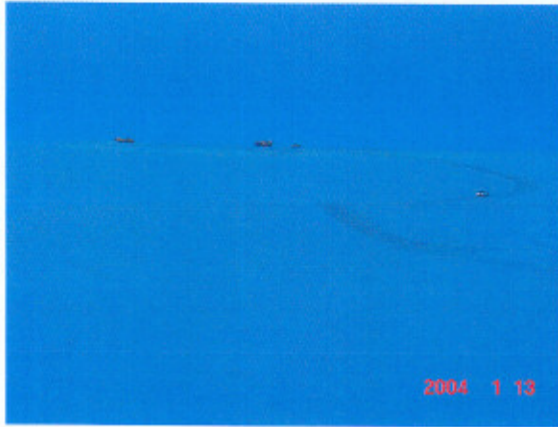
Figure 1. Water Supply. Access road to Lease Site.

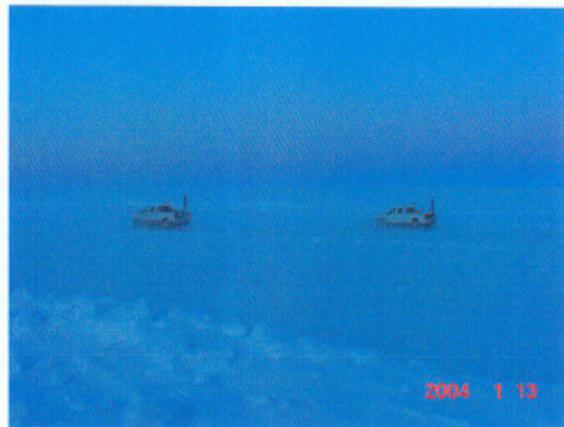
Figure 2. Water Supply. Flooding ice road on approved lake.

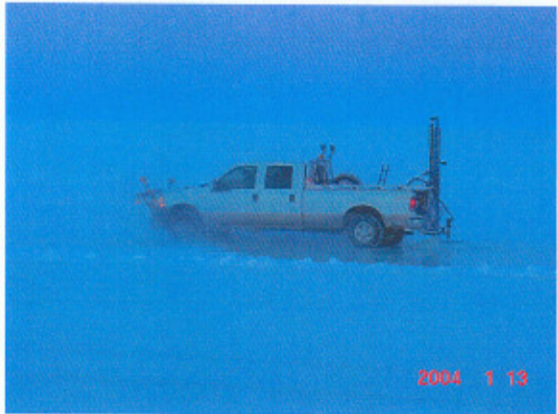
Figure 3. Water Supply. Flooding ice road on approved lake.

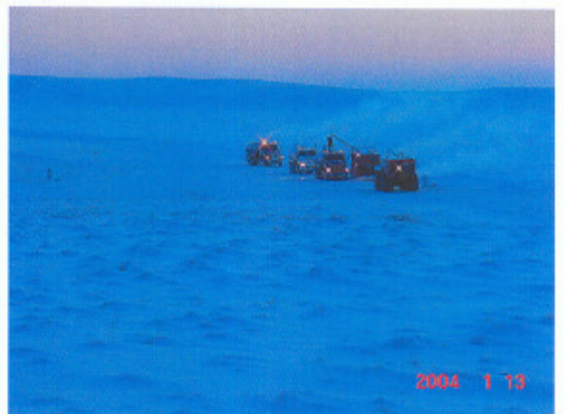
- All water uptake was from various sources (see above) and as described in the Project Description
- At the time there were four (4) water trucks and three (3) delta machines (Figure 4).
- ILA monitor (Roland Kikoak) indicated that fish screens were being used.
- Inspected water use records were in good order. All water withdrawal (Figures 2-4) from all sources was well below 1800 m³/day. At the time of inspection total water withdrawal was ~3400, 4200 3000, 7500 m³ from the Mackenzie River, Nesbitt Lake, Lake five (5) and four (4) respectively. This information will be reported.
- Sam indicated that they were able to haul 10-17 loads (~15 m³/load) of water per day.

Figure 4. Water Supply. Water uptake from lake four (4).

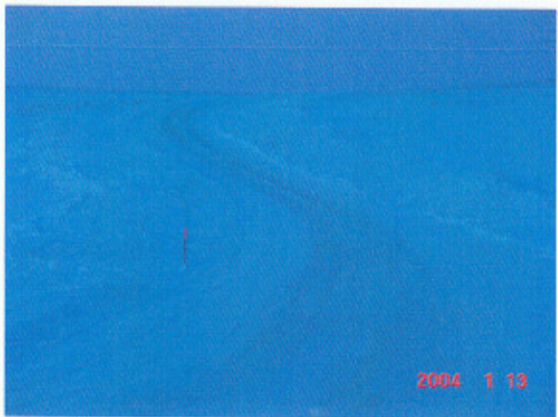
Figure 5. Water Supply. Ice access road to lease site. Road was constructed well. No foreign debris.

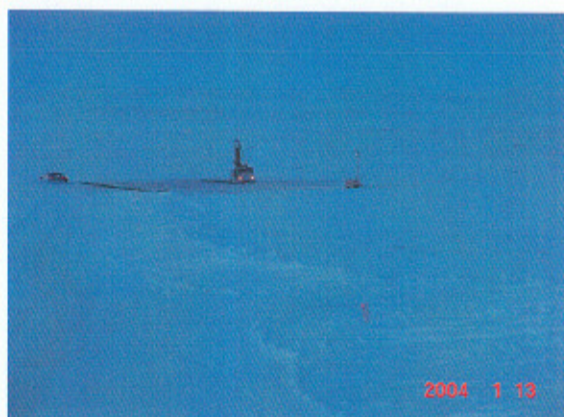
- Original drill sump area, as described in the Project Description, was deemed unsuitable due to large amounts of ice lenses discovered during test drilling. A new location (Figure 6) was chosen. **The new location was approved via Part D, section (7, 8, 10, 11) by this office** and was based on favorable topography, the distance (> 100 m) from water bodies, the low permeability of the Parent Geological Material (PGM), and that no additional land disturbance was required for access due to its location along the access route.

- During the inspection a geotechnical assessment was being conducted at the site to determine the suitability of the location (Figure 6). It is my understanding that EBA Engineering is currently conducting this assessment and a report will be available as soon as possible.

- Furthermore to assess the nature/permeability of the PGM of the new drill sump location a grab sample was collected from one of the bore holes and texturally classified. The result of the classification indicated that the PGM at that bore-hole is **loamy sand**. Loamy sands with water contents ranging from 20-50% inundated with permafrost are considered to have low permeability.

Figure 6. Waste Disposal. New sump location. Geotechnical was being conducted by EBA.

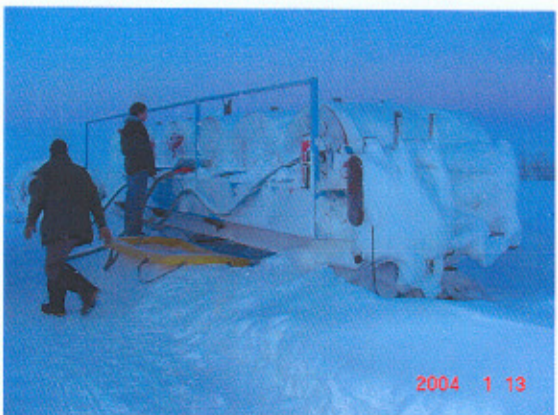
Figure 7. Fuel Storage. Fuel Sloop at beginning of access road. Fuel nozzle properly stored.

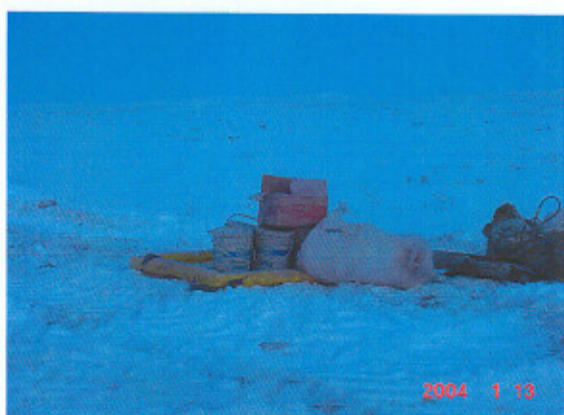
Figure 8. Oil/Chemical storage. Oil and chemicals were stored on hazmats.
