RE: Industrial Water Use (N7L1-1822)

INDUSTRIAL WATER USE INSPECTION REPORT

DATE:	March 26, 2008	COMPANY REP:	Glenn Miller
LICENCEE:	MGM Energy Corp.	LICENCE #:	N2007L1-1822

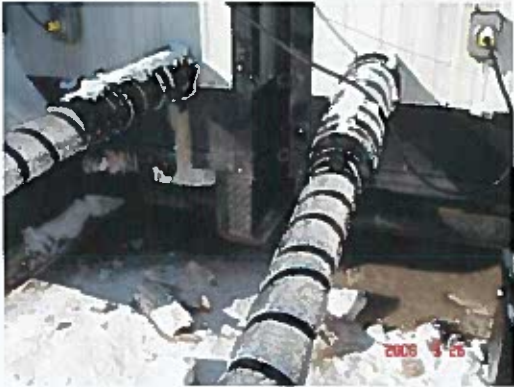
- Wash water from washing machines in trailer from camp leaking out onto ice pad. Upon review of the spill logs there was no indication of this kind of spill. Ensure that all spills are entered in the spill log.

Figure 1
Wash water from washing machines in trailer from camp
leaking out onto ice pad.
