**RE: INDUSTRIAL Water Use N7L1-1835
CLASS A – INDUSTRIAL
Inuvik – Tuktoyaktuk Highway – South End**

**RE: INDUSTRIAL Water Use N7L1-1835
CLASS A - INDUSTRIAL**

LICENCEE:	Government of the Northwest Territories - Department of Transportation	PREVIOUS INSPECTION:	May 20, 2014
COMPANY REP:	Larry Purcka	INSPECTION DATE:	June 13, 2014

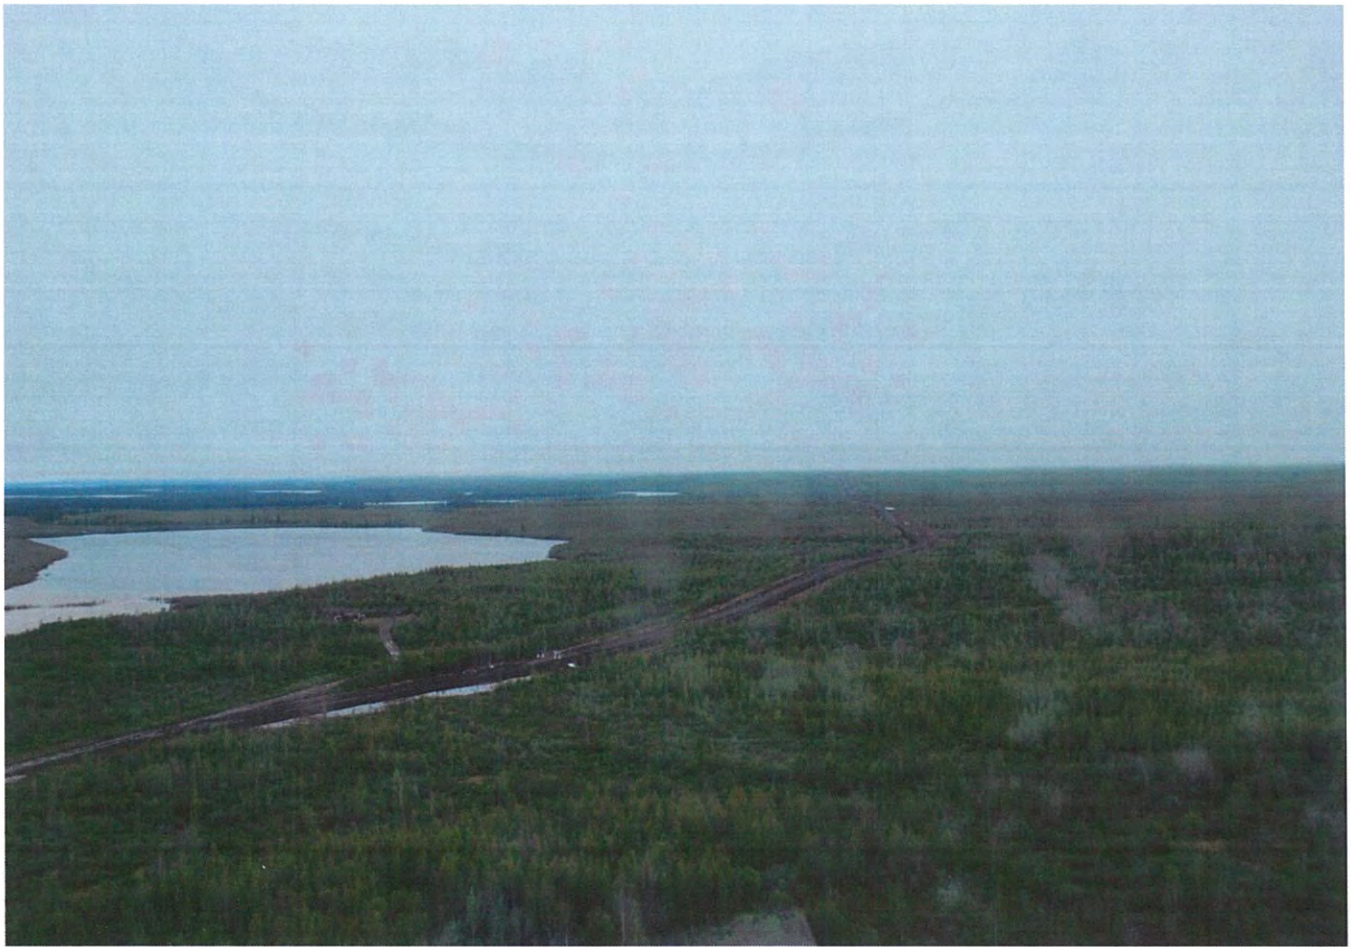
Aerial of road from start
