**RE: INDUSTRIAL Water Use N7L1-1835
CLASS A - INDUSTRIAL
ITH North End**

INDUSTRIAL WATER USE INSPECTION REPORT

LICENCE #:	N7L1-1835	EXPIRY DATE:	December 11, 2023
LICENCEE:	Government of the Northwest Territories - Department of Transportation	PREVIOUS INSPECTION:	March 20, 2015
COMPANY REP:	Dean Ahmet, Senior Program Manager	INSPECTION DATE:	January 22, 2016

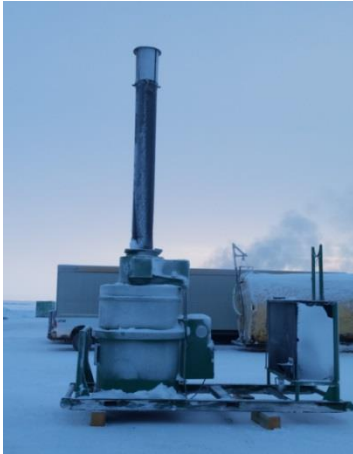
Figure 1

- All aspects with regards to solid wastes were satisfactory at the time of the inspection.
- An incinerator was observed at the camp but had not been used yet (see Figure 1). Please ensure that the requirements of the Waste Management Plan are followed when using the incinerator in the future.

Incinerator in place at camp by KM 81.

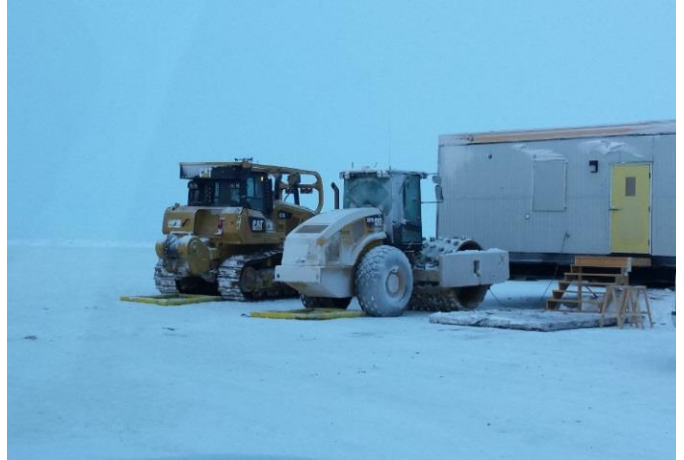
Figure 2

- Generally, most aspects of the inspection were satisfactory; drip trays were placed under most parked vehicles (see Figure 2), spill kits could be found where required, storage tanks were in good condition and kept clean, and all areas inspected were clear of debris and well maintained.

Drip trays in use – please ensure that they are placed correctly and secured underneath the equipment.

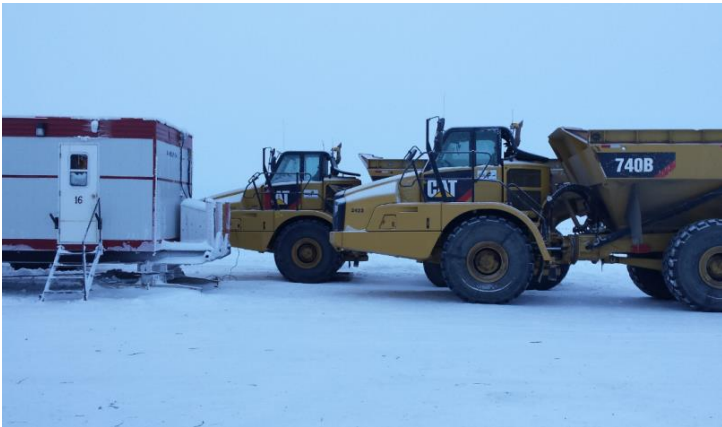
Figure 3

- Two concerns identified include missing drip trays under parked heavy equipment (see Figure 3) and the poor condition of a spill response kit (see Figure 4) around KM 81.

Missing drip trays underneath parked heavy equipment.

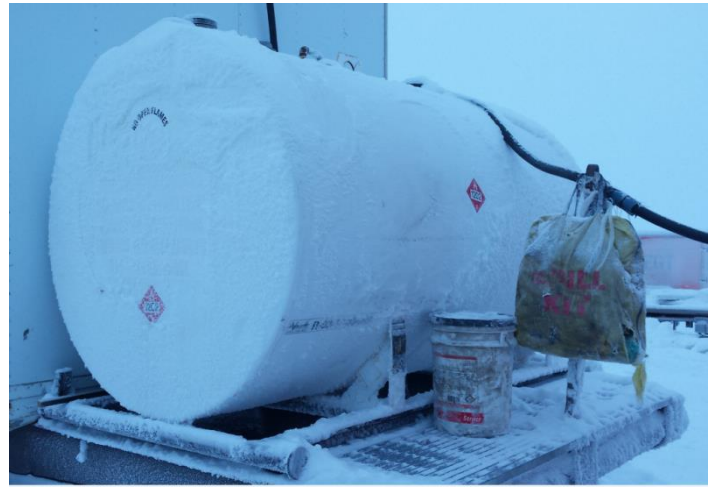
Figure 4

Spill response kit bag is punctured and in overall poor condition.

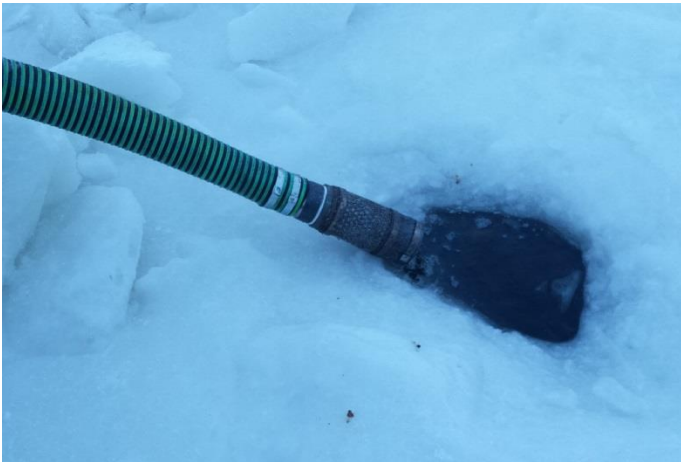
Figure 5

- Water was being withdrawn out of approved Water Source KP82B at the time of the inspection. Water use is being tracked and screens are being used as required and in good condition (see Figure 5).

Water withdrawal pump screens used as required at approved Water Source KP82B. Condition is regularly inspected.

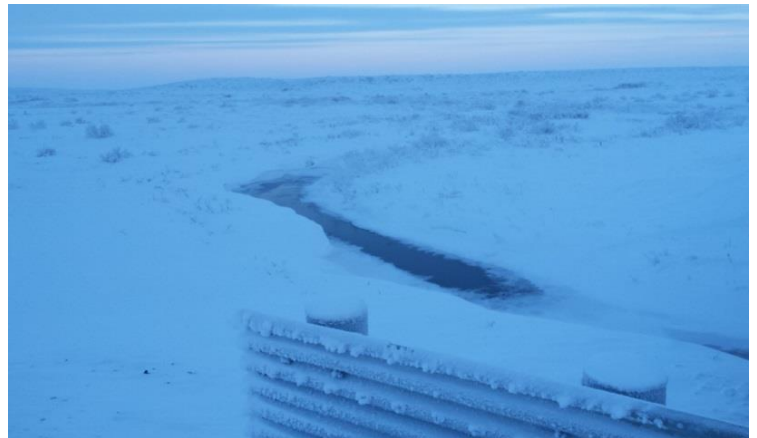
Figure 6

- The two bridge crossings appeared to be in good condition. No debris or obstruction of water flow observed and sediment control structures appear to be holding in place. Stream surface was frozen at Kilometer (KM) 102.5, and water was still flowing at bridge crossing near KM 91 at the time of the inspection (see Figure 6).

Open water at bridge crossing by KM 91.
