**RE: INDUSTRIAL Water Use N7L1-1835  
CLASS A - INDUSTRIAL  
ITH South End**

## INDUSTRIAL WATER USE INSPECTION REPORT

<b>LICENCE #:</b>	<b>N7L1-1835</b>	<b>EXPIRY DATE:</b>	<b>December 11, 2023</b>
<b>LICENCEE:</b>	<b>Government of the Northwest Territories - Department of Transportation</b>	<b>PREVIOUS INSPECTION:</b>	<b>March 8, 2016 / March 9, 2016</b>
<b>COMPANY REP:</b>	<b>Dean Ahmet, Senior Program Manager</b>	<b>INSPECTION DATE:</b>	<b>April 11, 2016</b>

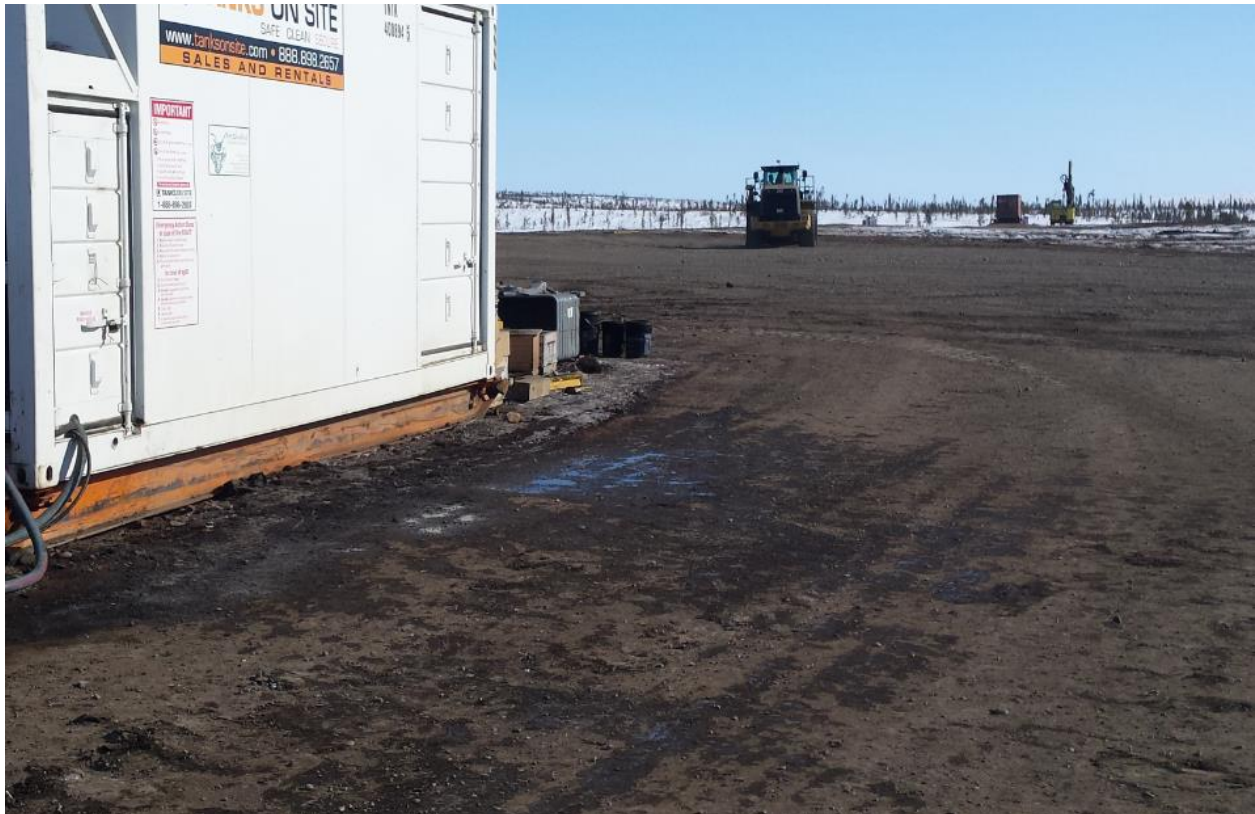
**Figure 1**

- <sup>1</sup>The soil around the fuelling area at Borrow Source GSC4 is visibly stained with fuel and smells strongly of hydrocarbons (see Figure 1). The equipment on site appeared to be in good condition, and there is secondary containment being used as well however it is not being properly maintained (see Figure 2). It appears this may have happened as a result of small amounts of fuel spilled from the nozzle overtime, and build-up on top of the drum leaking onto the ground. Please ensure that the affected surface area is scrapped off and that any build-up of fuel is removed from the site before the end of the construction season.

Fuel-stained ground at GSC4's fuelling area. Strong odour of hydrocarbons on site. Ground will need to be remediated.

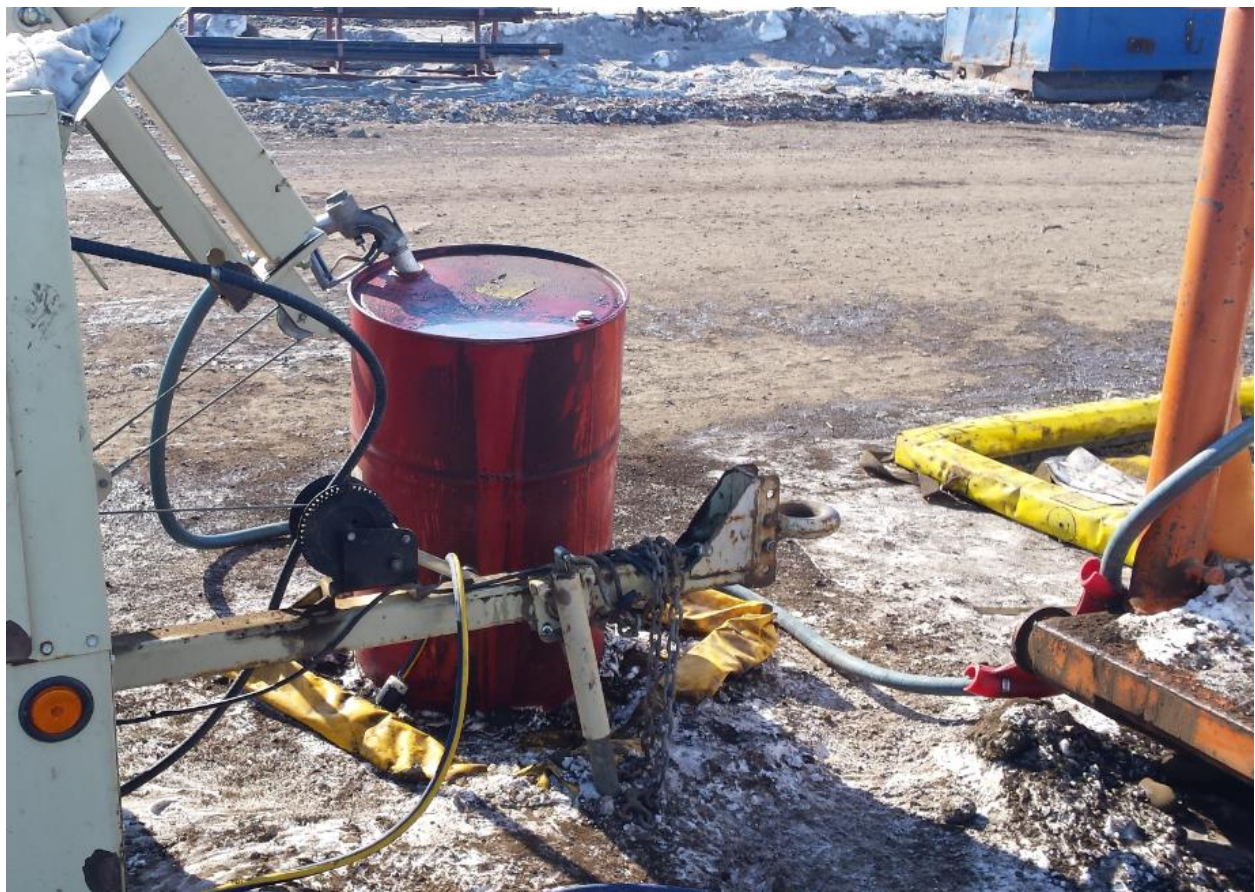
**Figure 2**

Residual fuel is building up on this drum at GSC4. Secondary containment is not properly maintained.

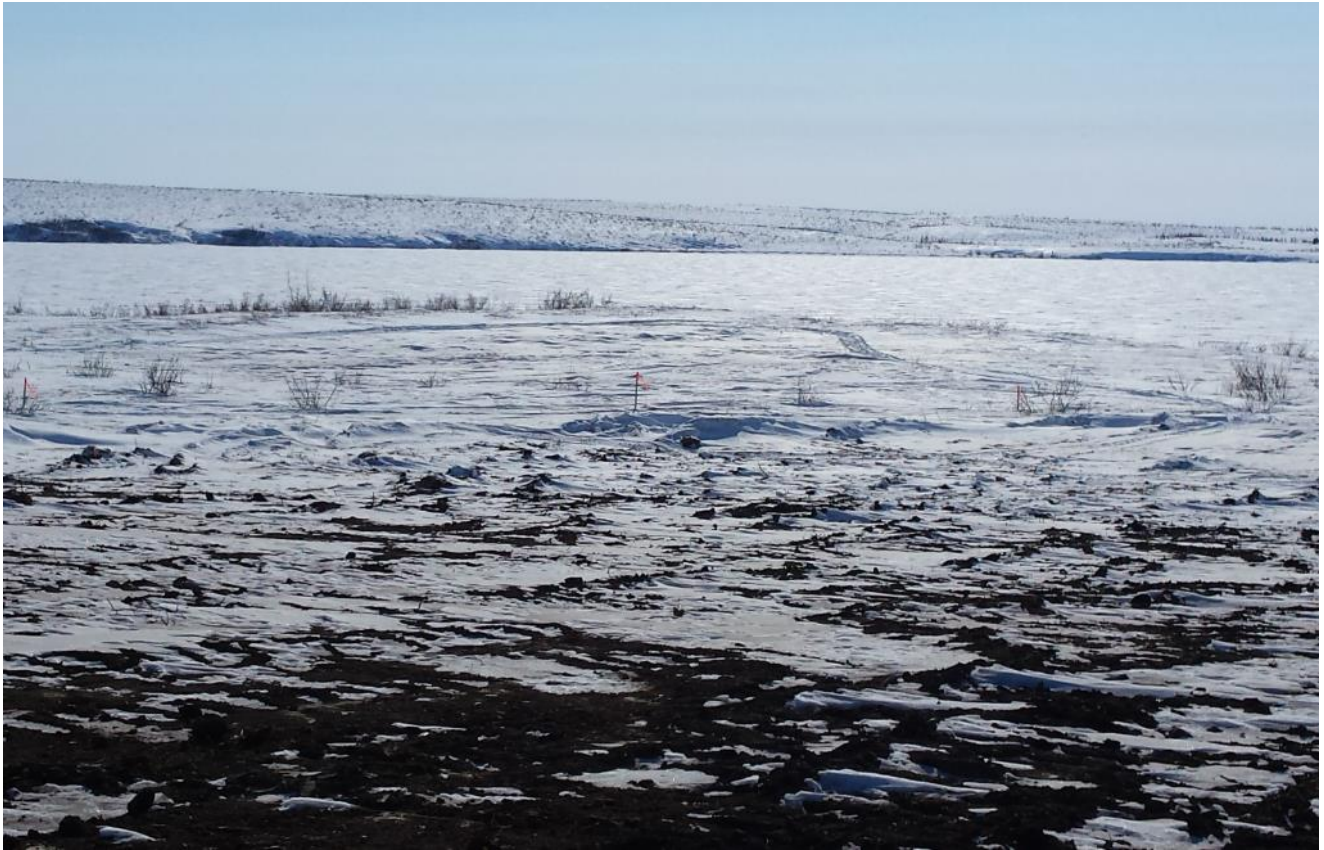
**Figure 3**

- In the last Water Licence inspection report, some significant concerns were noted with regards to inconsistencies between the approved Pit Development Plan for GSC4 and field operations. The concerns have been acknowledged by the Licensee and ENR Inspectors confirmed at the time of the inspection that the overburden stockpiles of concern near Jimmy Lake, at South West and South East corners have been pushed in and flattened out (see Figures 3 and 4). The area will need to be monitored during freshet to assess drainage of the area towards Jimmy Lake.
