KAVIK-STANTEC

# Technical Memo

To:	Russell Newmark, CEO EGT Northwind Ltd.	From:	Erica Bonhomme, P.Geo. 4910 53rd St. Yellowknife, NT
File:	123511255	Date:	September 8, 2016

**Reference: Assessment of Downslope Permafrost Erosion at Borrow Source 174**

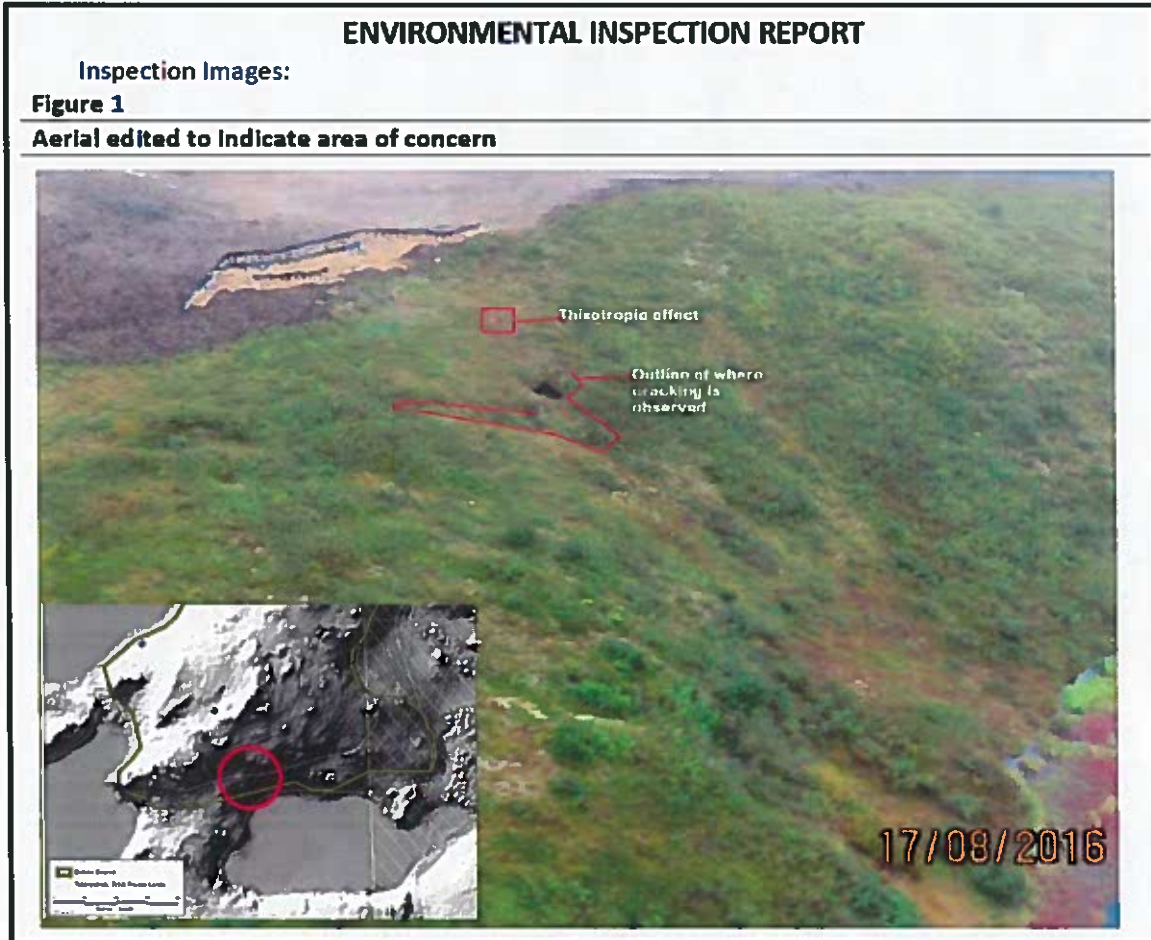
In April of 2015, April 2016, July 2016 and August 2016, the DOL and ILA conducted inspections of the borrow source. During 2016, conditions pertaining to erosion control at Borrow Source 174 were deemed "unacceptable", specifically pertaining to a "sinkhole" located approximately 20 m south, and downhill of silt fencing located at the southernmost edge of the borrow source, and an uphill area of saturated ground

Figure 2: Area noted in DOL inspection report of August 18, 2016 noting a sinkhole and cracking. Inset image shows area noted on pre-development LIDAR image (KAVIK-STANTEC 2014a)

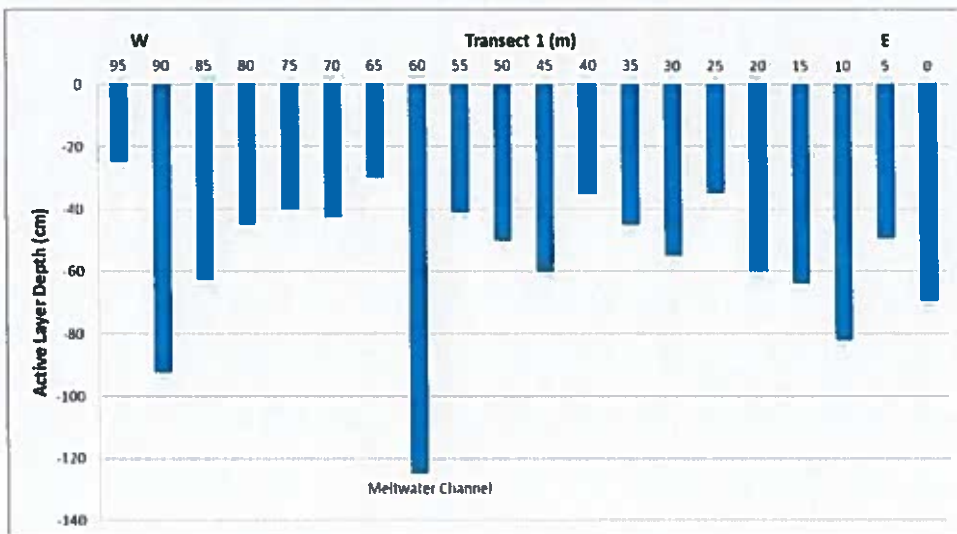
Active Layer depths are plotted in Figures 4a and 4b. They indicate a high variability in active layer depth, but show deeper active layer depths on the hill sides as compared to the middle of the valley. The exception is an isolated area at the location of the sinkhole, where active layer was not encountered – possibly because it was > 2 m (length of probe), or because the probe encountered a crack in the ground. From the top of the ridge to the lake, active layer depth did not change substantively until the lake level was reached, with permafrost present almost all the way to the lake.

**Figure 4a: Active layer depths along Transect 1 showing deeper active layer at the edges of the valley and at the location of the sinkhole and meltwater channel.**

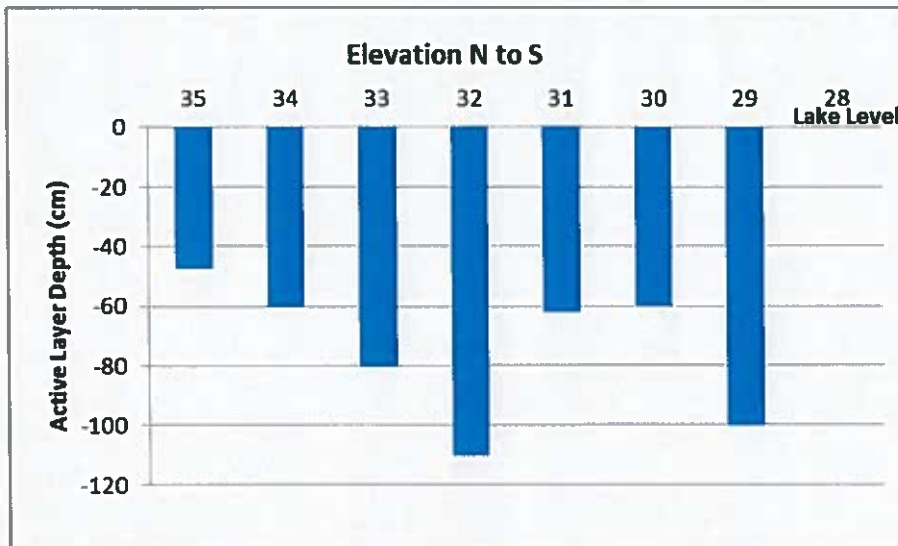
Figure 4b: Active Layer depths along the axis of the valley towards the lake

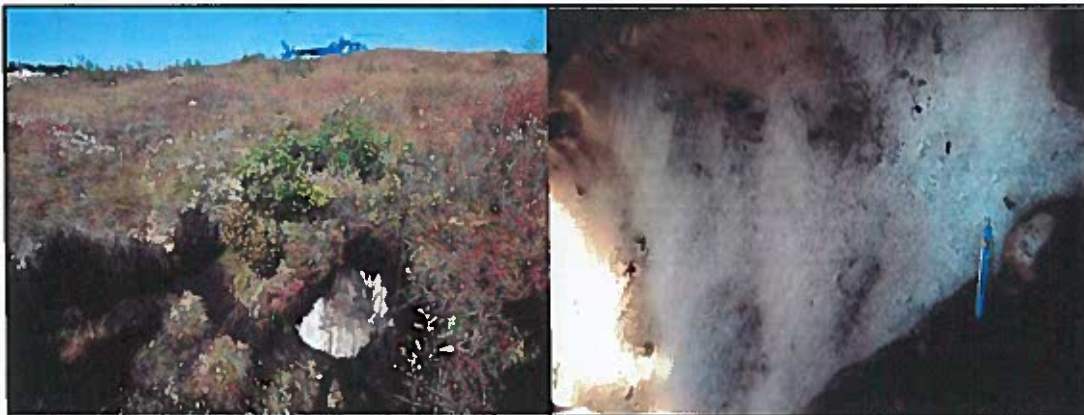
The sinkhole is the only location where ice is visible. At this location, the active layer depth was observed to range from 30 to 50 cm. Material within the active layer consists of sand and cobbles. Multiple ice wedges are visible, as identified by their shape and vertical foliation within the ice. Frozen ground is melting preferentially, leaving overhanging organic mats. There is no obvious expression of ice wedges at the surface (Figure 5).

Figure 5: Ice wedges and overhanging vegetation mat at the area of the sinkhole

The "sinkhole" as identified in the inspection reports, is due to (thermal) erosion of ice wedges on the hillslope (an "ice wedge slump"). Meltwater moving down the hill slope is being channeled along ice wedges, causing localized detachment of blocks of ground and exposing underlying ground. This process is fairly common in the Beaufort Delta uplands and has been observed, in rare cases to result in widespread erosion and catastrophic drainage of lakes (e.g., Fortier et al. 2007). The general morphology of the area (bowl-shaped) suggests that there historically may have been a larger thaw failure in the area. The central part of the swale consists of grasses and low shrubs indicating that moisture likely continues to concentrate and move through this area more than on the surrounding ridges in the summer months, but that freezes back effectively in the fall, as evidenced by the shallow active layer depths. If a failure event has occurred in the past, it has likely been 30 years or more, since the ice wedges in the central part of the swale are well-developed.

Since water from Borrow Source 174 may have contributed to the slumping, continued propagation of slumping *might* be mitigated by diverting surface water from the borrow source away from this area and into an area of vegetation, such as to east of the borrow source; however, this is likely not to mitigate the slumping altogether, as meltwater from the surrounding undisturbed area will continue to channel into this area.

The installed silt fencing at the top of the slope is effective at preventing sediment from surface meltwater from moving downslope. Trenching within the borrow source is directing ponded water away from the affected area and is also effective. Existing mitigations should be checked on an occasional basis to conduct and repairs or modifications as may be required. Additional mitigation measures are not recommended, as any impacts to the environment – particularly the adjacent lake – are likely to be negligible.

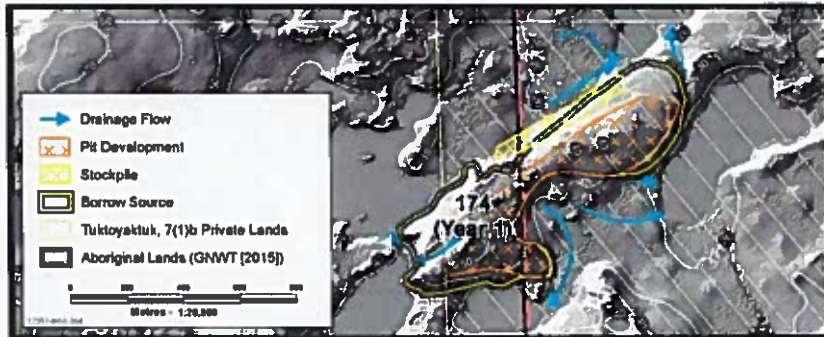
As indicated in the Pit Development Plan Figure 3-2, major drainage off of the high point of the borrow source was primarily identified towards the west (Figure 6).

**Figure 6: Pre-disturbance drainage as identified from LiDAR (2014a)**

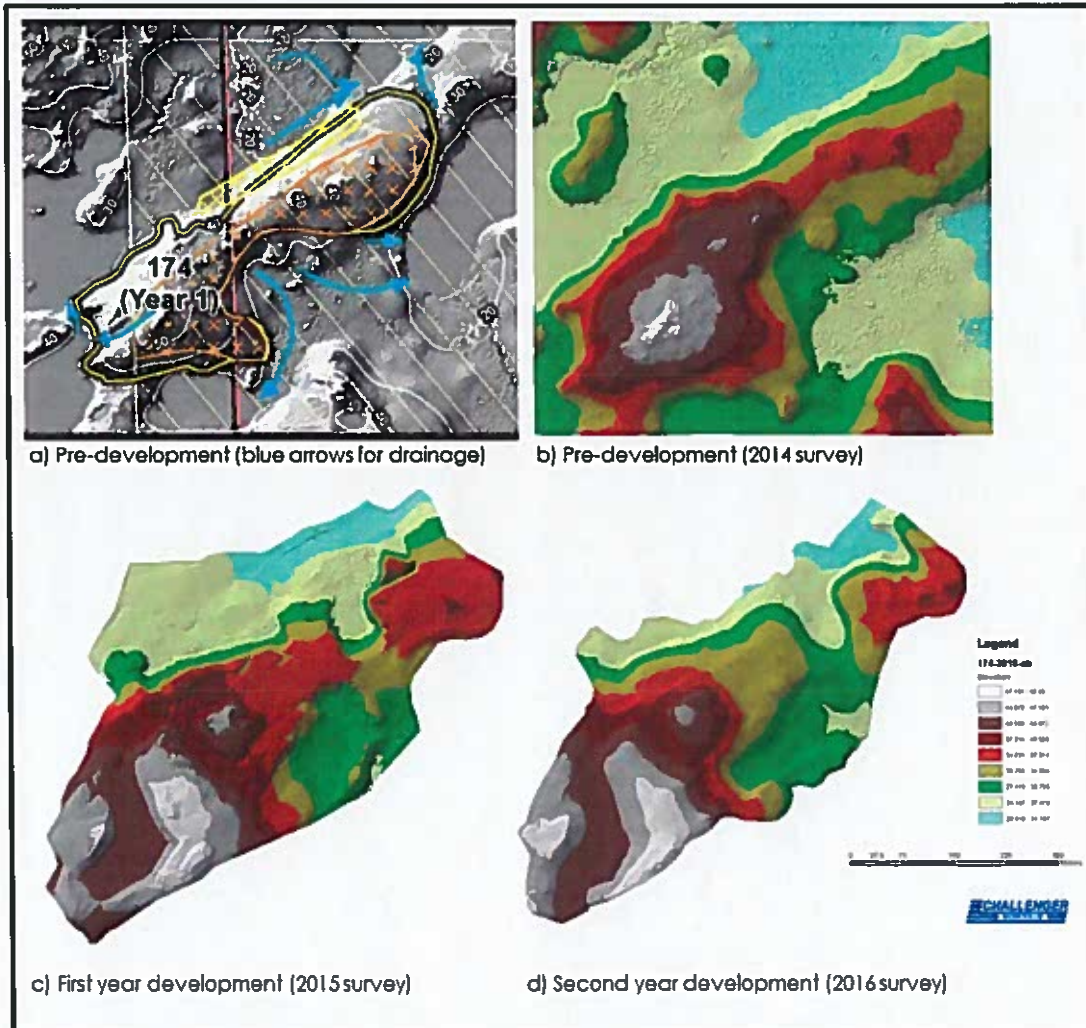
During pit development in 2014/15 and 2015/16, approximately 5 m of elevation was removed from the hill. The drainage from the southwest portion of the pit now drains primarily to the south as shown in the sequence of Figures 7a-d.

Figure 7: Pit development topography pre-development to 2016

In 2016, additional surface melt contribution and thermo-erosion may be due to the development of Borrow Source 174. As shown in figure 7d, the surface drainage is now directed towards to south of the borrow source. It is possible that this additional surface contribution has facilitated the development of the ice wedge slump through thermo-erosion along ice wedge troughs, but it cannot conclusively be determined to be the cause of it. Similar activity on the opposite (north-facing) side of the lake, and general widespread similar occurrences allows for possibility that the slumping has been initiated naturally.

Within the borrow source, a trench has been excavated to facilitate movement from the southernmost area of the borrow source northward away from the affected area. Such mitigation is considered best practice.

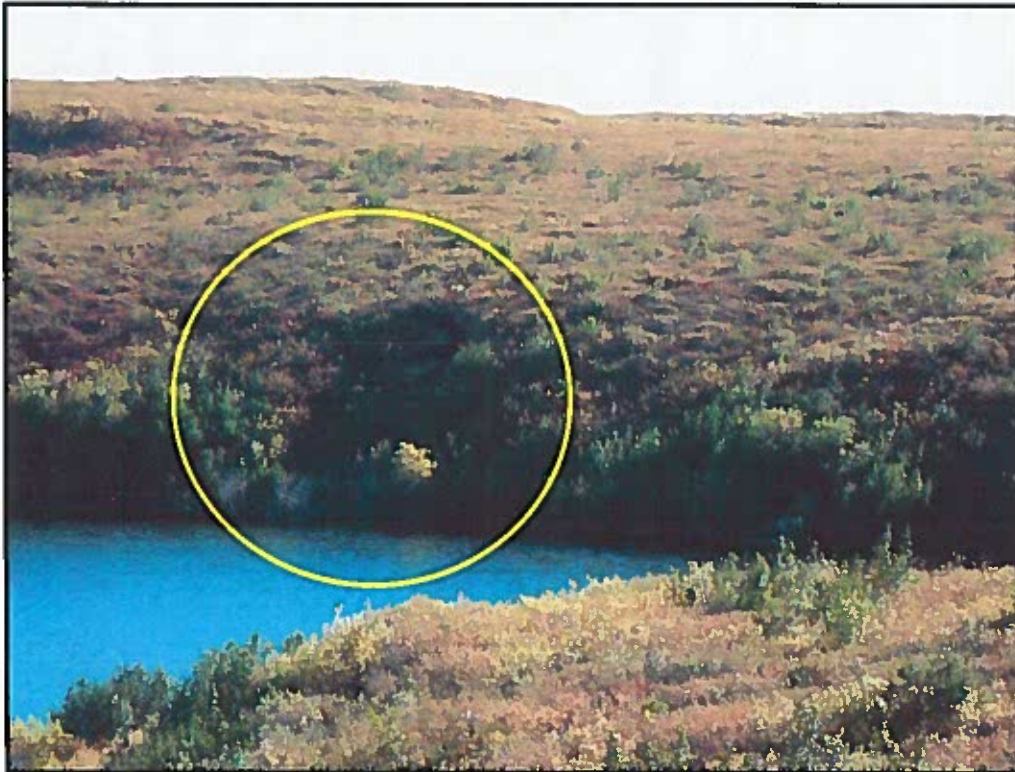
General observations of the area indicate that active layer detachments and thaw flowslides have likely occurred periodically in the past, as is evidenced by the general "bowl" shapes of many of the surrounding hillsides. On the south shore (north-facing) of the small lake to the south of the borrow source, a small (10 m wide) detachment is recent and unrelated to the development activity (Figure 8).

**Figure 8: Active Layer Detachment on shore of lake immediately south of Borrow Source 174. Photo taken from vantage of Transect 2.**
