File Number N7L1-1835
Type of Operation TYPE A - INDUSTRIAL

An inspection of the Department of Transportation Water Licence N7L1-1835 (expiry on December 11, 2023) was conducted on November 25, 2016. Enclosed is a copy of the inspection report (8 pages) for your review and records.

INDUSTRIAL WATER USE INSPECTION REPORT

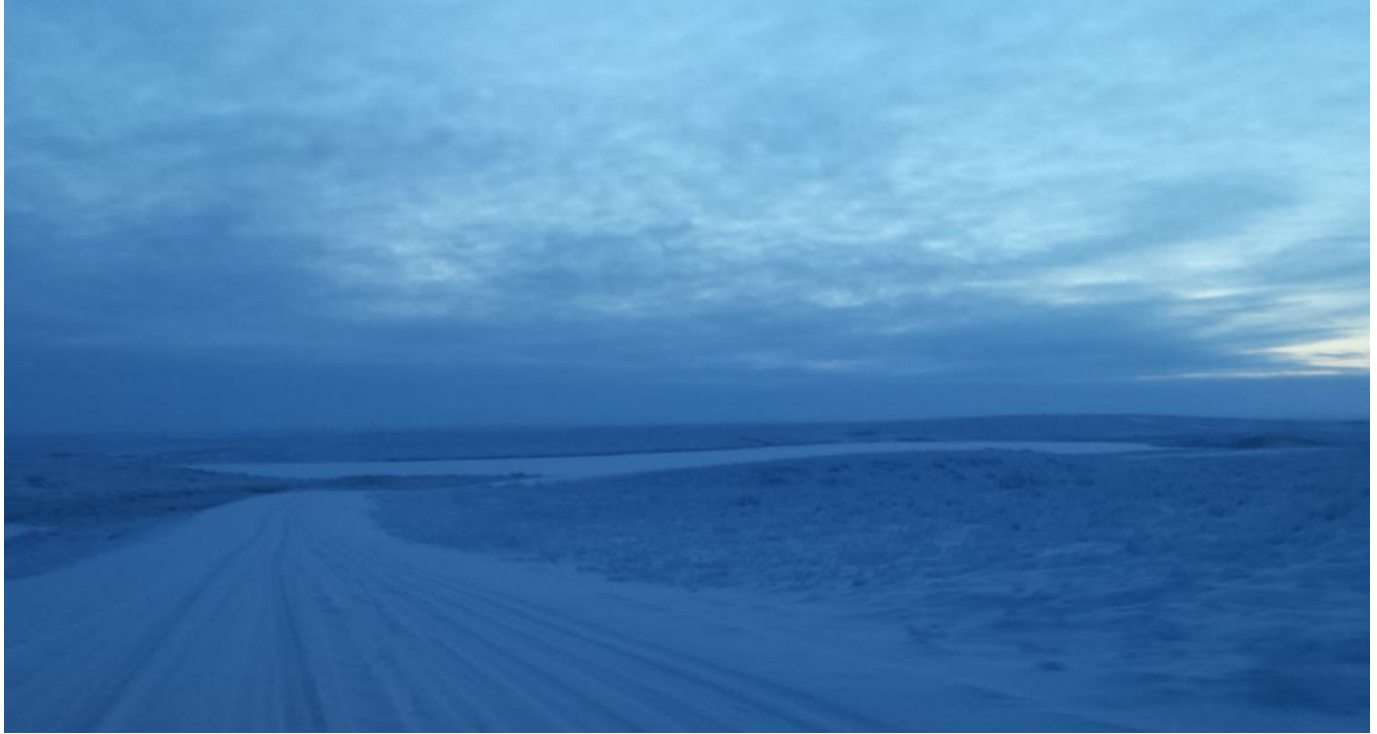
Figure 1

- Approved Water Source K61 which is meant to be used for winter construction this year as indicated by the Licensee was not active at the time of the inspection (Figure 1) and did not have an access road. No concerns were identified with regards to water use at the site.

Approved Water Source KP61: Overview from the main road, looking southeast.

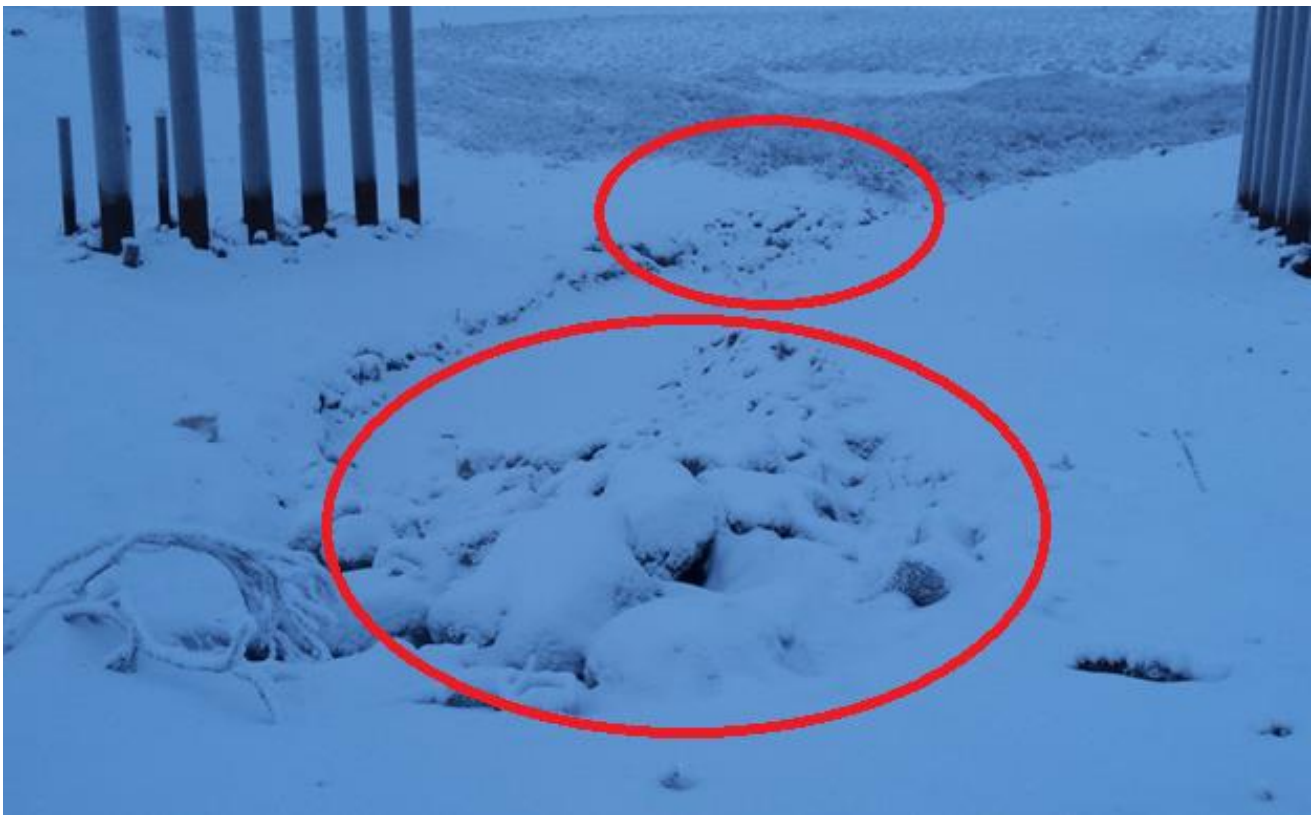
Figure 2

- Large angular stone rock piles were observed in the streambed under a thin snow cover (Figure 2). There was no water flow at the time of the inspection and the ice crossing appeared to be stable (Figure 3), however the large rock piles identified at the site do not belong there and will have to be removed in full before the spring. Failure to do so will lead in a violation of the Water Licence as the rock piles will surely obstruct natural water flow of Trail Valley Creek come snow-melt.

Trail Valley Creek: Overview of 2 rock piles in the creek bed, looking west.

- Retrieve the rock piles identified in the creek bed at Trail Valley Creek before snowmelt.
- As directed in the last Water Licence inspection report, the Licensee provided an update to the Inspector and the Board in the form of an independent report on the state of the sinkhole at Borrow Source 174. The findings of the report can be summarized as follows:
 1. The cause of the slumping could be partly attributed to the development of the borrow source and issues with drainage;

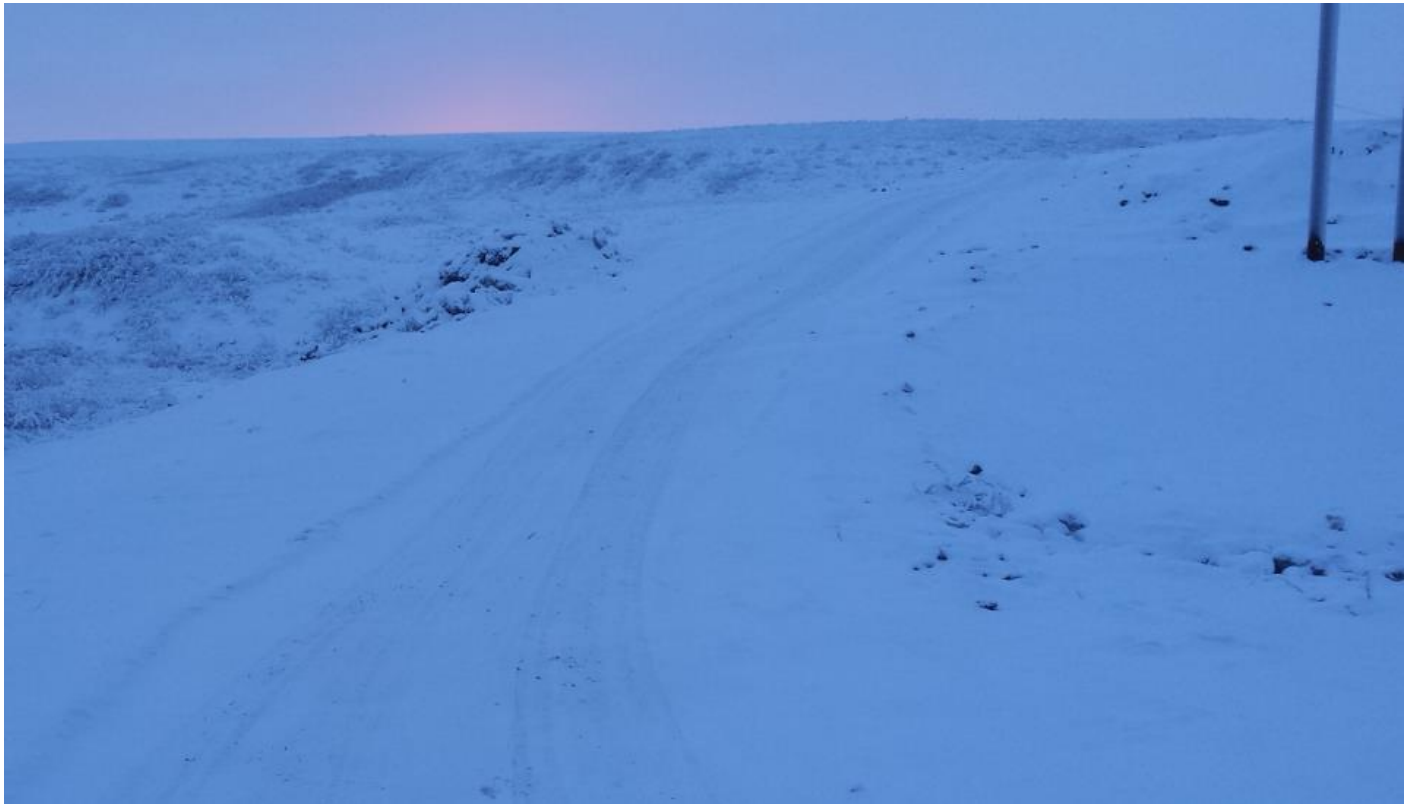
Figure 3

Trail Valley Creek: Overview of the ice crossing/snowfill, looking south.

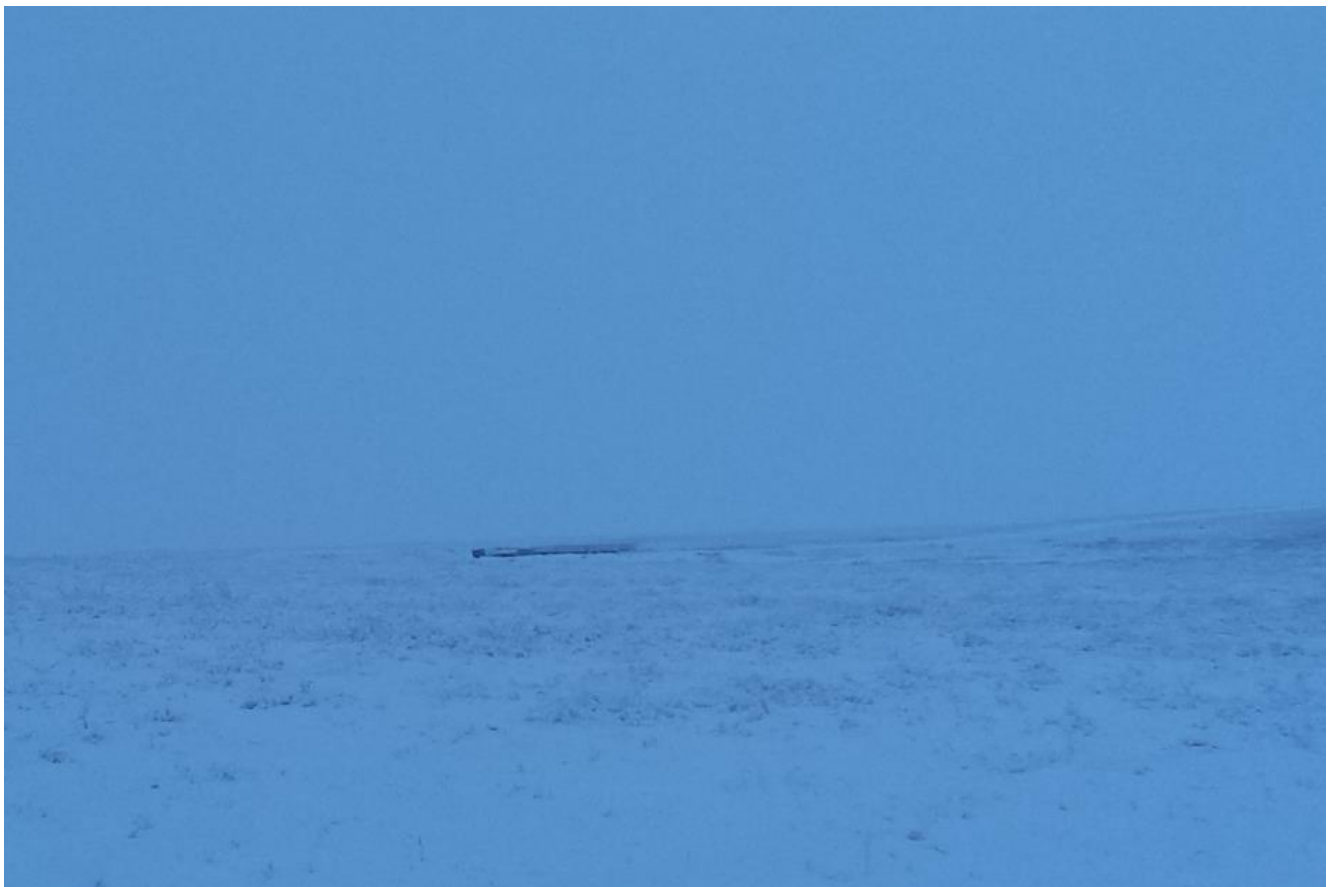
Figure 4

- At the time of the inspection, there was no activity on site at Borrow Source 312. Mobile camp units were on-route to the site, a few hundred meters away from the road and 312 (Figure 4).
- The ice bridge at Hans Crossing appeared to be stable and no flowing water was identified (Figures 5 and 6). There were 2 pieces of heavy equipment on site with no signs of leakage.

Borrow Source 312: Overview of the mobile camp units, looking northeast.

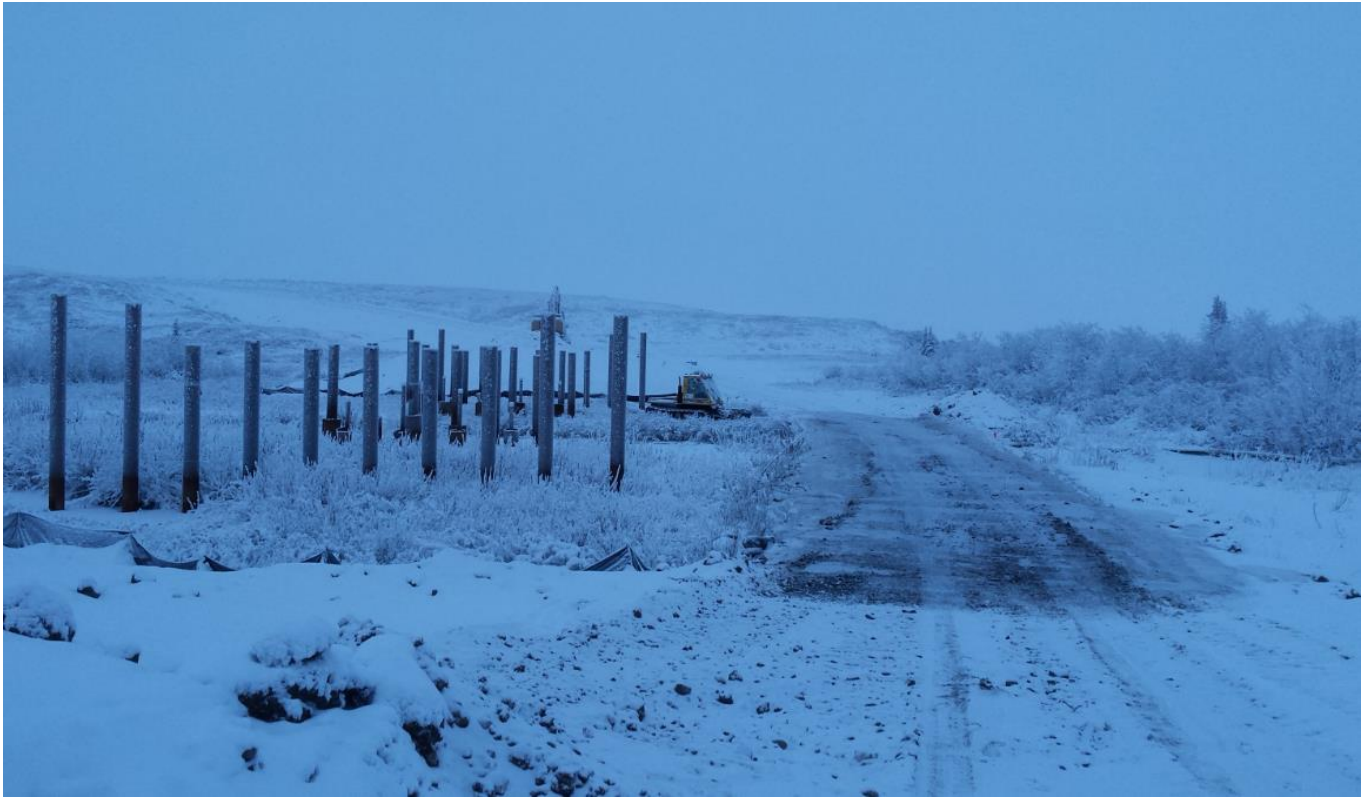
Figure 5

Hans Creek Crossing: Ice bridge, looking southwest.

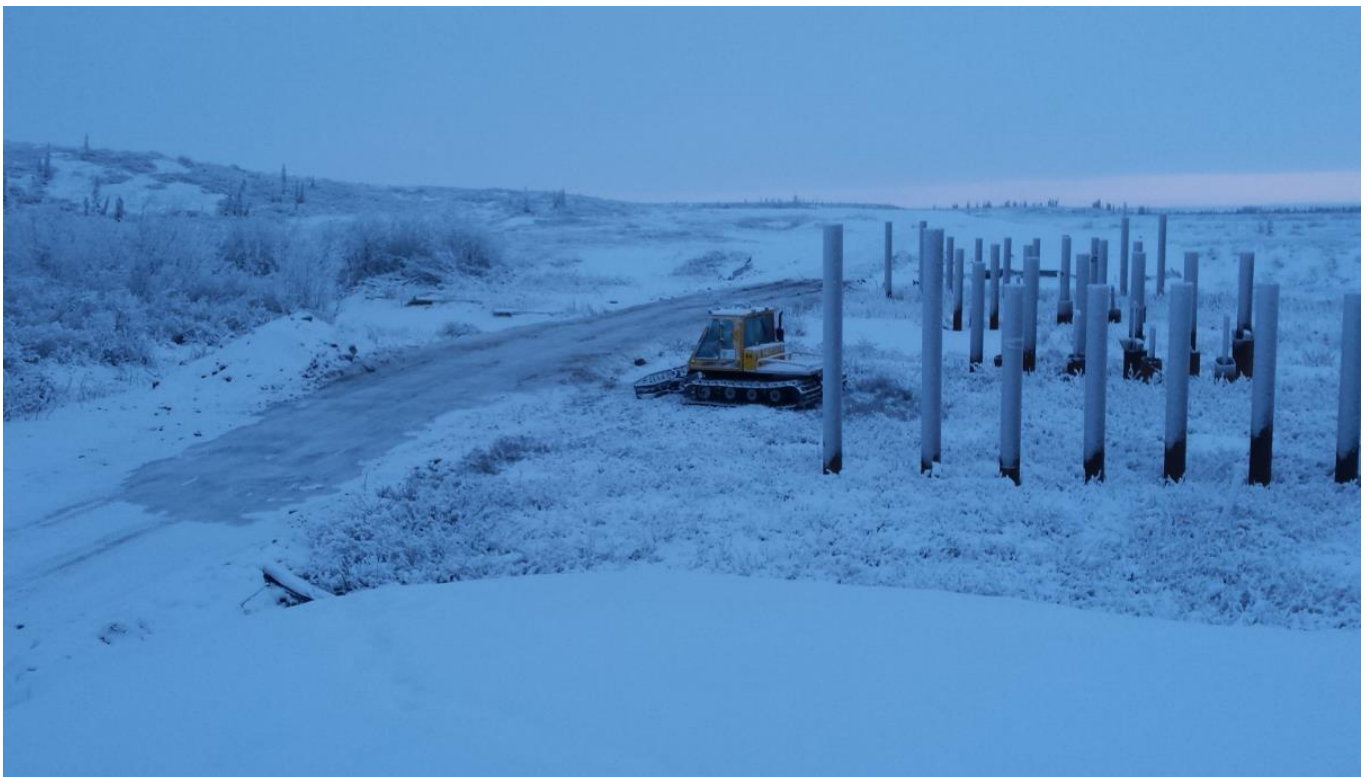
Figure 6

Hans Creek Crossing: Ice bridge, looking northeast.

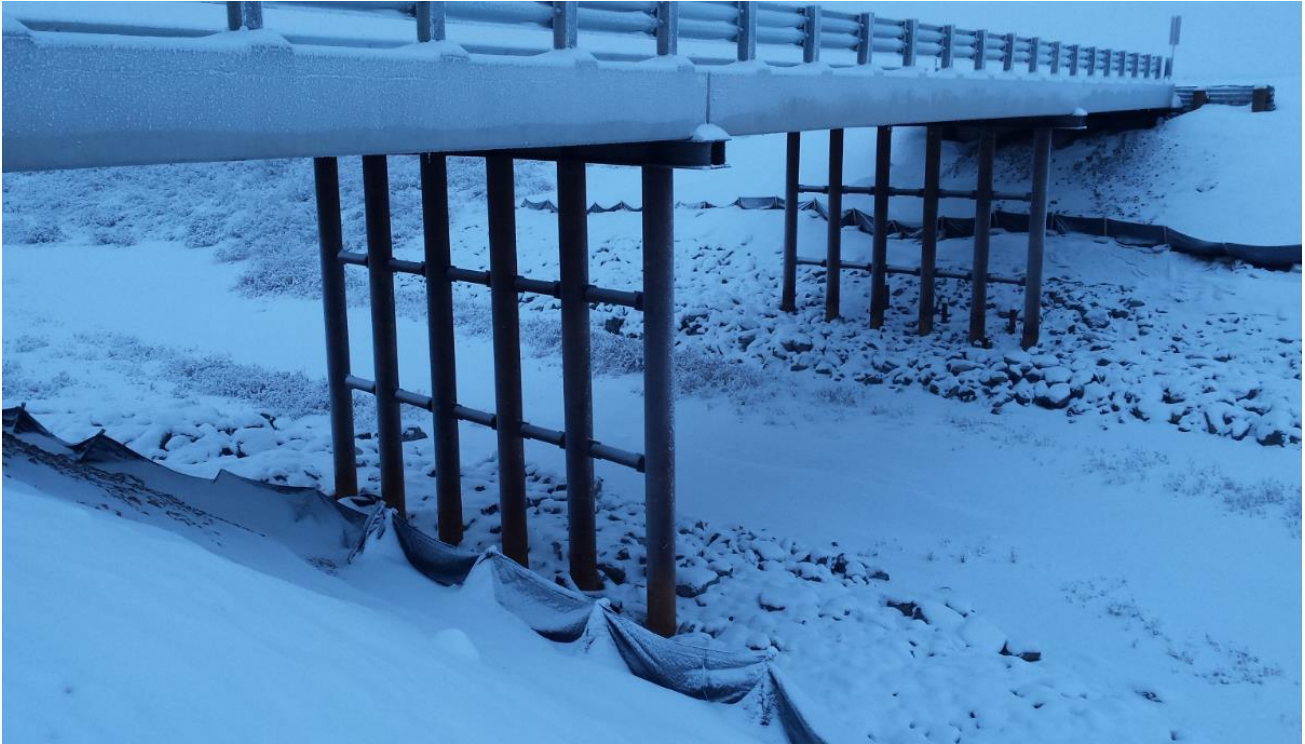
Figure 7

- All environmental aspects were satisfactory (Figures 7, 8 and 9). Open water was observed downstream of the Bridge A12 crossing.

Zed Creek Crossing overview.

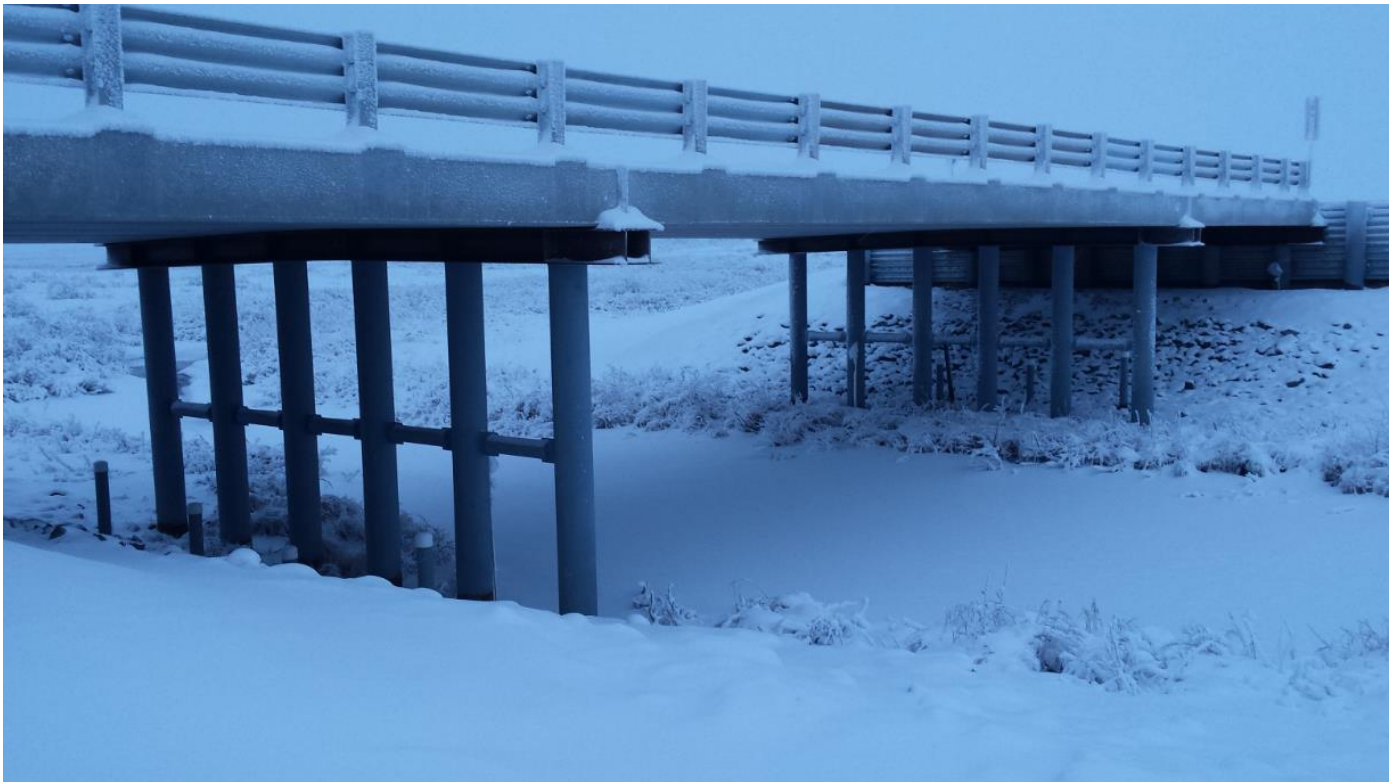
Figure 8

A12 Bridge Crossing overview.

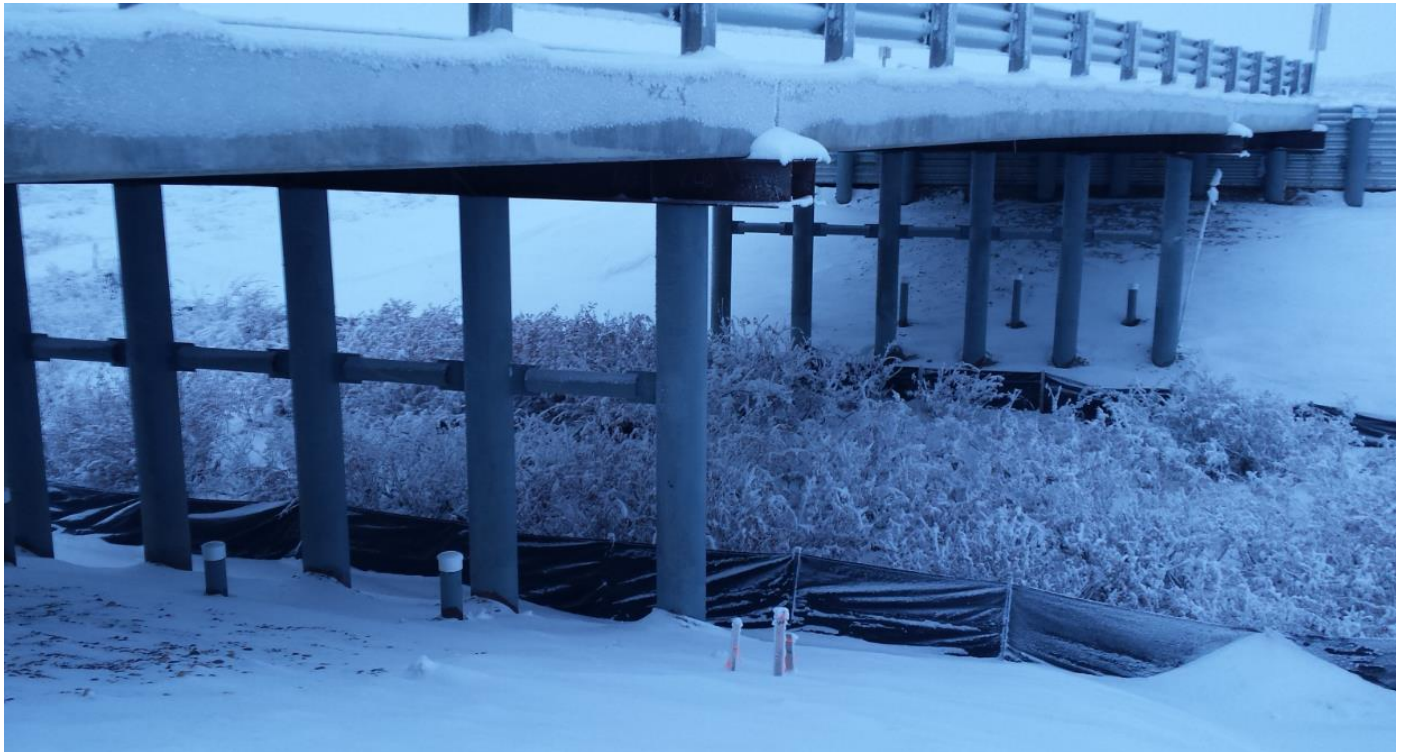
Figure 9

A3 Bridge Crossing overview.
