RE: Municipal Water Licence (N3L3-0570)

WATER LICENCE INSPECTION REPORT

DATE:	August 1, 2007	COMPANY REP:	Archie Arey – DPW, Dean Arey - Hamlet
LICENCEE:	Hamlet of Aklavik	LICENCE #:	G99L3-003 and N3L3-0570

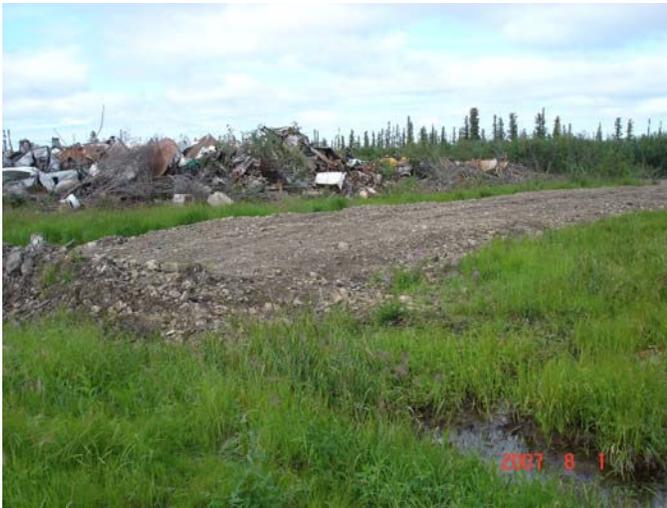
Figure 1
Berm around the Bulky Metal Waste Disposal Area.

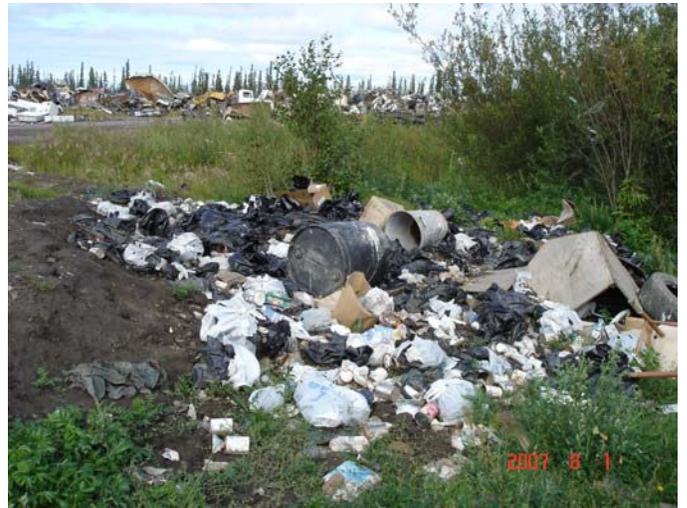
8. Berm for the Honey Bag Pit needs to be lengthened and maintained so it surrounds the whole pit. (figure 2)
9. After the initial inspection with the Hamlet foreman a sheen was noticed on water in the wetland area and ditch along the road outside of the berm on the East Side of the Bulky Metal Waste Area. Water samples need to be taken to identify this sheen. (figure 3)

Figure 2
Honey Bag Pit needs to have the berm lengthened so it surrounds the whole pit.

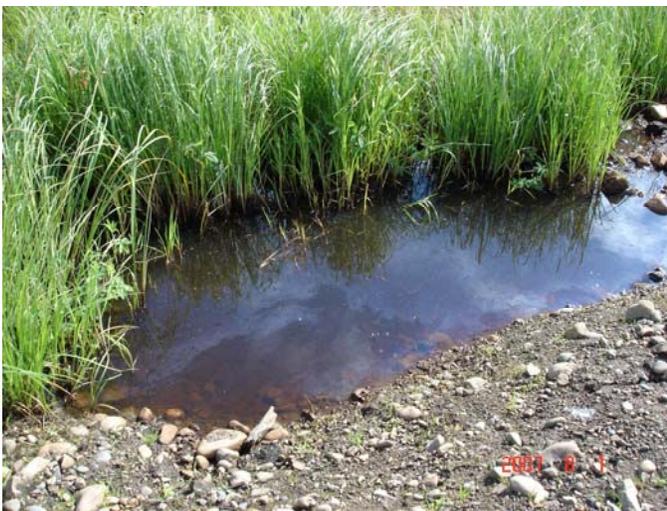
Figure 3
Sheen in the wetland area and ditch by Bulky Metal Waste Disposal Area.
