**RE: Municipal Water Licence (N7L3-0714)**

## WATER LICENCE INSPECTION FORM

<b>DATE:</b>	November 24, 2008	<b>COMPANY REP:</b>	Debbie Raddi
<b>LICENCEE:</b>	Incorporated Hamlet of Tuktoyaktuk	<b>LICENCE #:</b>	N7L3-0714

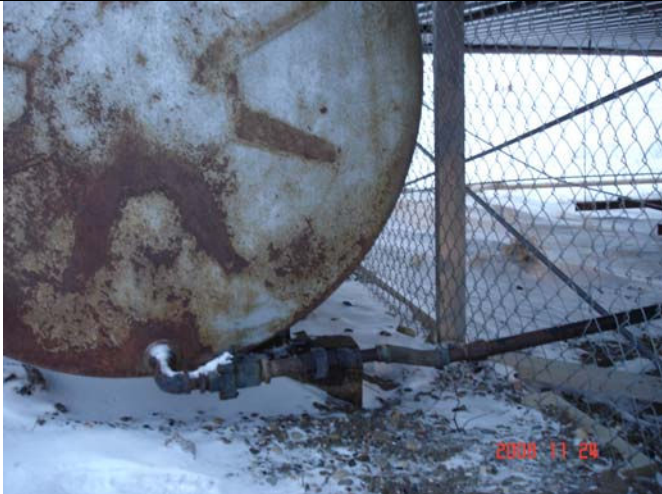
**Figure 1**

Owner:	Hamlet of Tuktoyaktuk	Operator:	Hamlet of Tuktoyaktuk	Condition of tanks:	Fair, has rusty connection points <sup>1</sup>
Berms & Liners	N/A	Water within Berm:	N/A	Evidence of Leaks:	None detected during inspection
Drainage Pipes	N/A		Pump Station and Catchment Berm		N/A
Pipeline Condition	Poor, corroded, hose flex connector mis-aligned <sup>1</sup>		Not Applicable:		N/A

1. Fuel tank and hose flex connector is out of alignment. The pipeline connection to the tank needs to be repaired. Further movement of the tank and pipeline connection can cause a spill. Fuel tank has rust/corrosion at the connection points and should be replaced. Recommend moving the pipeline so it draws from the top of the tank so as to prevent future spills. (see Figure 1)

Fuel Tank has rusted connection points, the flex connector is mis-aligned and piping could leak. The piping system needs to be repaired.

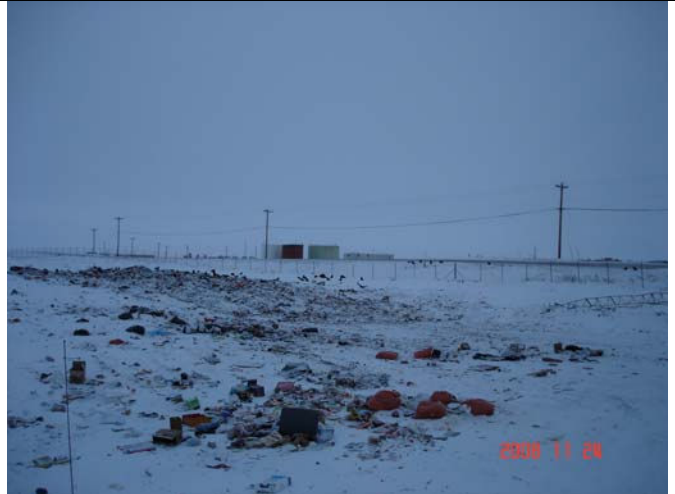
**Figure 2**

- Very little cover material to cover solid waste. This is required to ensure proper maintenance of the SWDF. This would also assist with controlling windblown debris. (see Figure 2)

Additional cover material is needed to cover solid waste and this will assist with controlling windblown debris.
