RE: Municipal Water Licence (N7L3-0714)

An inspection was conducted of the Municipal Water Supply and Waste Disposal Facilities on November 24, 2009. Enclosed is a copy of the Water Licence Inspection Report.

WATER LICENCE INSPECTION FORM

DATE:	November 24, 2009	COMPANY REP:	Debbie Raddi
LICENCEE:	Incorporated Hamlet of Tuktoyaktuk	LICENCE #:	N7L3-0714

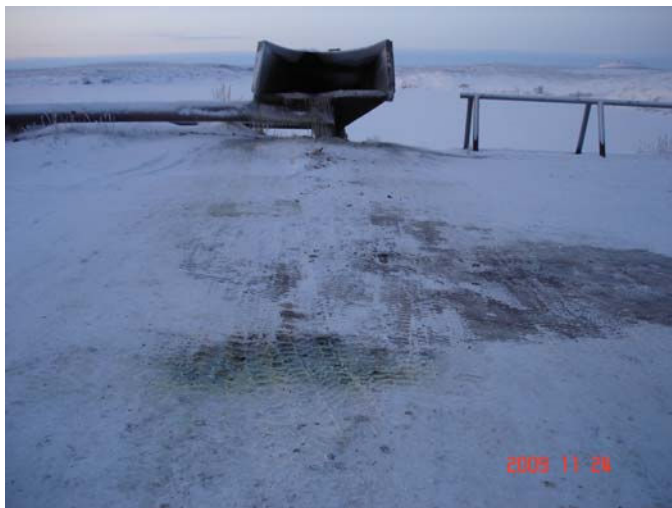
Figure 1

2. Glycol on ground in front of sewage discharge chute from one of the vacuum trucks that had a leak (see Figure 1). The leak was reported to be repaired. Someone was notified to clean up the spill since snow removal occurs to move the snow with sewage (that accumulates on the pad) off to the side of the turn around pad to drain back into the sewage lagoon.

Glycol leak that occurred from one of the vacuum trucks at the Sewage Disposal Facilities.

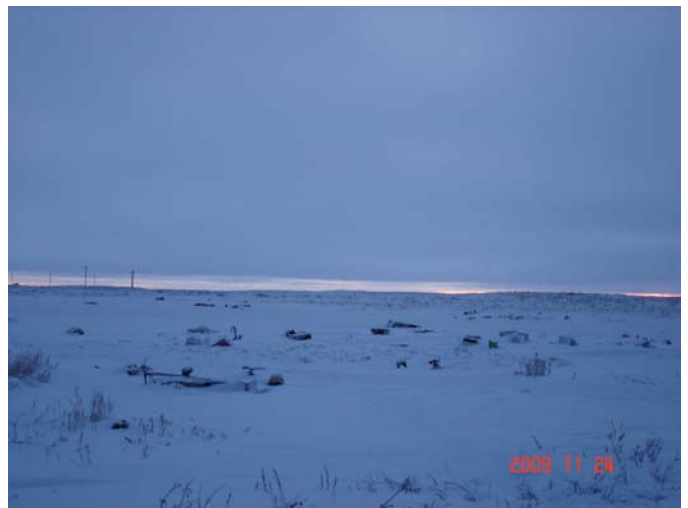
Figure 2

3. There was a visible amount of waste that needs better segregation throughout the Solid Waste Disposal Facility (SWDF). There was a large amount of waste all over the SWDF lagoon that needs to be cleaned up and properly segregated as well (see Figure 2). Waste disposal areas need to be better designated to encourage waste segregation. Signage was present at the SWDF however, additional signage and the continued use of barriers are needed to further increase public guidance. Signs should be posted for but not limited to the following areas: domestic garbage, waste tires, waste appliances(washers/dryers, etc.), wood waste, bulky metal wastes, vehicles/ATVs etc, empty drums, honey bag pit, waste animal pit and hazardous waste(waste oil, batteries etc.).

Large amount of waste in the SWDF lagoon that needs to be cleaned up and properly segregated.

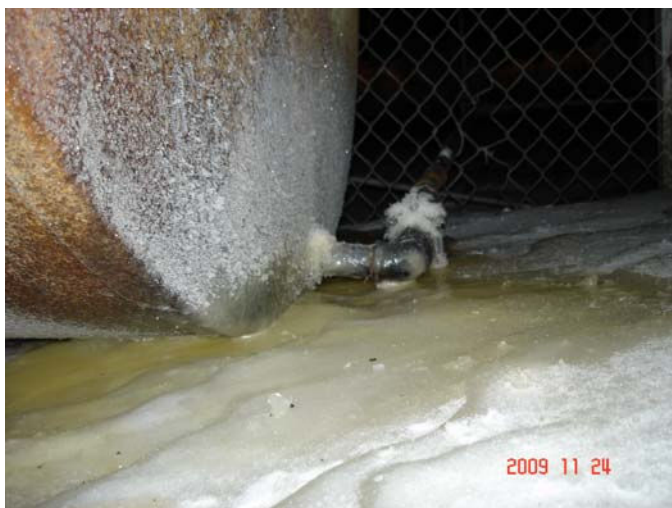
Figure 3

1. At the old Water Treatment Plant (WTP) there is very serious frozen water buildup around tank and associated piping which connects to the tank at the bottom. Movement of frozen water, ice etc. against the pipe and tank could lead to a large spill due to the pipe connecting to the tank at the bottom (see Figure 3). Very strongly recommend protecting the tank and associated piping by moving the tank so the piping is free of the ice around it. It is understood that the use of this tank will be discontinued in a short time as the old Water Treatment Plant will soon be decommissioned. Additionally the fuel tank and hose flex connector is out of alignment and the pipe connection to the tank needs to be repaired.

Movement of frozen water, ice etc. against the old Water Treatment Plant pipe and fuel tank could lead to a large spill.

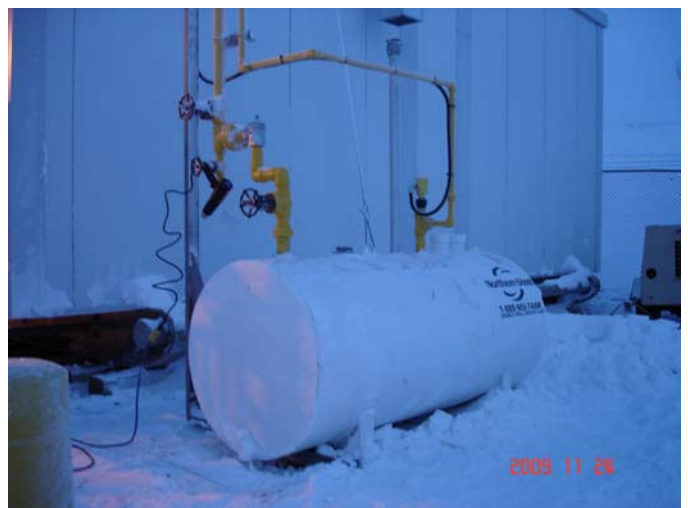
Figure 4

2. New WTP has a new double walled fuel storage tank with a day tank inside the facility. The outside double walled tank has valves that are accessible to the public and should be locked and secure from unauthorized use (see Figure 4). Associated piping is anchored to the tank itself with flex pipes but continue to monitor the current setup against the seasonal changes which could shift infrastructure etc over time.

New Water Treatment Plant fuel tank valves that are accessible to the public and should be locked and secure.
