## MUNICIPAL WATER USE INSPECTION FORM

<b>DATE:</b>	September 23, 2004	<b>COMPANY REP:</b>	Debbi Raddi/Peter Nogasak
<b>LICENSEE:</b>	Incorporated Hamlet of Tuktoyaktuk	<b>LICENCE #:</b>	N7L3-0714

## LIST OF FIGURES FOR WATER LICENCE INSPECTION REPORT

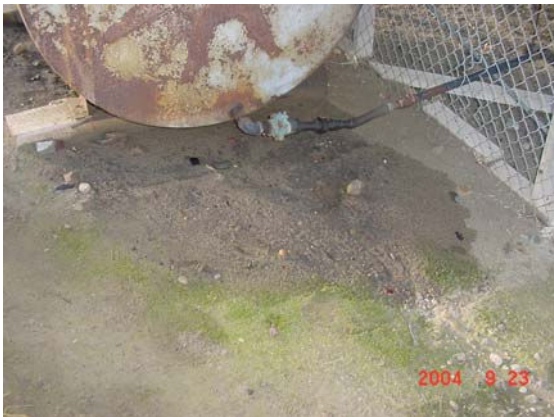
- Small fuel spill at water treatment plant (figure 1). Fuel tank and distribution/conveyance lines badly corroded (figure 1,2). This was addressed in the 2003 Inspection Report.
- Fuel spill 04-572 Pumping Station at Kudlak Lake pumping station (Figure 3). Clean up efforts are currently in progress (figure 4).

Owner:	Hamlet	Operator:	Hamlet	Condition of tanks:	Poor (Figure 1)
Berms & Liners	Not bermed	Water within Berm:	N/A	Evidence of Leaks:	Yes (Figure 1, 4)
Drainage Pipes:	N/A	Pump Station and Catchment Berm:	N/A		
Pipeline Condition:	N/A	Not Applicable:

**Figure 1. Water Supply.** Fuel storage at water treatment plant.

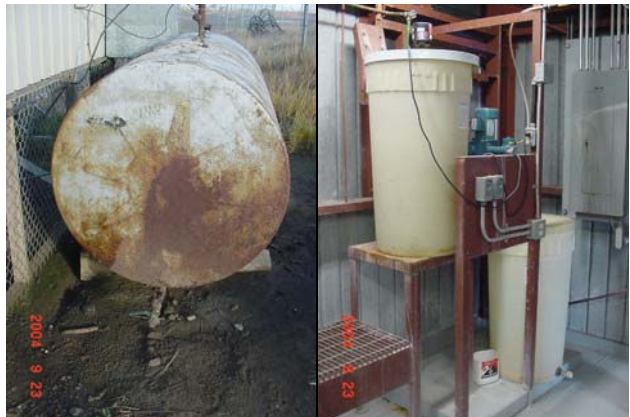
**Figure 2. Water Supply.** Fuel storage at water treatment plant and chlorination system.

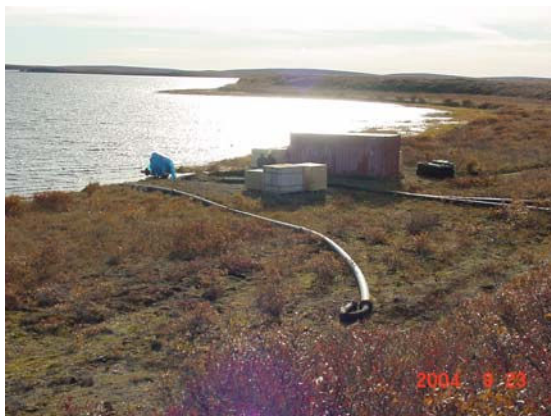
**Figure 3. Water Supply.** Water intake pumping station at Kudlak Lake

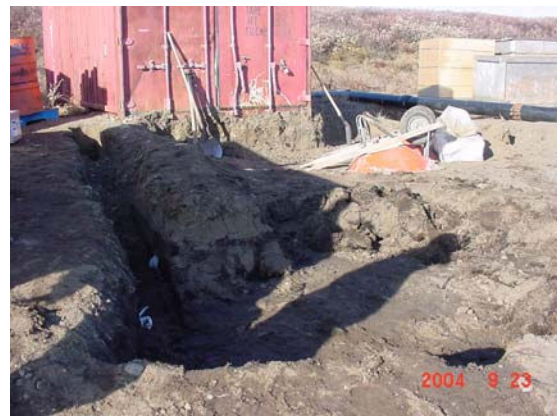
**Figure 4. Water Supply.** Sea Can Fuel Storage Container at Figure 3 and spill 04-572 clean up efforts.

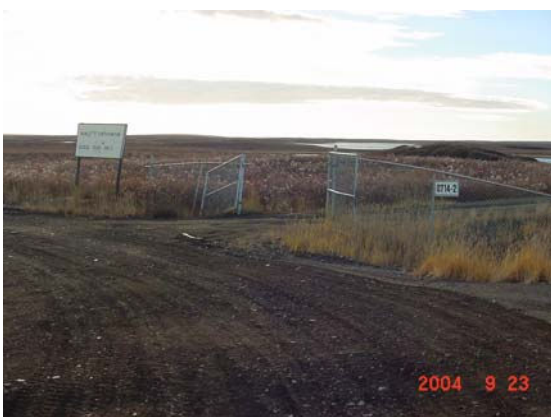
1. SNP 0714-2 & 3 signs (figures 5 & 9 respectively) posted but should be relocated. Please place SNP 0714-2 & 3 where water samples are taken at locations identified in figures 7 & 15 respectively.

**Figure 5. Waste Disposal.** Sewage Lagoon entrance and SNP 0714 sign.

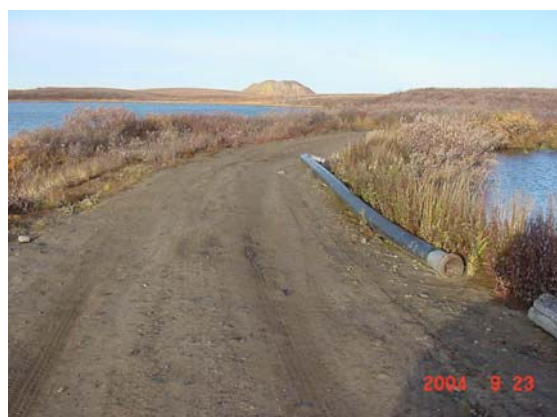
- Discharge of the Sewage Lagoon (figures 6-8) was requested on September 22, 2004. As last year, approval of the discharge at that time was rejected due to high pH levels (above pH 9). As per our letter dated October 05, 2004 fall emergency decant was authorized to maintain structural integrity of the containment berm (figure 6,7) and thus Sewage Lagoon (Part D5, D6). All other parameters were sampled on time and met license effluent quality standards. In the future, industrial discharges to this lagoon will be discouraged until the Hamlet can meet their Water License Discharge criteria. As a note the Hamlet was diligent and made every effort, through sampling and delaying discharge, to meet discharge criteria.

- Lagoon green color indicating aerobic conditions (figure 8).
- No leaks found at sewage Lagoon and SWDF containment berm (figure 6, 7 and 14, 15 respectively).
- In general considerable work has been done at the SWDF including the old bulk metal waste storage area. This material was crushed and buried. The hamlet is looking for a new bulk metals waste disposal area.
- Currently understood that the landfill does not accept hazardous wastes (used oil, batteries, etc). Currently used oil is disposed of at Grubens and is incinerated. Public does not drop off used oil at this facility.

**Figure 6. Waste Disposal.** Sewage Lagoon (south west end) containment berm.

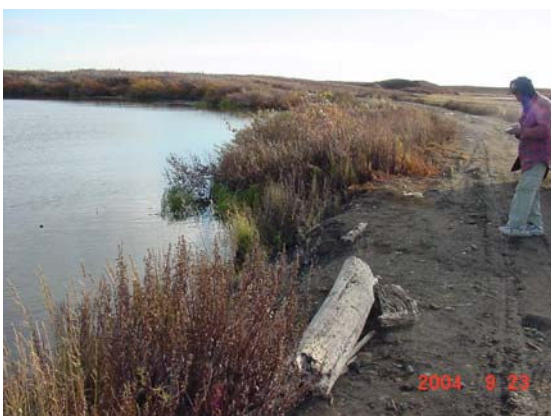
**Figure 7. Waste Disposal.** Proper location for SNP 0714-2 sign.

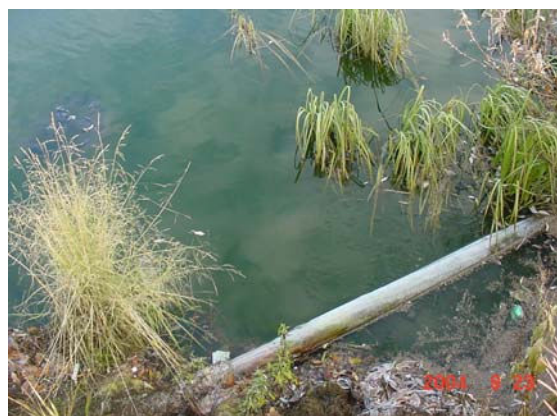
**Figure 8. Waste Disposal.** Sewage Lagoon SNP 0714-2 sampling area.

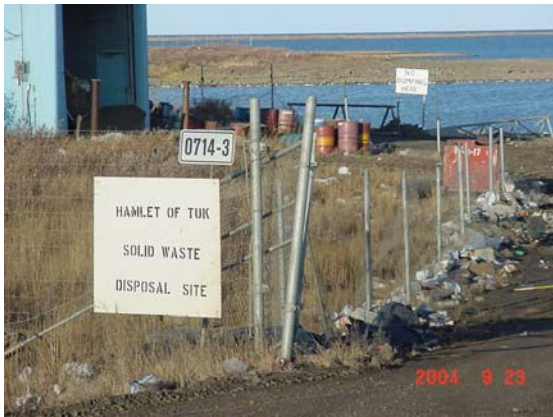
**Figure 9. Waste Disposal.** SWDF entrance and SNP 0714-3 SNP sign.

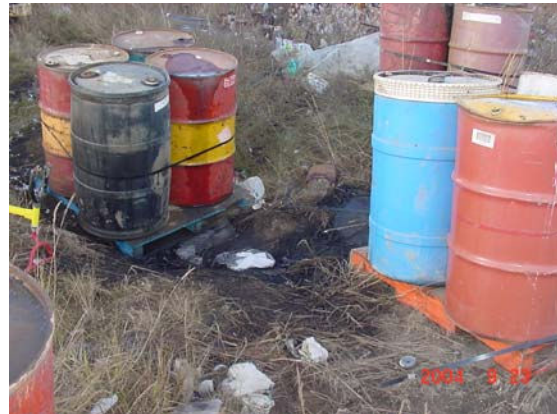
- As indicated last year the SWDF waste oil and hazardous materials area (Figure 12, 13) are becoming permanent storage areas. It is recommended that every effort be made to dispose of these materials at a certified disposal facility. Long term/permanent storage of this material is not recommended. It is only a matter of time before spills occur. It is understood that there is a plan to dispose of this material (waste oil) at Grubens

**Figure 12. Waste Disposal.** SWDF waste oil and hazardous wastes area.

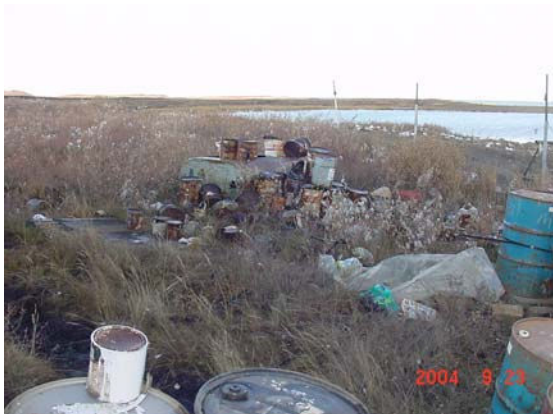
**Figure 13. Waste Disposal.** SWDF waste oil and hazardous wastes disposal area.

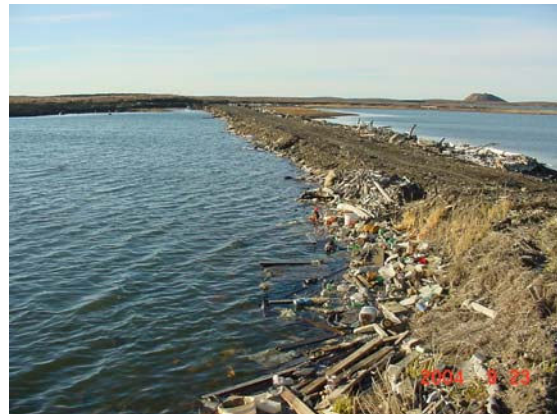
**Figure 14. Waste Disposal.** SWDF north west containment berm.

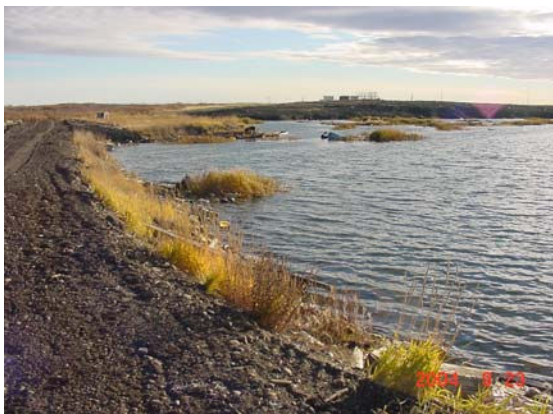
**Figure 15. Waste Disposal.** SWDF north west containment berm and proper location for SNP 0714-3 sign.
