**RE: Municipal Water Licence N7L3-0714  
CLASS B - MUNICIPAL**

An inspection was conducted of the Municipal Water Supply and Waste Disposal Facilities on September 28, 2015. Enclosed is a copy of the Municipal Water Licence Inspection Report.

<b>LICENCE #:</b>	<b>N7L3-0714</b>	<b>EXPIRY DATE:</b>	<b>June 30, 2014</b>
<b>LICENCEE:</b>	<b>Hamlet of Tuktoyaktuk</b>	<b>PREVIOUS INSPECTION:</b>	<b>August 27, 2013</b>
<b>COMPANY REP:</b>	<b>Grant Scott, SAO</b>	<b>INSPECTION DATE:</b>	<b>September 28, 2015</b>

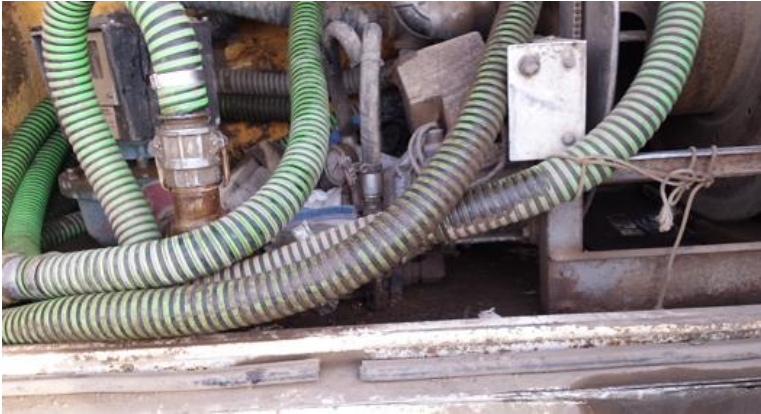
**Figure 1**

- Recommend consolidating all chemicals in a designated area as it is currently spread around the WTP due to lack of space.
- Oil and dirt were observed at the back of one of the potable water trucks (see Figure 1). It is the Hamlet's responsibility to see that such issues are resolved in a timely manner as soon as they are noticed. If left unattended the potable water storage compartment and domestic potable water storage tanks risk being contaminated. Otherwise, the general condition of the truck seemed adequate.

Potable water trucks should be kept clean at all times as it is a potential source of water contamination. Oil and dirt was observed at the back of this truck.

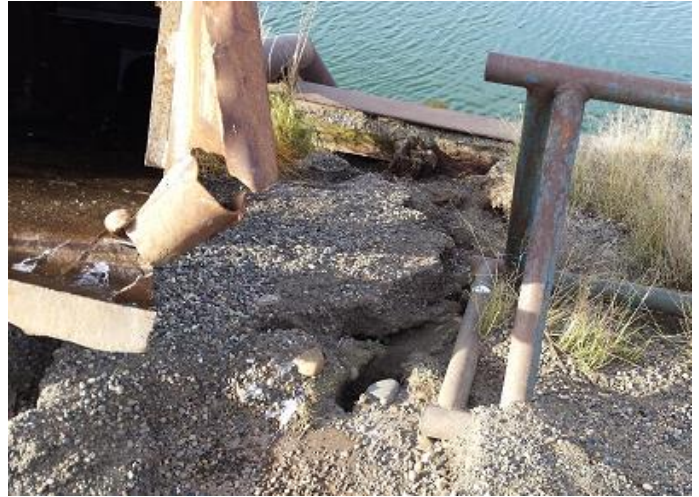
**Figure 2**

- Access road is in good condition (good slope and drainage).
- Important erosion and stability issues observed around the discharge structure (see Figures 2 and 3). The Hamlet is aware of this and Hamlet staff work continuously on mitigation. This is satisfactory in the short term but recommend revamping the entire discharge structure in the near future. Recommend using a catchment basin under the sewage pipes to help minimize damage from spilled sewage.

Important erosion and stability issues observed at the sewage discharge structure (1 of 2).

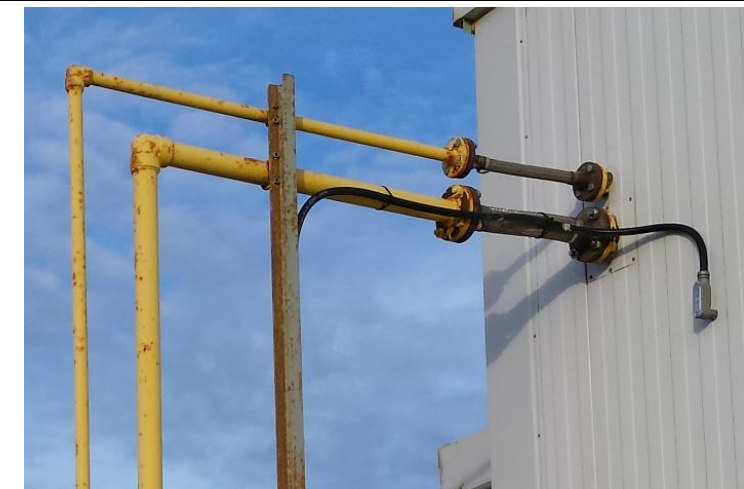
**Figure 5**

- Hamlet benefits from having a number of certified water operators and dedicated backups.
- Hamlet staff reported leveling the WTP building in July 2015. Building has settled since. Advise keeping a close eye on above-ground fuel tank flexor pipe when such work occurs.

Flexor pipe connecting the above ground fuel tank to the WTP is fully stretched.
