**RE: Municipal Water Licence N7L3-0714
CLASS B - MUNICIPAL**

MUNICIPAL WATER LICENCE INSPECTION FORM

LICENCE #:	N7L3-0714	EXPIRY DATE:	November 20, 2013
LICENCEE:	Hamlet of Tuktoyaktuk	PREVIOUS INSPECTION:	September 3, 2010
COMPANY REP:	Tom Matus	INSPECTION DATE:	September 8, 2011

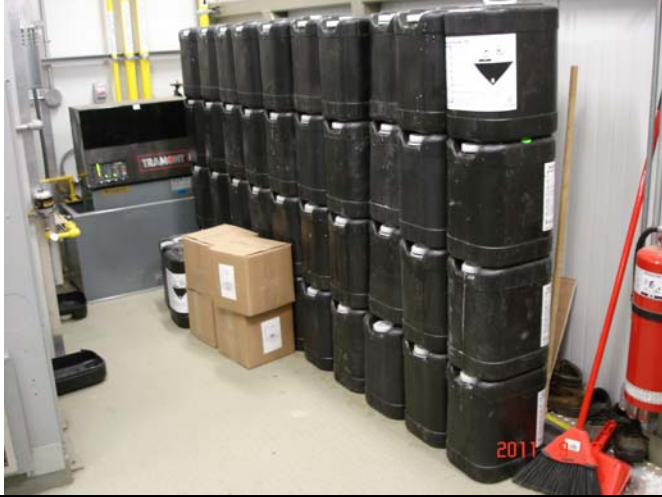
Figure 1

1. There are a large amount of empty sodium hypochlorite(chlorine) containers that need to be disposed of (see Figure 1). Ensure they are properly cleaned and rinsed to get rid of any residuals so as to minimize risk to the environment and any possible future users. They are located by the day tank (fuel tank) located in the Water Treatment Plant (WTP).
2. No drip trays under the emergency generator but are suggested. Continue to monitor as regular operation and maintenance will require its use as eventually there will be oil present. For future operations please ensure that any maintenance activities on WTP equipment are cleaned up afterwards and pose no risk to the cleanliness of the facility.

A large amount of empty sodium hypochlorite (chlorine) containers that need disposal. Ensure they are properly cleaned and rinsed to get rid of any residuals so as to minimize risk to the environment and possible future users.

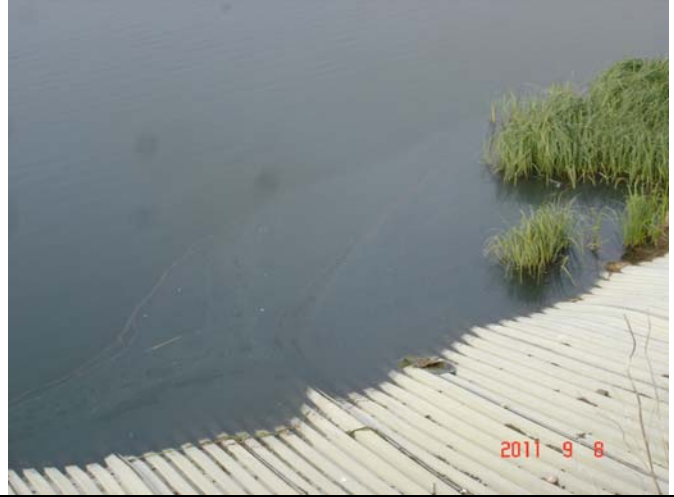
Figure 2

1. In the sewage lagoon a sheen was below the sewage discharge chutes on the northern edge of the lagoon (see Figure 2). It appeared that the sheen and scum layer were at the one end due to prevailing winds/wave action. A sample for oil and grease was taken as part of the sampling for the sewage lagoon discharge. The results can be assessed then if it is still within discharge criteria.

Seen below the sewage discharge chutes and northern edge of lagoon. A sample for oil and grease was taken as part of the sampling for the sewage lagoon discharge.

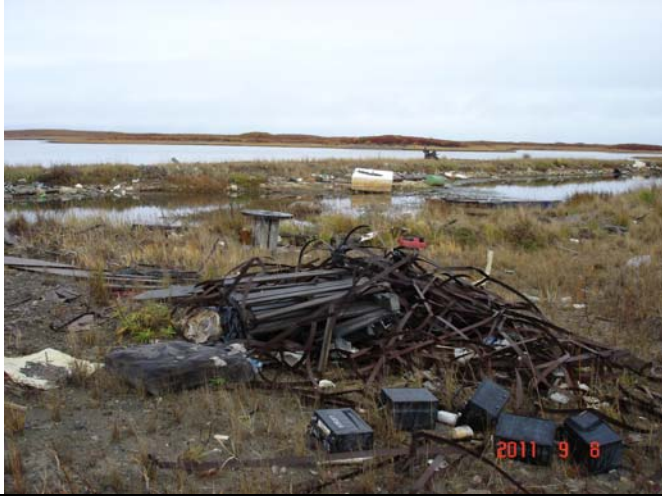
Figure 3

7. There are hazardous wastes (oil/fuel containers, drums, batteries (some cracked), etc.) located throughout the SWDF (see Figure 3) but need to be segregated in a designated temporary storage area that needs to have a berm so as to ensure containment for the hazardous waste. The blue building present on site could easily fulfill this requirement if all the hazardous was stored and contained there (see Figure 4). The roof over head provides an excellent cover for a bermed area as well. It would be important to store full and empty drums separately to aid in any future waste disposal activities. All these procedures would aid in ensuring wastes are collected in an organized and secure fashion that would then be ready for shipping out for disposal. Since the hazardous wastes are not stored in a bermed temporary storage area, this is a violation of Part D: Conditions Applying to Waste Disposal, Item 23, of the Water Licence.

A pile of batteries located by the SWDF lagoon berm that need to be properly segregated from the other waste, stored and prepared for proper disposal.

The Hamlet needs to make certain hazardous wastes (oil/fuel containers (are sealed and made secure), batteries, etc.) are collected and properly stored. The Hamle Foreman mentioned collecting used oil and batteries at an old shop in the Hamlet. In the containment/storage areas these materials need to be collected, consolidated, prepared and either shipped to an approved facility for disposal or burned (fuel and/or oil) in approved equipment. This will ultimately maintain the SWDF in a well managed state that encourages public participation and assistance. There needs to be regular checks at the SWDF for leaks and subsequent repairs including containment of leaking drums, containers, materials to prevent spills and further contamination of the environment. Ensure drums are secure, contained, properly segregated and fluids are unable to leak from containers (strong drum, bung in place, no holes). If required, fluids should be transferred to secure and approved containers.

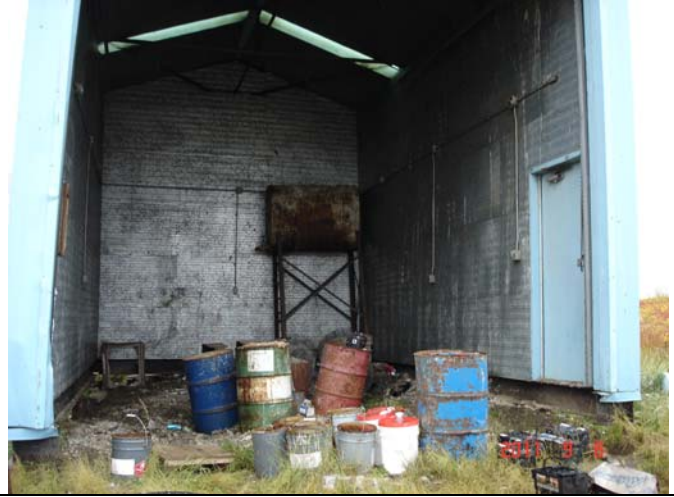
Figure 4

19. Under the SWDF blue building were some unique hazardous waste materials present – 5 gallon pails/metal buckets (see Figure 4). The identity of these containers and contents needs to be confirmed, stored appropriately, and the materials disposed of properly.

There are hazardous wastes located throughout the SWDF that need segregation in a temporary storage area with a berm to ensure containment for the waste. The blue building present on site would fulfill this requirement and the roof over head provides a great cover for a bermed area as well.

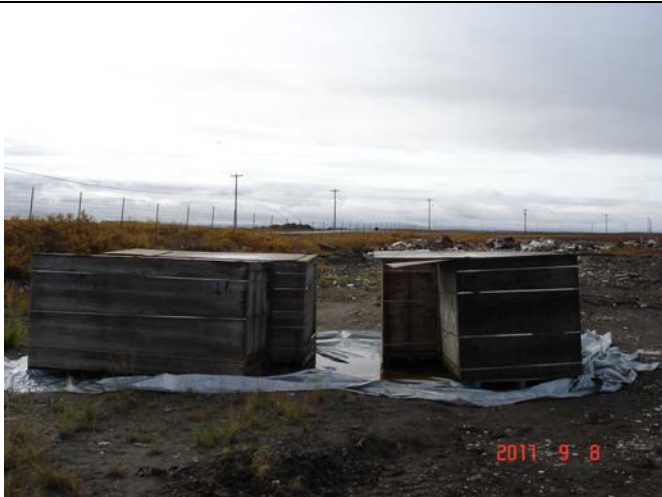
Figure 5

11. There were wooden sea crates of contaminated soil in geotextile liners sealed and stored at the SWDF (see Figure 5). It needs to be sent to a proper contaminated soil remediation and/or disposal facility. Since this soil was located at the SWDF without notification of the Inspector this is a violation of Part D: Conditions Applying to Waste Disposal, Item 21, in the Water Licence which states: "The Licensee shall notify an Inspector when any cotaminated soil or contaminated snow is deposited at the Solid Waste Disposal Facilities." It is encouraging to see the soil is properly contained and secured but notification should have occurred. Now the waste is needing proper disposal as it will continue to be a potential risk of contamination.

There were wooden sea crates of contaminated soil in geotextile liners sealed and stored at the SWDF. It needs to be sent to a proper contaminated soil remediation and/or disposal facility.

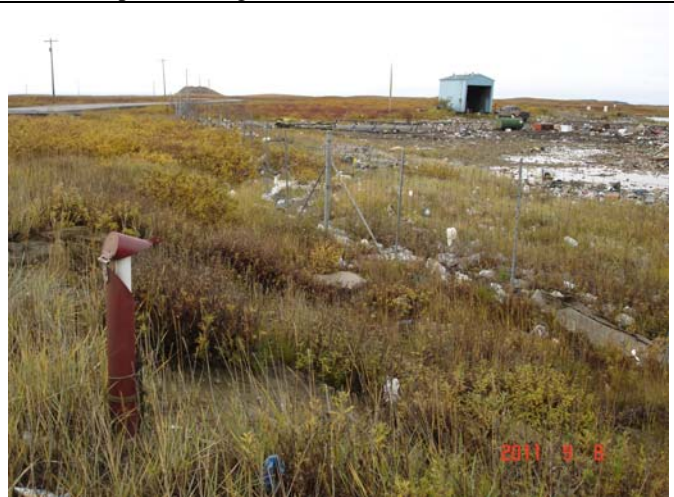
Figure 6

17. All ground water wells need maintenance – any excess pipe needs to be cut off, ensure well cap securely closes, and each well is locked (see Figure 6). This also prevents any possible contamination of groundwater and/or any future samples to be collected.

20. There was pooled water present in amongst the SWDF waste cell area near the entrance of the facility (see Figure 6). Drainage water needs to be prevented from going through the cell area where the current domestic waste etc. is piled up. The drainage ditches and other possible sources of water need to be maintained and have water moving away from the site.

All ground water wells need maintenance – any excess pipe cut off, ensure well cap securely closes, and locked. This also prevents any possible contamination of groundwater and/or any future samples to be collected. Drainage water needs to be prevented from going through the SWDF cell area where the current domestic waste is piled up.
