**RE: Municipal Water Licence (N7L3-1531)**

## WATER LICENCE INSPECTION FORM

<b>DATE:</b>	September 9, 2008	<b>COMPANY REP:</b>	Raymond Kaslak
<b>LICENCEE:</b>	Hamlet of Sachs Harbour	<b>LICENCE #:</b>	N7L3-1531

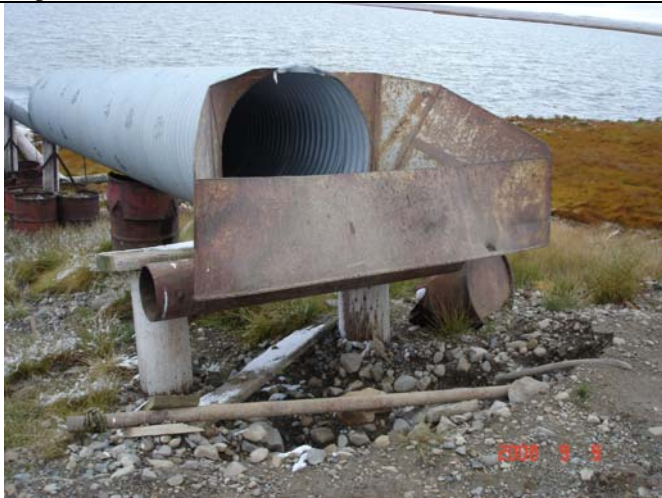
**Figure 1**

1. Erosion is occurring around the sewage discharge chute at the Sewage Disposal Facility(SDF). Maintenance needs to occur around chute and area to prevent further erosion. Sewage truck needs a truck tire stop/barricade. (see Figure 1)

Erosion occurring at the sewage discharge chute. Truck tire stop/barricade is needed.

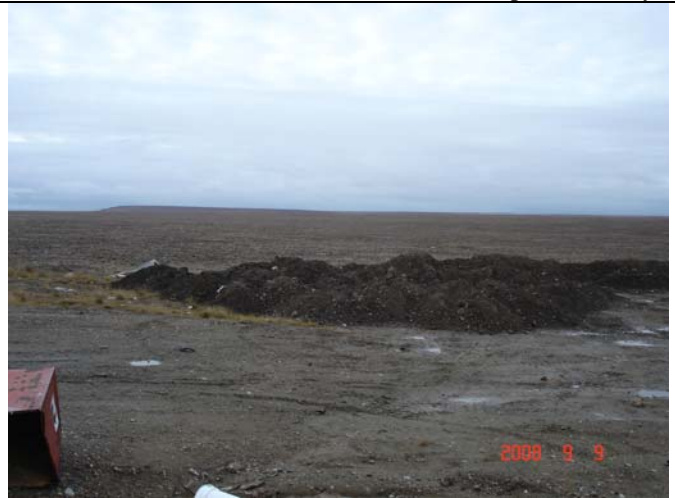
**Figure 2**

2. An old POL tank farm spill on the beach in front of the Hamlet has been excavated and dumped on a geotextile liner. It was requested by the Hamlet to remove the soil to the Solid Waste Disposal Facility(SWDF). Contaminated soil has been transported to the SWDF. During the inspection it was mentioned that there should be a berm/liner at the SWDF for the contaminated soil. The presence of contaminated soil at the SWDF occurred as a modification without notification of the Northwest Territories Water Board and without proper containment is unacceptable and could lead to further contamination. The Hamlet needs to comply with the Water Licence Part E: Conditions Applying to Modifications and provide proper containment for the contaminated soil. (see Figures 2 and 3)

Contaminated soil pile from the tank farm spill excavation with no visible containment at Solid Waste Disposal Facility.

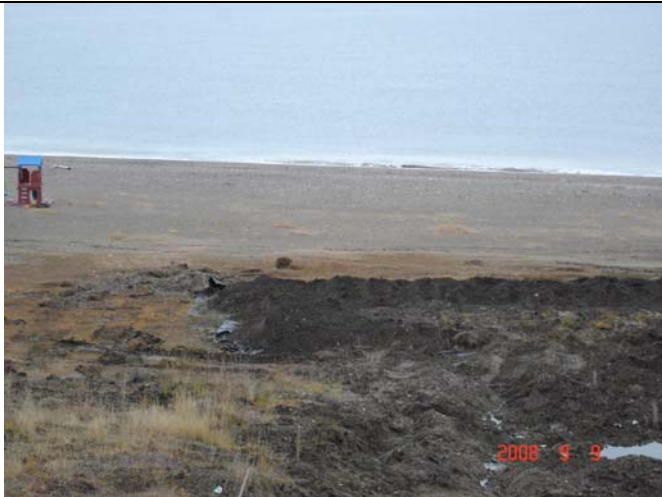
**Figure 3**

Contaminated soil pile with visible geotextile liner at the excavation site.

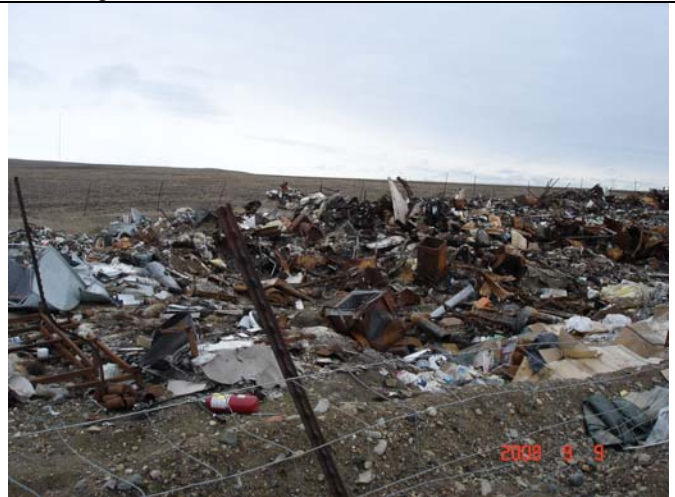
**Figure 4**

4. Burning of non-segregated Municipal Solid Waste (MSW) is still occurring. Burning of non-segregated MSW remains an unacceptable option for the management of MSW. Wastes that are conditionally suitable for open burning are paper products, paperboard packaging and untreated wood wastes according to the document from the GNWT Department of Environment and Natural Resources titled 'Municipal Solid Wastes Suitable for Open Burning' (Please see enclosed document). (see Figure 4)

Burning of non-segregated Municipal Solid Waste is still occurring.
