**RE: Industrial Water Use N7L1-1759
CLASS B - INDUSTRIAL
Mackenzie River**

INDUSTRIAL WATER USE INSPECTION REPORT

LICENCE #:	N7L1-1759	EXPIRY DATE:	November 30, 2002
LICENCEE:	Suncor Energy Inc.	PREVIOUS INSPECTION:	January 31, 2002
COMPANY REP:	John Kerkhoven	INSPECTION DATE:	August 24, 2011

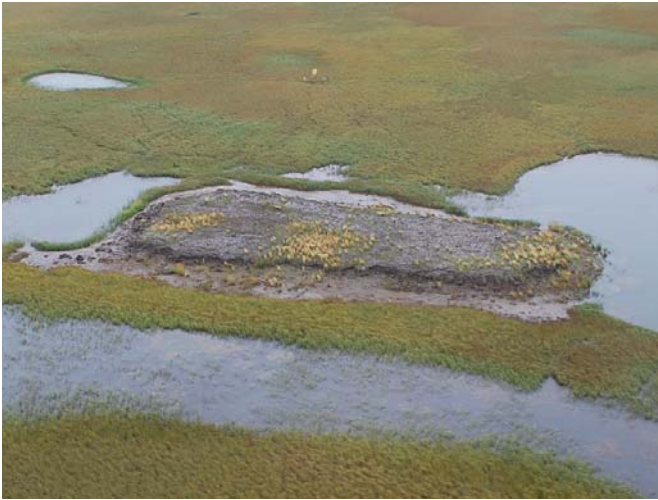
- Drilling sump has what is estimated to be natural ponding surrounding the sump on all sides. It still appears stable and the sump cap is intact and well drained. Soil is good silt/clay like quality and is compacted. Did not observe any issues as waste appears to be contained and no subsidence is evident (see Figures 1-4).

Figure 1
Kurk M-15 drilling sump. Eastern side of sump with ponding surrounding the sump and poor vegetation cover, August 23, 2010.

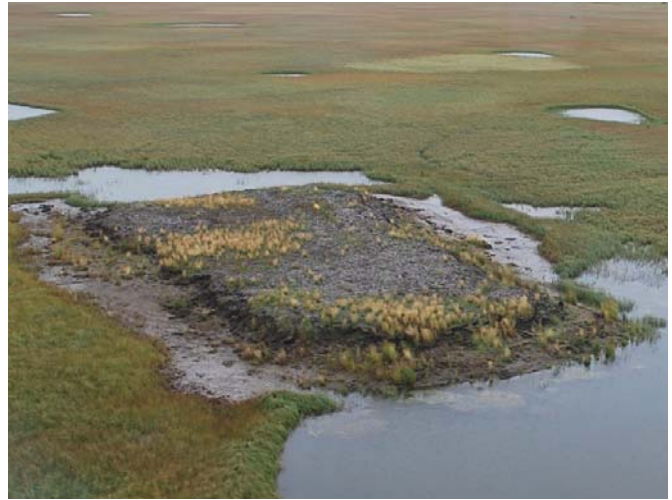
1. Local river flooding and other conditions are contributing to erosion of the sump cap for the drill sump. Sump cap edges are sloughing due to erosion but it is now a 90 degree hard edge as compared to a sloping edge to the ground surface. This is much more susceptible to continued erosion. Further vegetation growth and establishment is needed to prevent further erosion over the long term.
2. Both the drill sump and camp sump have bare soils present which need more vegetation growth. There has been an improvement for the drill sump and only slightly so for the camp sump. The vegetation growth is needed to protect the soil and ensure better protection for the sump caps

Figure 2
North end of drilling sump. Erosion occurring with sump cap edges, August 23, 2010.

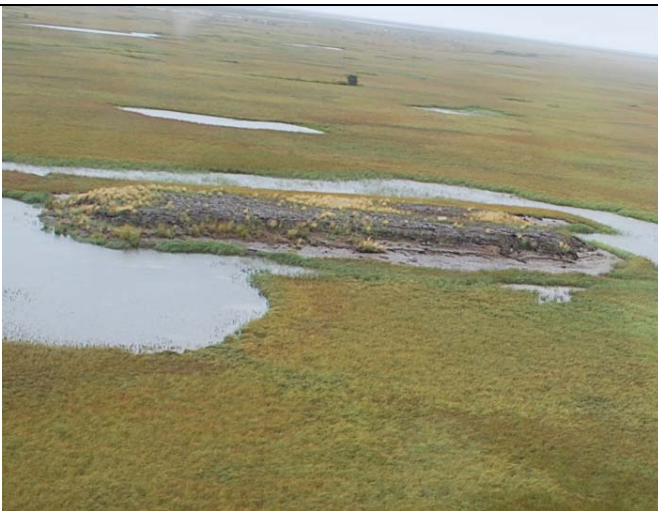
Figure 3
Western side of drilling sump, August 23, 2010

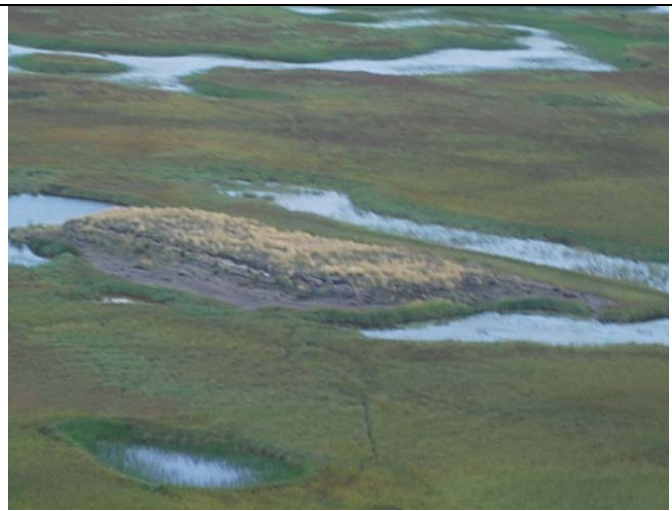
Figure 4
South west side of drilling sump. Improved vegetation growth, coverage ~70%, August 24, 2011.

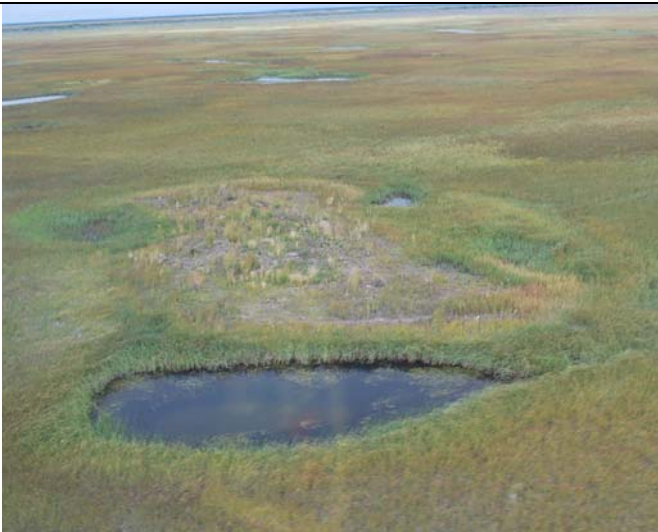
- Camp sump appears stable and well drained. The vegetation coverage is ~70%. There is ponding surrounding the sump on most sides. Do not observe any issues with the sump itself (see Figures 5 and 6).

Figure 5
Kurk M-15 camp sump, south end. Vegetation coverage ~70%, August 24, 2011.

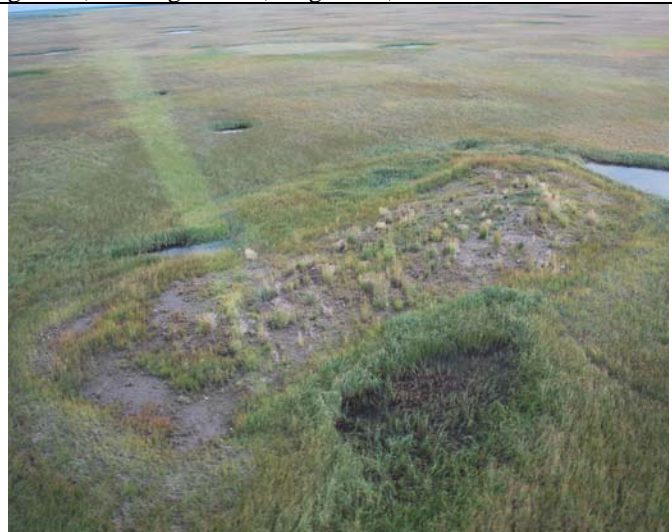
Figure 6
Northwest end of camp sump. Sump cap is not very elevated and has a more gradual slope, August 24, 2011
