**RE: INDUSTRIAL Water Use N7L1-1759
CLASS B - INDUSTRIAL
Mackenzie River**

INDUSTRIAL WATER USE INSPECTION REPORT

LICENCE #:	N7L1-1759	EXPIRY DATE:	November 30, 2002
LICENCEE:	Suncor Energy Inc.	PREVIOUS INSPECTION:	August 24, 2011
COMPANY REP:	John Kerkhoven	INSPECTION DATE:	July 31, 2013

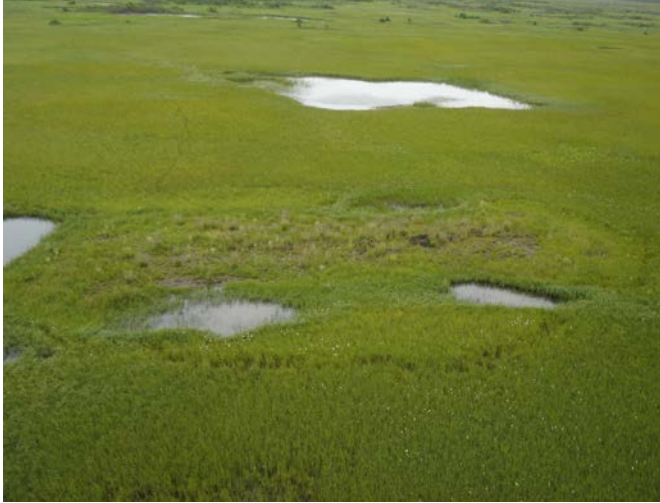
Figure 1

- Vegetation is well established on camp sump
- No erosion issues noted.

Good vegetation growth on the camp sump.

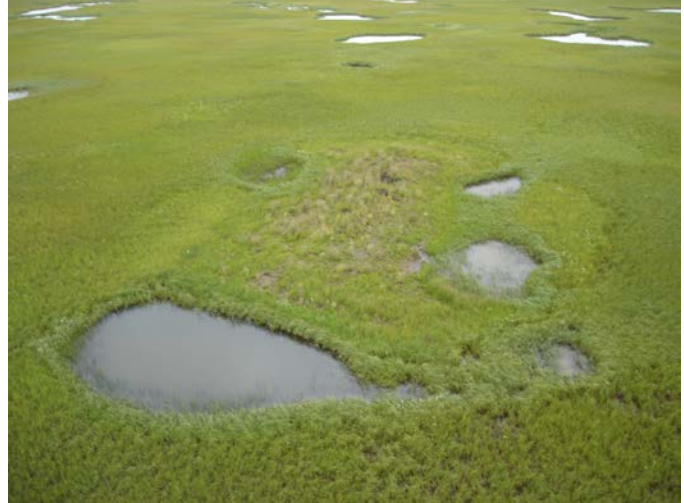
Figure 2

- Vegetation coverage is 70-80% on the drill sump. It is somewhat bare on edges and slope of sump.
- The camp sump is well vegetated with 70-80% with ponding present.

Camp sump surrounded by ponding and cap with visual indications of bare soil.

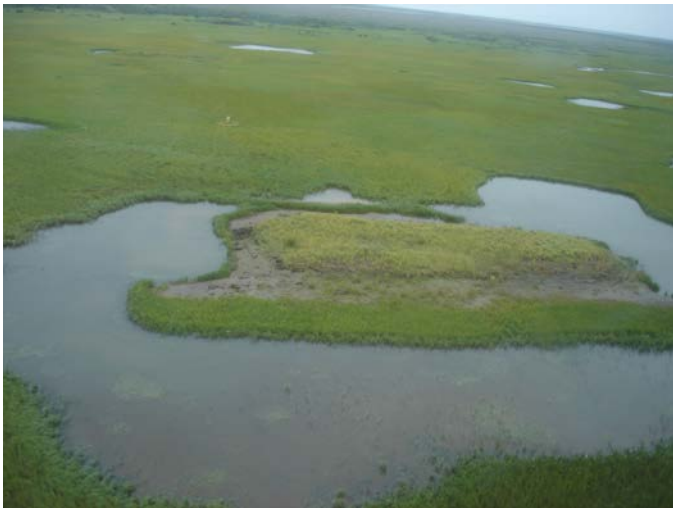
Figure 3

- Ponding surrounding the drill sump but also present in other areas.
- Drill sump cap visually is better sloped then previous site visits and inspections.
- Drill sump and area appears to be stabilized.
- At the base around the drill sump there is bare soil that has less vegetation coverage. Further vegetation growth is needed to protect the soil and ensure better protection for the drill sump cap.
- No other erosion issues noted.

Drill sump with a view of the extent of ponding and bare soil present surrounding base of sump.

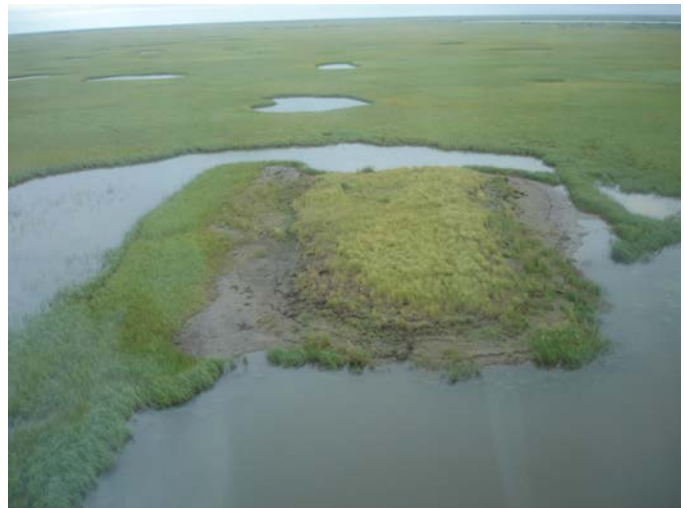
Figure 4

Drill sump showing improved vegetation growth in addition to be better sloped sump cap compared to previous inspections.

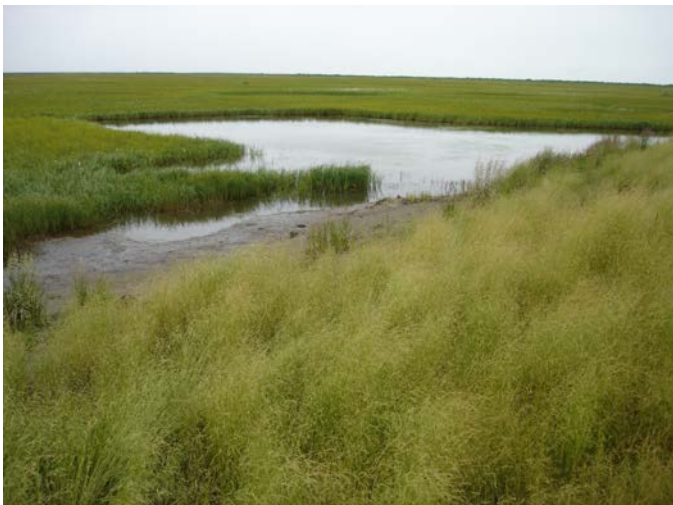
Figure 5

Drill sump cap with bare soil and ponding proximity to sump base.

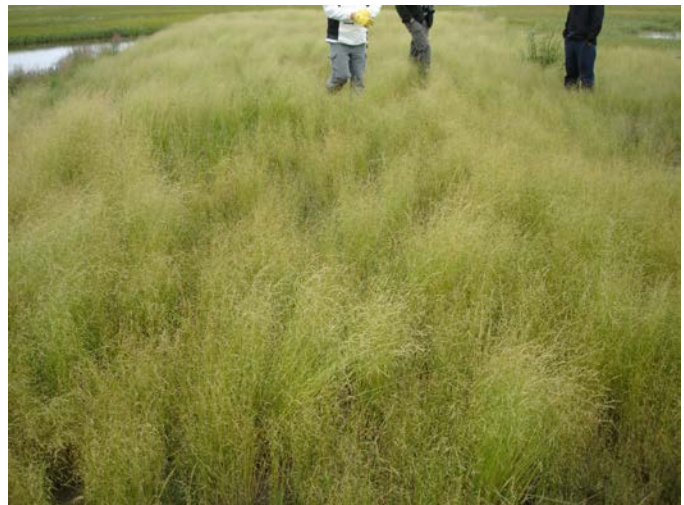
Figure 6

Thickness and extent of vegetation growth on surface of drill sump cap.
