**RE: Industrial Water Use N7L1-1769
CLASS B - INDUSTRIAL
Unnamed Channel – Mackenzie River**

INDUSTRIAL WATER USE INSPECTION REPORT

LICENCE #:	N7L1-1769	EXPIRY DATE:	September 30, 2002
LICENCEE:	JAPEX Canada Limited	PREVIOUS INSPECTION:	March 26, 2002
COMPANY REP:	Toshi Hirata	INSPECTION DATE:	August 24, 2011

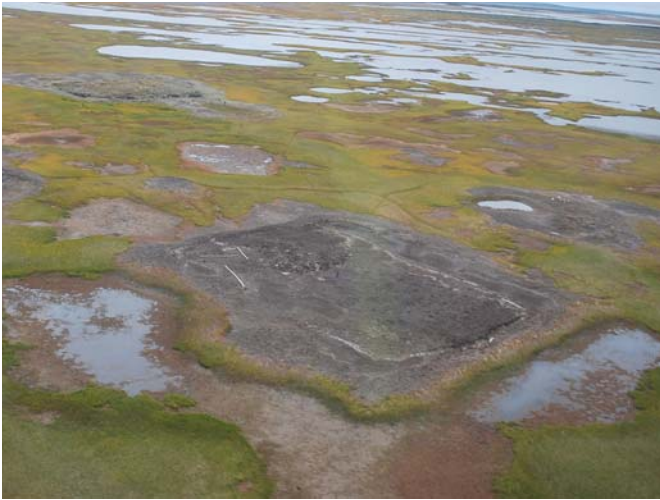
1. The drill sump cap has subsidence present and there is some water ponding surrounding the sump cap (see Figures 1 and 3). The camp sump has major subsidence in fact it is the most of any sumps in the area and there is water ponding in the northern section of sump subsidence in addition to major cracking and sloughing (see Figures 5 and 6). These issues will have an influence on sump long term stability. The presence of water ponding within the sump caps or in close proximity to the sumps could manifest larger problems later on. This is a concern as it relates to a possible effect on permafrost and the subsequent containment of wastes. Continued monitoring is recommended but the long term solution would be to give this matter the appropriate action such as reclaiming the sump caps by filling in the subsidence. This would aid in ensuring long term stability.

Figure 1
Aerial overview of drill sump, water ponding around the sump edges. Some subsidence on the sump cap, August 24, 2011.

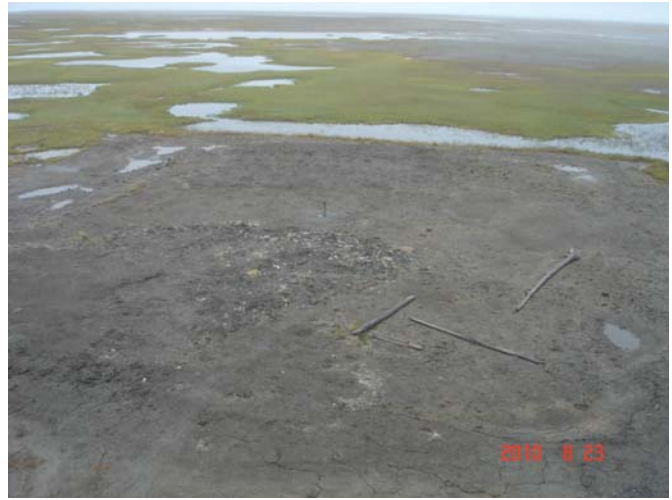
- Both the drill and camp sump are sloped to the ground surface but there is minimal sump cap present. A lot of areas it is almost at or close to the ground surface or subsided (see Figures 2 and 4). The vegetation cover on the drill sump is <10% whereas the camp sump has ~15% vegetation cover.
- There was a site visit in August 23, 2010 that found similar observations to the Inspection. The camp sump has major slumping and subsidence in the north and south ends about 1 – 1.5 metres deep, ponding was present in the north end. For the drill sump there was subsidence on the south end and northeast corner. It was noted that there was little vegetation cover. The sumps looked like they were in a state of change especially the camp sump.

Figure 2
Drill sump cap with subsidence and ponding present. Poor vegetation growth, coverage of <10%, August 23, 2010.

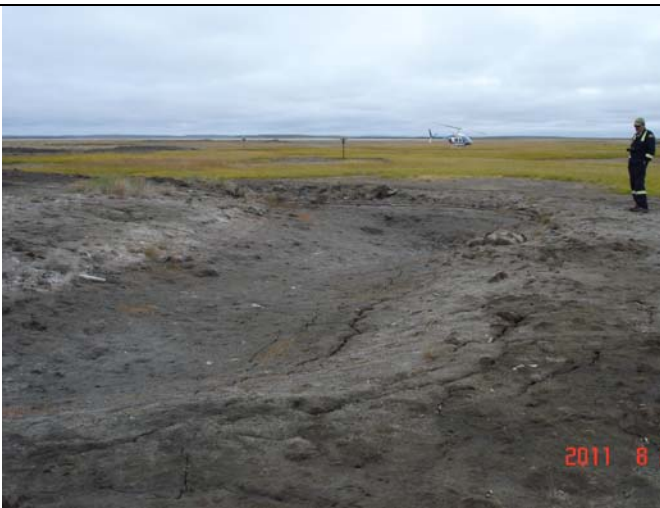
Figure 3
Drill sump southeast corner major subsidence, August 24, 2011.

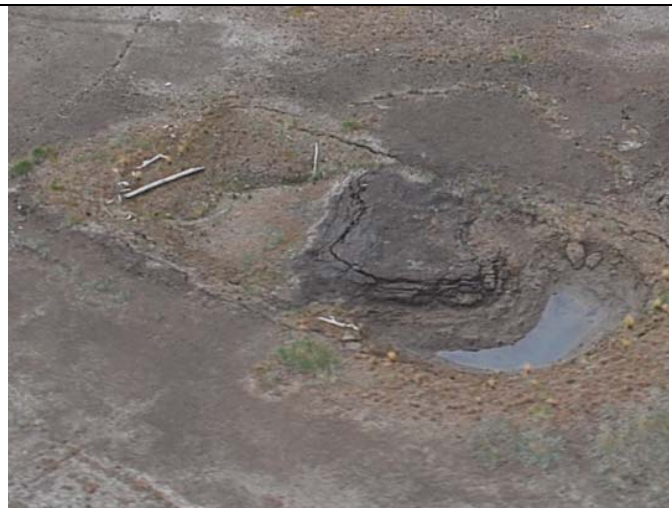
Figure 4
Aerial overview of camp sump. Large amount of deep subsidence and surficial cracking. Poor vegetation growth, coverage of ~15%, August 24, 2011.

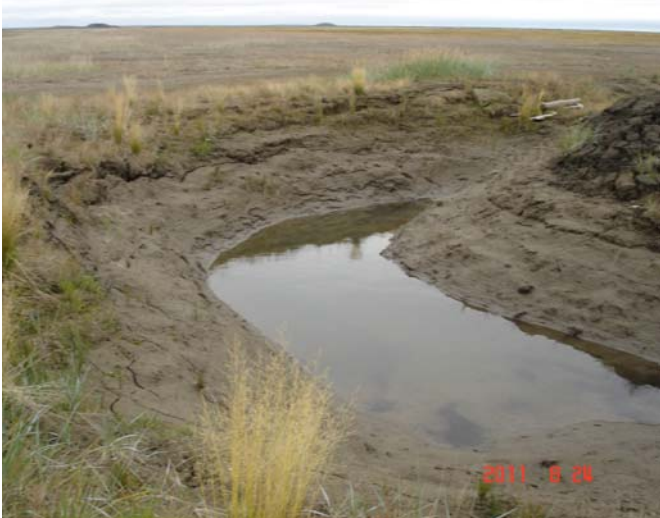
Figure 5
Camp sump with very deep north side subsidence and water ponding in the bottom, August 24, 2011.

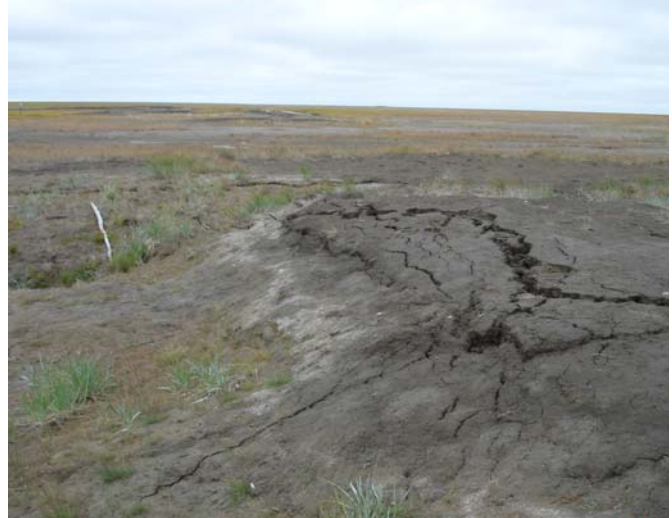
Figure 6
Camp sump south side subsidence and cracking, August 24, 2011.
