**RE: Industrial Water Use N7L1-1769  
CLASS B - INDUSTRIAL  
Unnamed Channel – Mackenzie River**

## INDUSTRIAL WATER USE INSPECTION REPORT

<b>LICENCE #:</b>	N7L1-1769	<b>EXPIRY DATE:</b>	September 30, 2002
<b>LICENCEE:</b>	JAPEX Canada Limited	<b>PREVIOUS INSPECTION:</b>	August 24, 2011
<b>COMPANY REP:</b>	Yukio Kishigami	<b>INSPECTION DATE:</b>	October 2, 2012

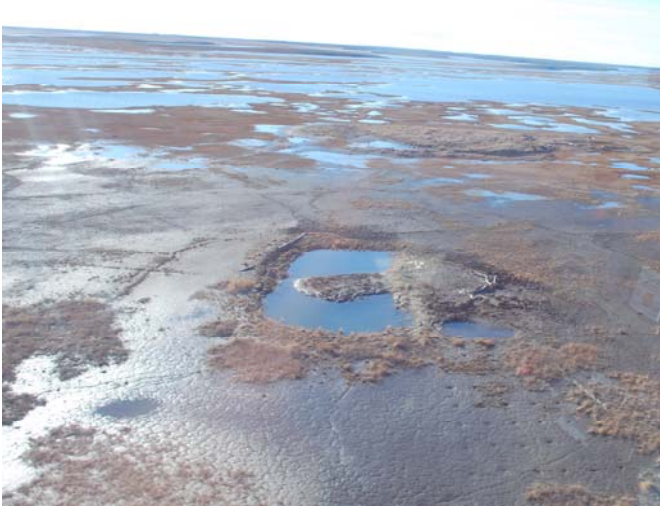
Figure 1

1. Subsidence remains consistent with the previous Water Licence Inspection dated August 24, 2011. There was a significant amount of water throughout the Mallik area and ponding within sump subsidence. The camp sump continues to have the deepest subsidence of any of the sumps in the area and the water almost filled its northern and southern sections.

1. The camp sump had major ponding present since there was a lot of water in the Mallik area. The northern and southern sections of the sump were almost completely full of water. In the previous inspection the depth of subsidence was estimated to be about 1-1.5 metres deep. The drill sump had more water ponding then previously seen in the south end and northern portions where subsidence has occurred.
2. The sumps associated with this program have minimal sump caps remaining. The caps are close to the surface of the ground with minor sloping. Vegetation cover remains consistent with previous inspections and site visits where sump surface has a lot of bare soil - the drill sump is <10% whereas the camp sump has ~15%.

Aerial overview of camp sump. Subsided areas have more ponded water present compared to previous inspections. Poor vegetation coverage, October 2, 2012.

Further monitoring is recommended but a longer term solution would be to give the sumps the appropriate attention such as reclaiming the sump caps by filling in the subsidence to ensure long term stability. Continued subsidence and especially the ponded water when present will have an influence on sump long term stability. These could both cause larger problems later on due to possible effects on permafrost and containment of wastes.

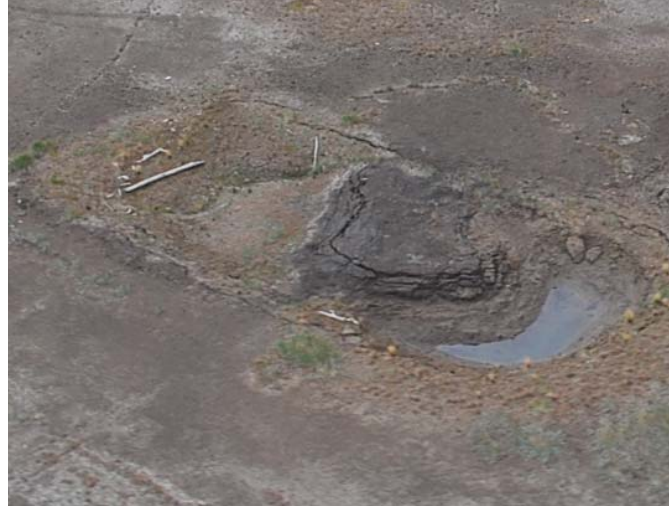
Figure 2

Camp sump with large amount of subsidence and surficial cracking. Very deep north side subsidence and water ponding in the bottom, August 24, 2011.

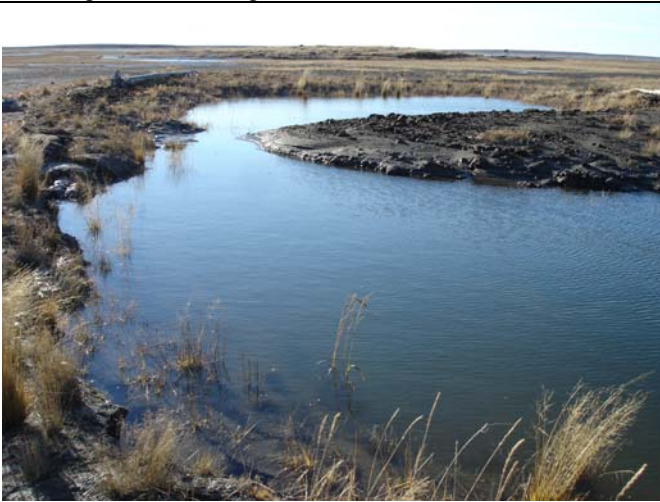
Figure 3

Camp sump subsidence and ponding, from northeast corner, October 2, 2012.

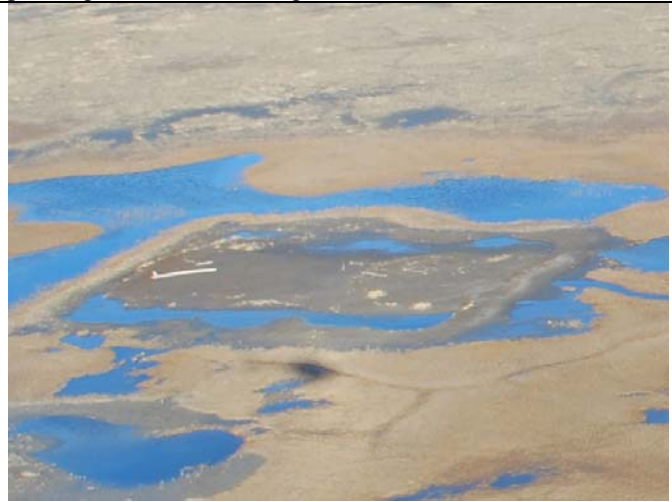
Figure 4

Aerial overview of drill sump, water ponding on the south end and northern portions of the sump in addition to the area surrounding the sump, October 2, 2012.

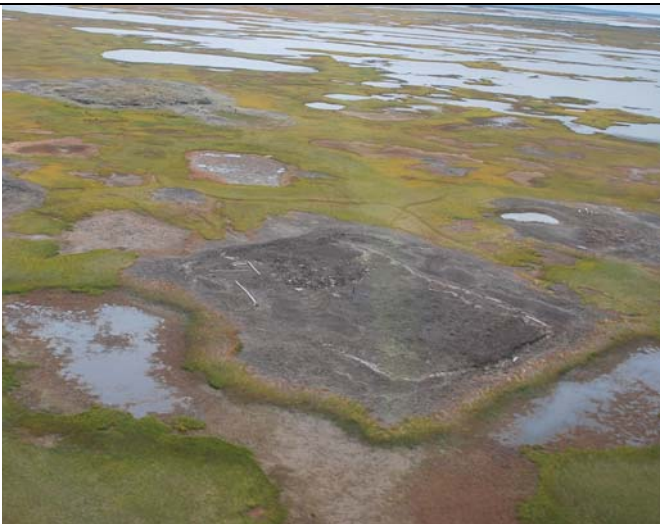
Figure 5

Drill sump cap with subsidence and poor vegetation growth, August 24, 2011.

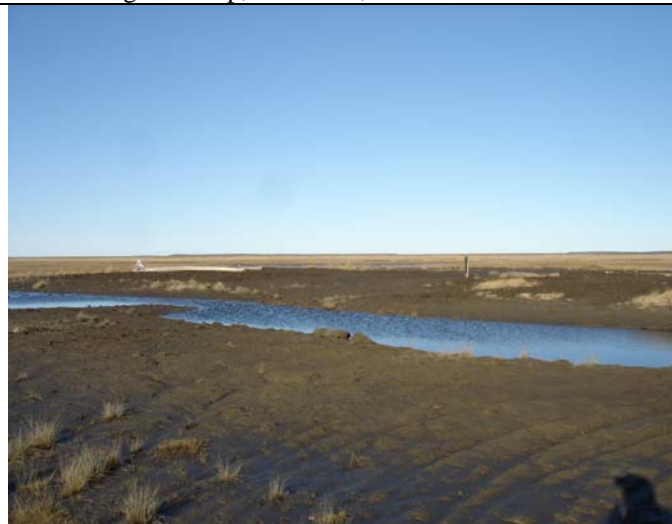
Figure 6

Drill sump subsidence now full of ponded water, from southeast corner, October 2, 2012.
