**RE: Industrial Water Use N7L1-1788
CLASS B - INDUSTRIAL
Mackenzie River**

An inspection of the Suncor Energy Inc. Water Licence N7L1-1788 (expiry on November 30, 2002) was conducted on August 25, 2011. The operation under the above mentioned Industrial Water Use was inspected to assess compliance and ensure that the terms and conditions were met. Enclosed is a copy of the Inspection Report (3 pages) for your review and records.

INDUSTRIAL WATER USE INSPECTION REPORT

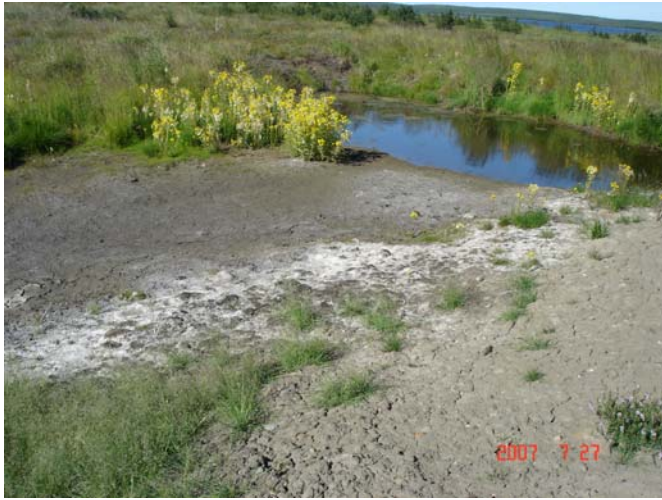
Figure 1

White coloration present on the western edge of the drill sump bordering the larger pond, July 27, 2007.

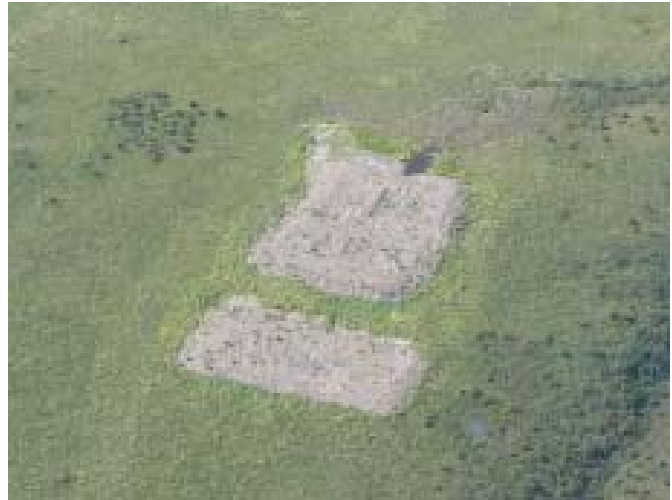
- Two site visits occurred previously. The August 23, 2010 site visit observed similar conditions to those noted above in that there was ponding on site and vegetation cover present but a lot of bare soil, the edges of the sumps appeared stable. There were very prevalent cracks and stress fractures throughout sumps - very large, very deep, a couple of inches wide and many inches deep (see Figure 3). Ponding on site was very deep, subsidence that ranged in depth from at least 0.5 to 1.0 meters in depth from the surrounding area. There was some surface sheen on the small pond in between the sumps, it was very small pockets and surrounded by a surface scum throughout but thought to be natural. During the July 27, 2007 site visit there was a white coloration present on the western edge of the drill sump bordering the larger pond (see Figure 1). The growth of vegetation was evident when compared to the current inspection (see Figure 2 and 4).

Nuna I-30 drill and camp sumps with poor vegetation growth, July 27, 2007.

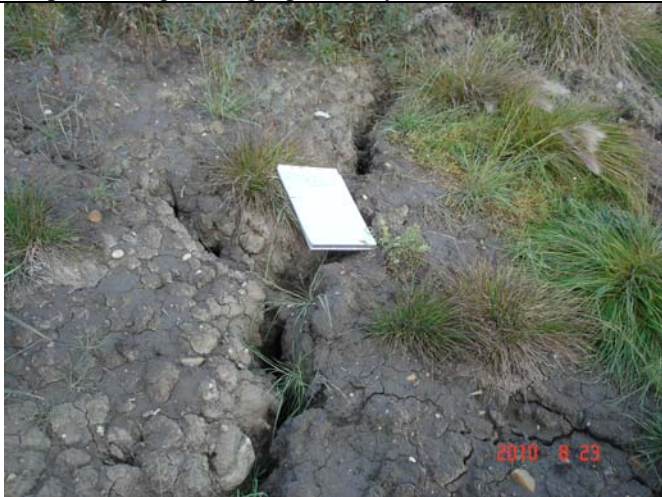
Figure 3

1. Large surficial cracking present throughout both the drill and camp sump caps. This is a concern as the cracks are quite deep and might pose a stability or erosion risk in the future (see Figure 3).

There were very prevalent cracks and stress fractures throughout sumps - very large, very deep, a couple of inches wide and many inches deep, August 23, 2010.

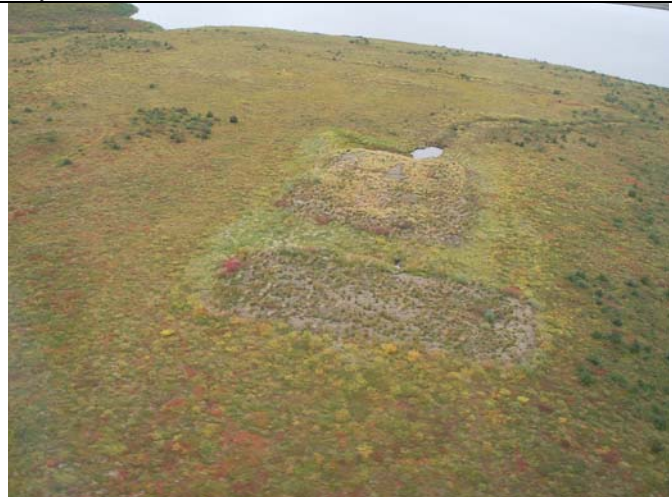
Figure 4

- Vegetation cover is ~60-70% but there is a lot of bare soil remaining with no vegetation cover (see Figure 4). Erosion of sump cap does not appear to be an issue on site as soil surface erosion was not observed. There does seem to be protection from the vegetation that is present and the type of soil on site.
- Site was clean and void of any garbage or solid waste.
- By observation the sump appears stable, no containment issues noted, the waste appears to be contained.
- Both the sumps are well drained and sloped to the sides.

Facing west, the Nuna I-30 sumps appear to be stable with sufficient vegetation coverage ~60-70%. Subsidence and ponding visible in between the sumps and on the west side of the drill sump, August 25, 2011.

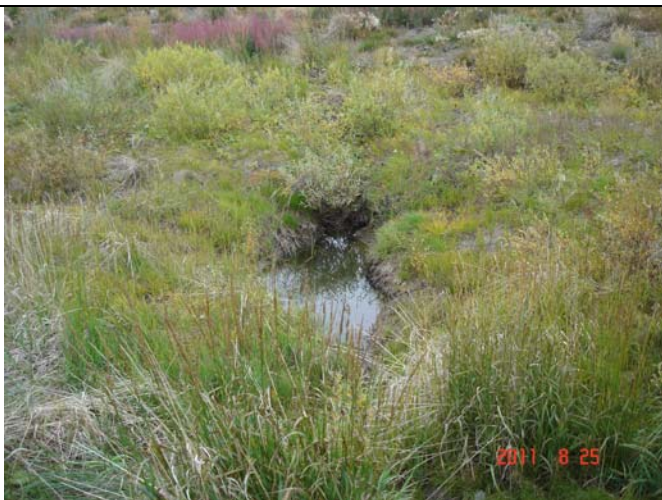
Figure 5

Small subsidence between the drilling and camp sumps with more vegetation coverage, August 25, 2011.

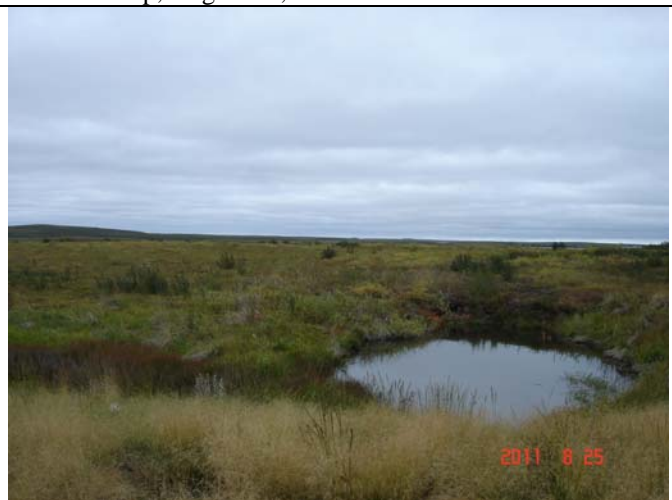
Figure 6

3. Slumping or subsidence of the sump cap is not occurring aside from ponding in specific areas by the drill and camp sump. There is a large pond to the west of the drill sump (see Figure 6). A small pond in the middle between the drill sump and the camp sump with drainage from the sumps on each end and out to the side (see Figure 5). These two areas are largely subsided but remain similar over time and might be associated with the presence of the sumps in combination with the local hydrology. The ponding is away from sump caps but there is still a possibility of influence on sump long term stability. This is a concern as it relates to a possible effect on permafrost and the subsequent containment of wastes. The presence of water ponding in close proximity to the sumps could manifest larger problems later on. Continued monitoring is recommended but the long term solution would be to give this matter the appropriate action such as reclaiming the subsided areas surrounding the sump caps by filling in the subsidence. This would aid in ensuring long term stability.

Larger pond on the west side of the drilling sump with increased vegetation coverage present, August 25, 2011.
