**RE: INDUSTRIAL Water Use N7L1-1788
CLASS B - INDUSTRIAL
Mackenzie River**

INDUSTRIAL WATER USE INSPECTION REPORT

LICENCE #:	N7L1-1788	EXPIRY DATE:	September 30, 2007
LICENCEE:	Suncor Energy Inc.	PREVIOUS INSPECTION:	August 25, 2011
COMPANY REP:	John Kerkhoven	INSPECTION DATE:	August 27, 2013

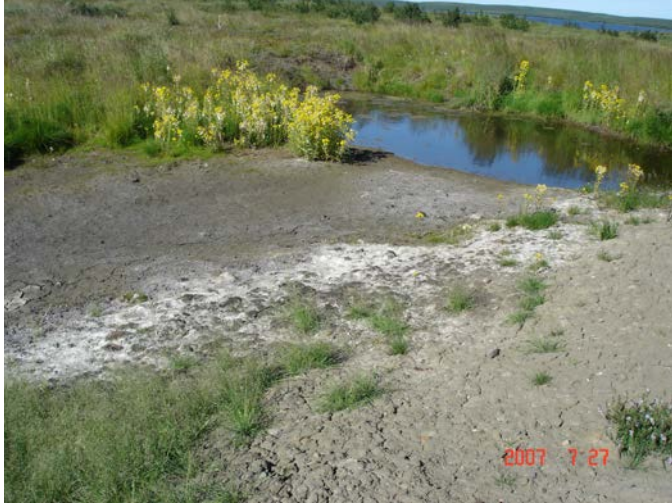
Figure 1

- During the July 27, 2007 site visit there was a white coloration present on the northwestern edge of the drill sump bordering the larger pond (see Figure 1). This has not been seen since during subsequent site visits or inspections.

White coloration present on the western edge of the drill sump bordering the larger pond, July 27, 2007.

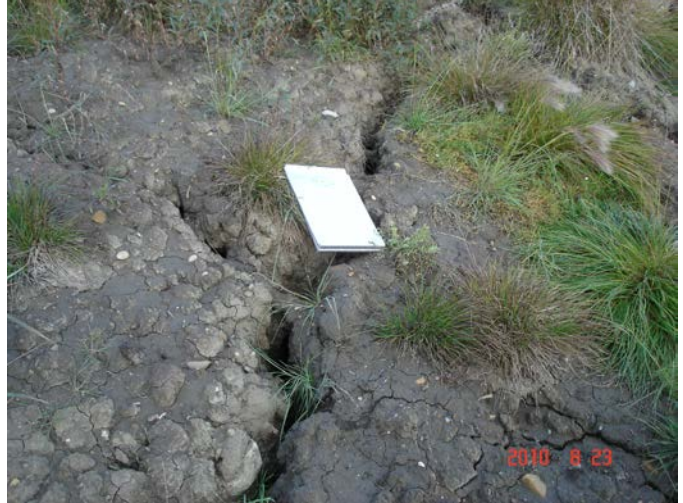
Figure 2

- There remain larger cracks throughout the sump surface (see Figure 2).
- Well drained sump cap that is well sloped
- Natural drainage flowing across above the north end of the drilling sump.
- Water ponding on north end of drilling sump. According to Suncor Energy Inc. staff this pond was there before the drilling program.
- In between the drilling and camp sumps there is water ponding in a deep depression.
- During the various site visits and inspections this is some of the most water that has been present in the waterbodies on site.
- No erosion seen on site besides the depression in the northwest corner of the drilling sump.

On site there were cracks similar to these, which were found on August 23, 2010.

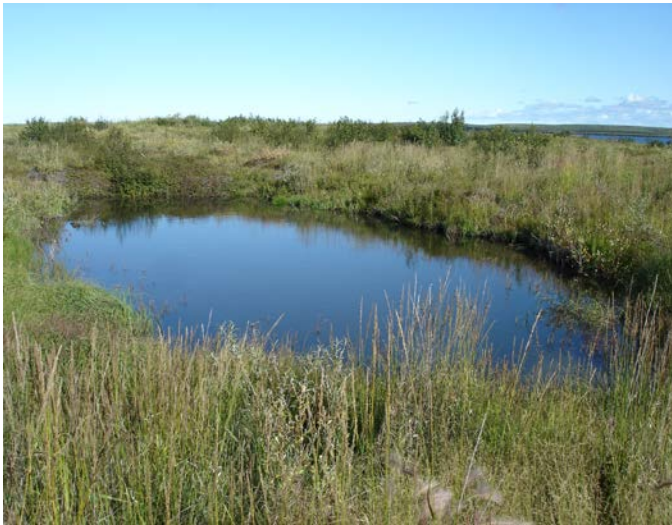
Figure 3

1. The drill and camp sump caps appear stable aside from ponding and subsidence in the immediate vicinity which is consistent with previous years. The large pond to the northwest of the drill sump appears to be due to natural drainage in the area. The small pond between the drill and camp sumps takes in drainage from between the sumps and the surrounding area. The ponding is away from sump caps but there is still a possibility of influence on sump long term stability. Water ponding near the sumps can have an effect on the containment of wastes and permafrost. Further monitoring remains a prudent measure to identify issues early on before they become larger problems.

Larger pond on the northwest side of the drilling sump which has increase in water volume from previous inspections.

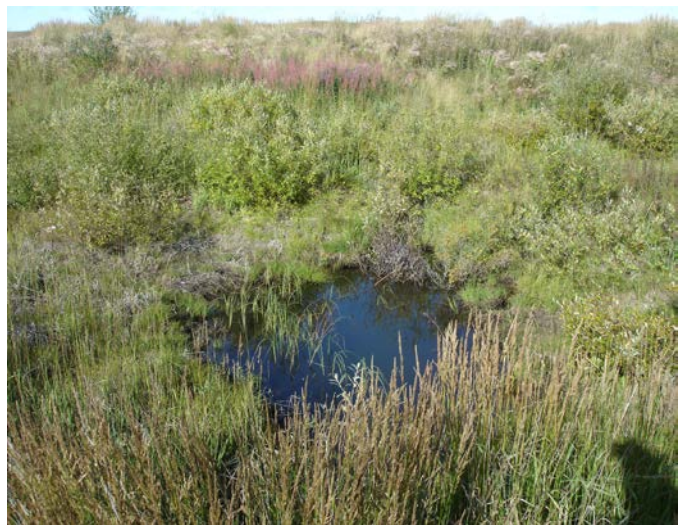
Figure 4

Small pond and associated subsidence between the drilling and camp sumps. There is more water present than before.

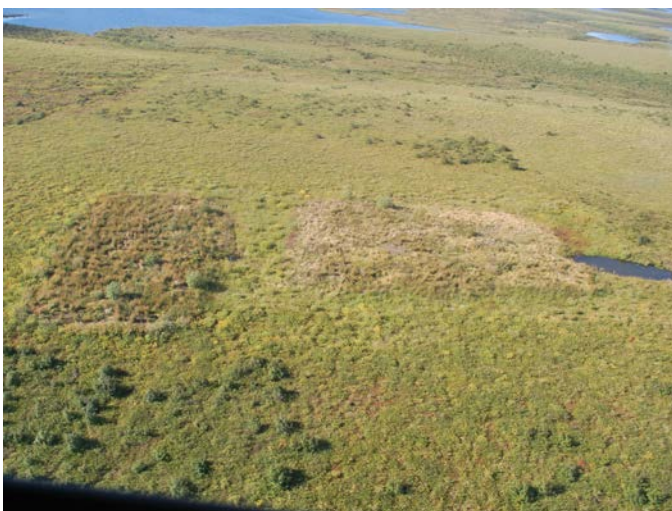
Figure 5

Aerial of Nuna I-30 site with camp and drill sumps in addition to associated waterbodies.

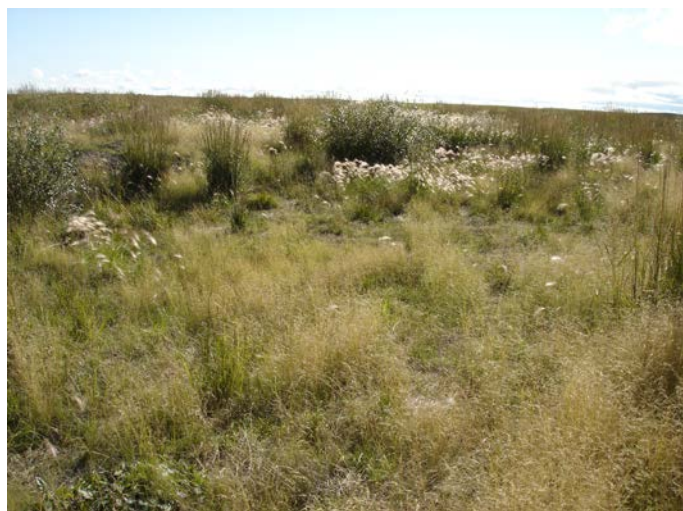
Figure 6

- 2009 Nuna I-30 Wellsite Inspection Report is now on file.
- Vegetation growth of 90% on the drill and camp sumps which is large increase from the Industrial Water Licence Inspection conducted on August 24, 2011.

Example of the thickness and extent of vegetation growth on surface of drill and camp sumps.
