RE: 2009 Sump Monitoring Report for Water Licence N7L1-I817

Mallik Gas Hydrate Production Research Project:

**Aurora Research Institute Mallik 2L-38 and 3L/4L/5L- 38
Sump Monitoring and Retrofit Program**

November 25, 2009

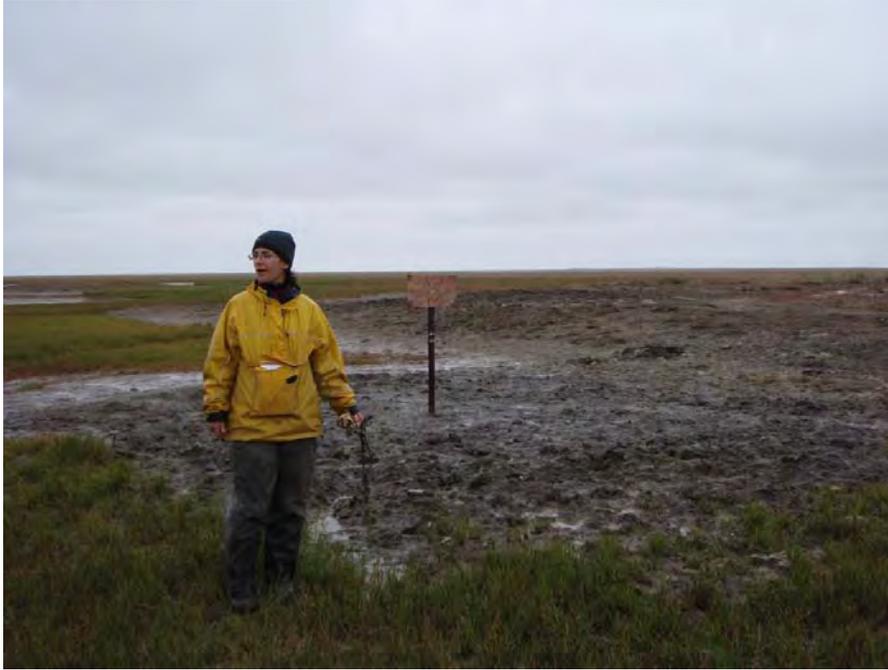
Figure 3: Aurora/JOGMEC/NRCan Mallik 2L-38, August 16, 2009 (photo credit S.R. Dallimore). As detailed by K. Martin in the Aurora College 2008 monitoring report, fill was placed at the surface of this well head in the summer of 2008. Site conditions on August 16th were found to be stable with no evidence of settlement or contamination. Grasses and sedges are beginning to colonize in the disturbed area.

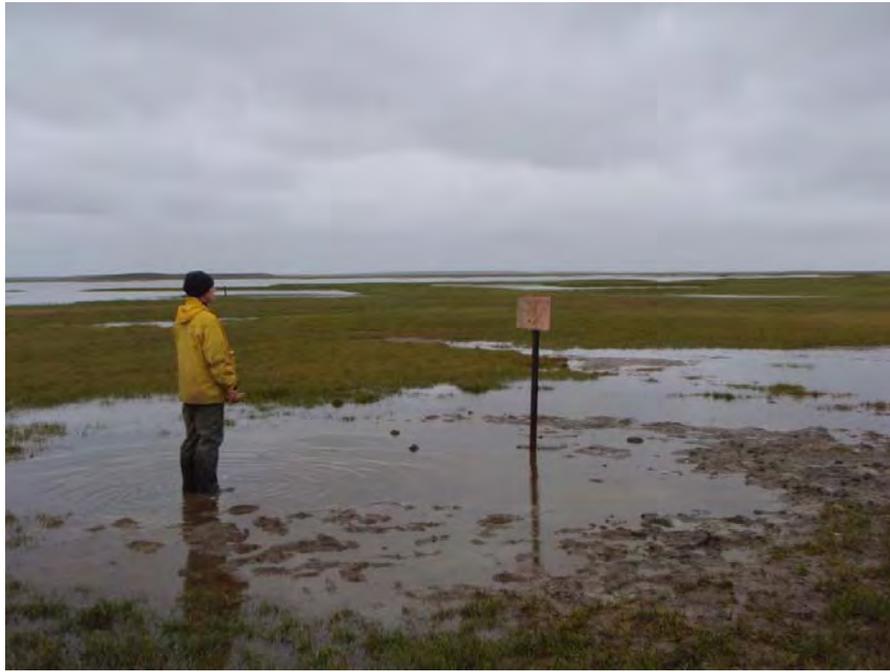
Figure 4: Aurora/JOGMEC/NRCan Mallik 3L-38, August 16, 2009 (photo credit S.R. Dallimore). As detailed by K. Martin in the Aurora 2008 monitoring report, fill was placed at the surface of this well head in the summer of 2008. Site conditions on August 16th were found to be stable with no evidence of settlement or contamination. Site conditions on August 16th were quite wet however, with standing water and encroachment of a small pond. Grasses and sedges are beginning to colonize in the disturbed area and it is expected that the standing water only occurs after storm surges or after heavy rain.

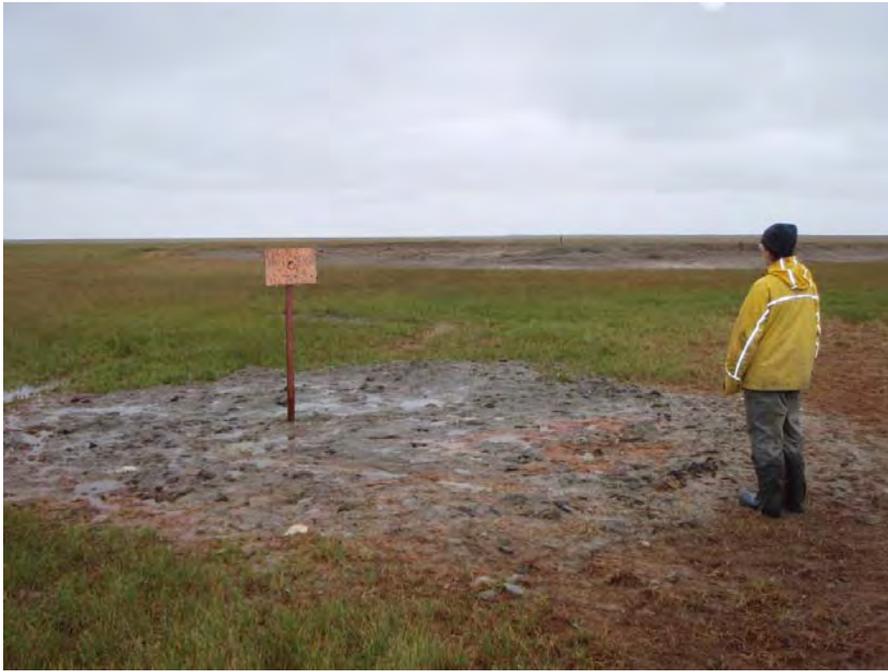
Figure 5: Japex/JNOC/GSC et al Mallik4L-38, August 16, 2009 (photo credit S.R. Dallimore). Site conditions on August 16th were found to be stable with no evidence of settlement or contamination.

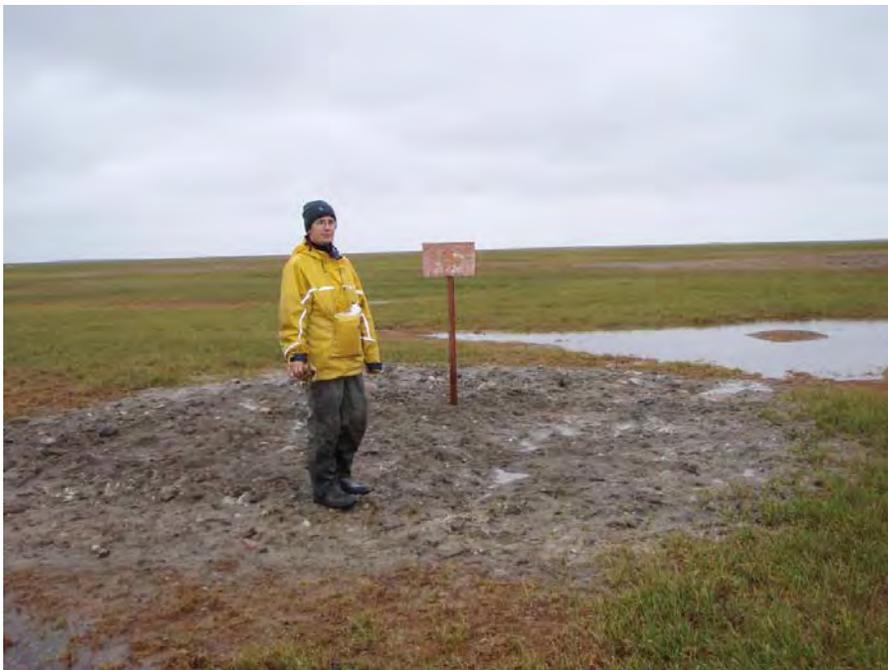
Figure 6: Japex/JNOC/GSC et al Mallik 5L-38, August 16, 2009 (photo credit S.R. Dallimore). Site conditions on August 16th were found to be stable with no evidence of settlement or contamination.

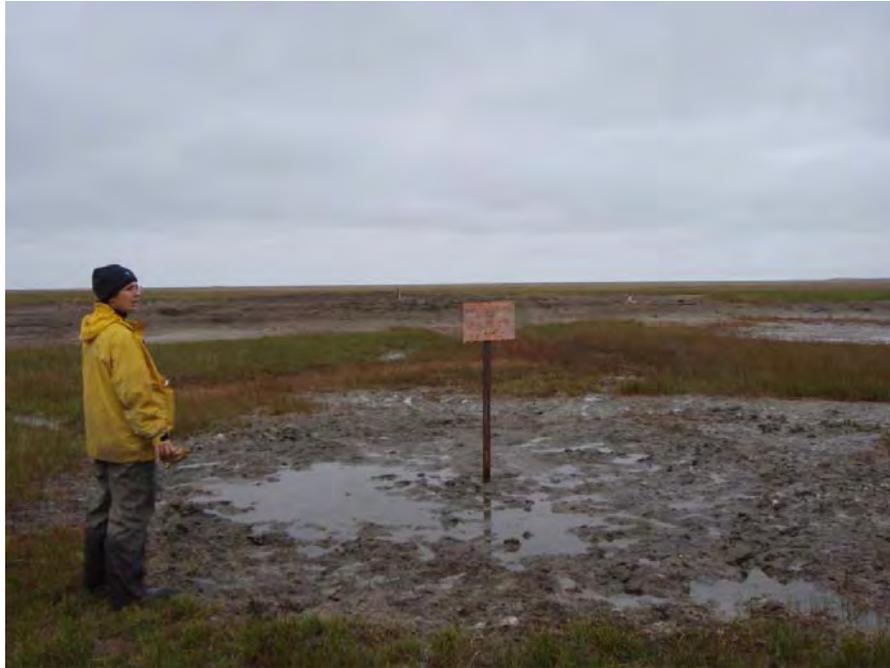
Figure 7: Aurora/JOGMEC/NRCan Mallik 6L-38, August 16, 2009 (photo credit S.R. Dallimore). As detailed by K. Martin in the Aurora College 2008 monitoring report, fill was placed at the surface of this well head in the summer of 2008. Site conditions on August 16th were found to be stable with no evidence of settlement or contamination. Grasses and sedges are beginning to colonize in the disturbed area.

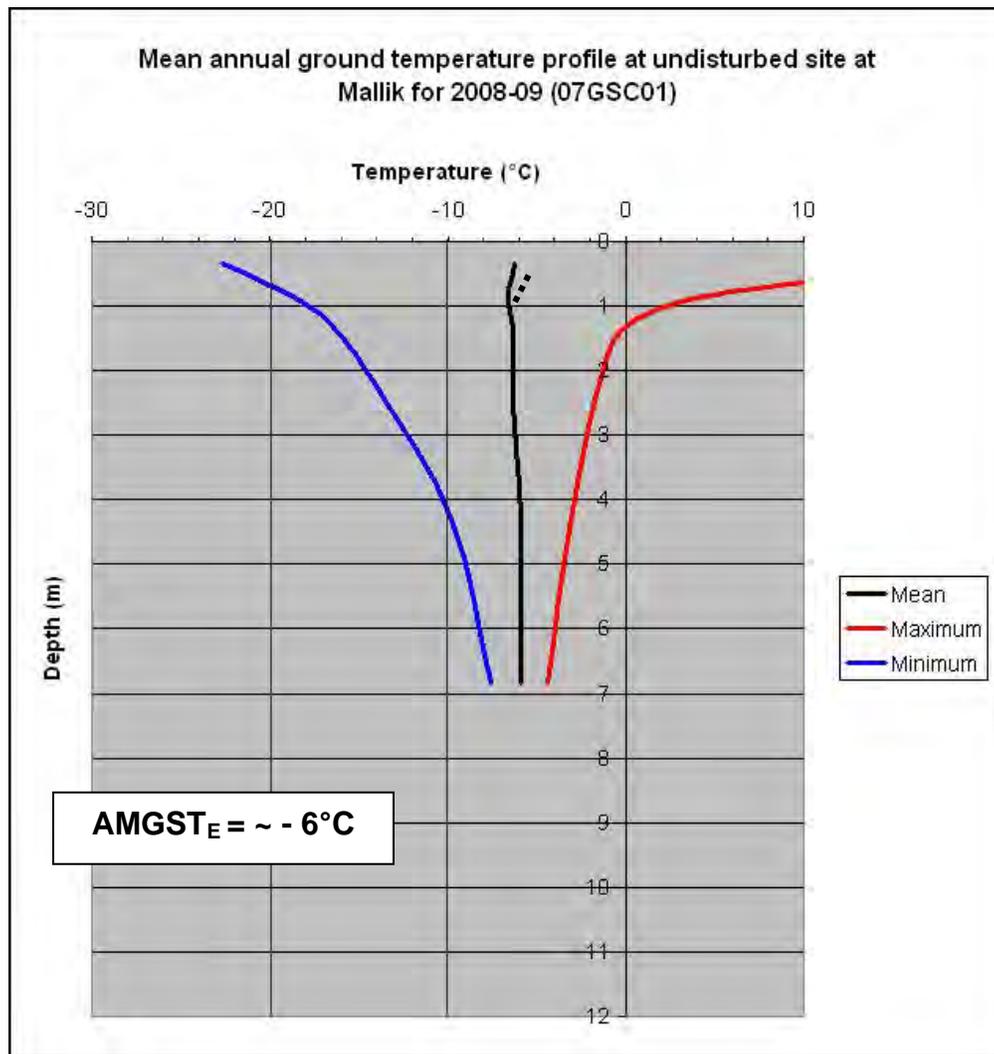
Figure 8: Trumpet curve of permafrost temperatures for 07GSC01 site. Mean annual ground surface temperature at this undisturbed site at the edge of a pond with approximately 10cm of standing water is approximately -6°C.

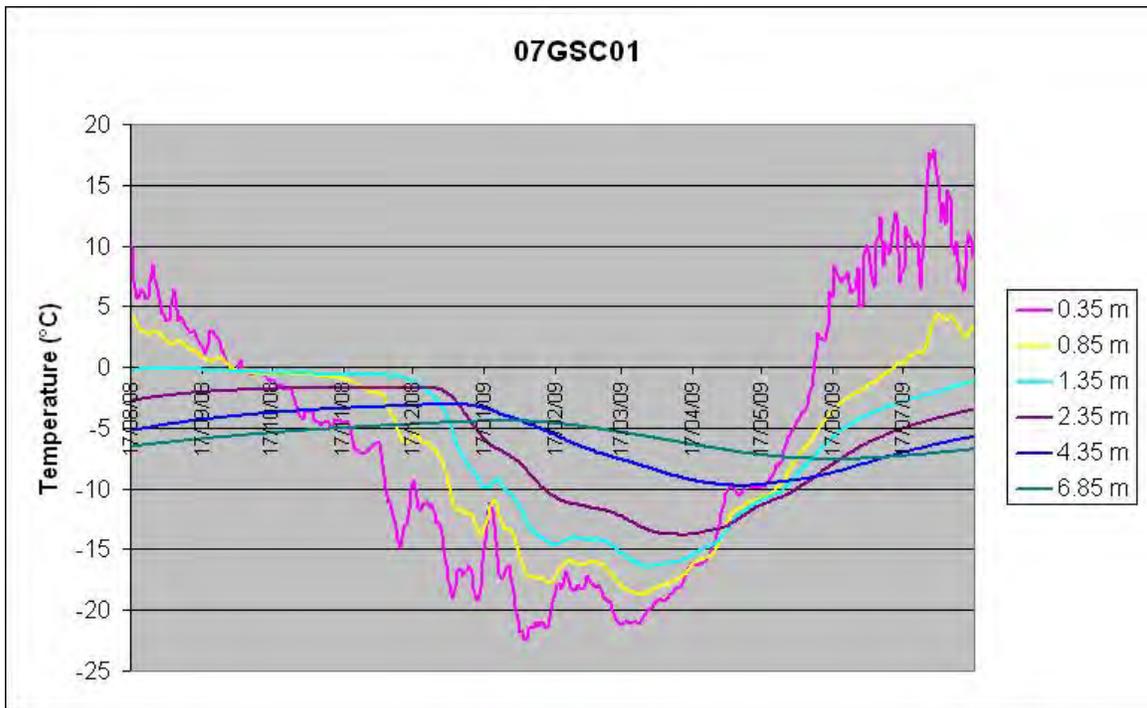
Figure 9: Record of annual temperatures at each measured depth below ground surface in 07GSC01 showing that surface thawing at this site was less than 1.35m.

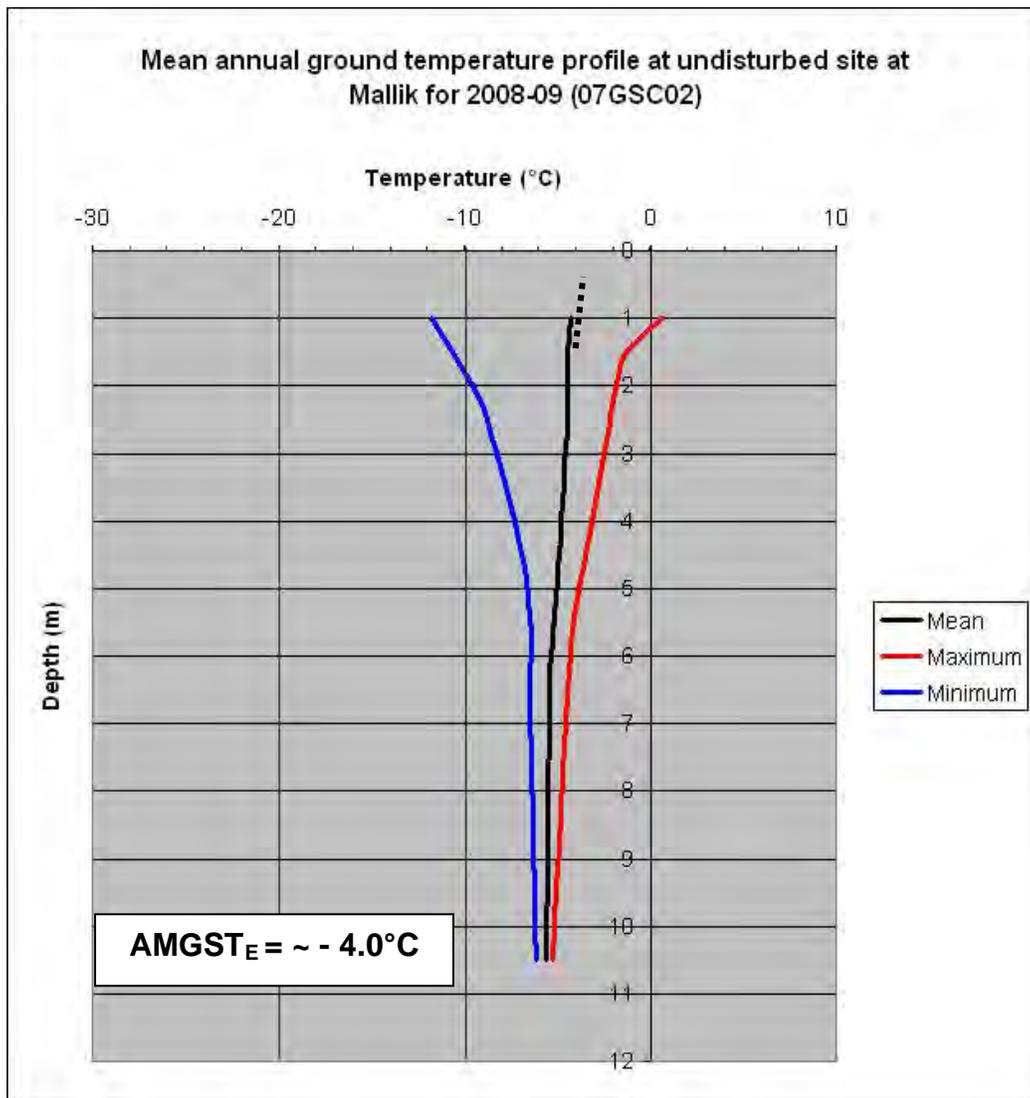
Figure 10: Trumpet curve of permafrost temperatures for 07GSC02 site located in an undisturbed site with low sedge and grass ground cover. Mean annual ground surface temperature at this site is approximately -4°C.

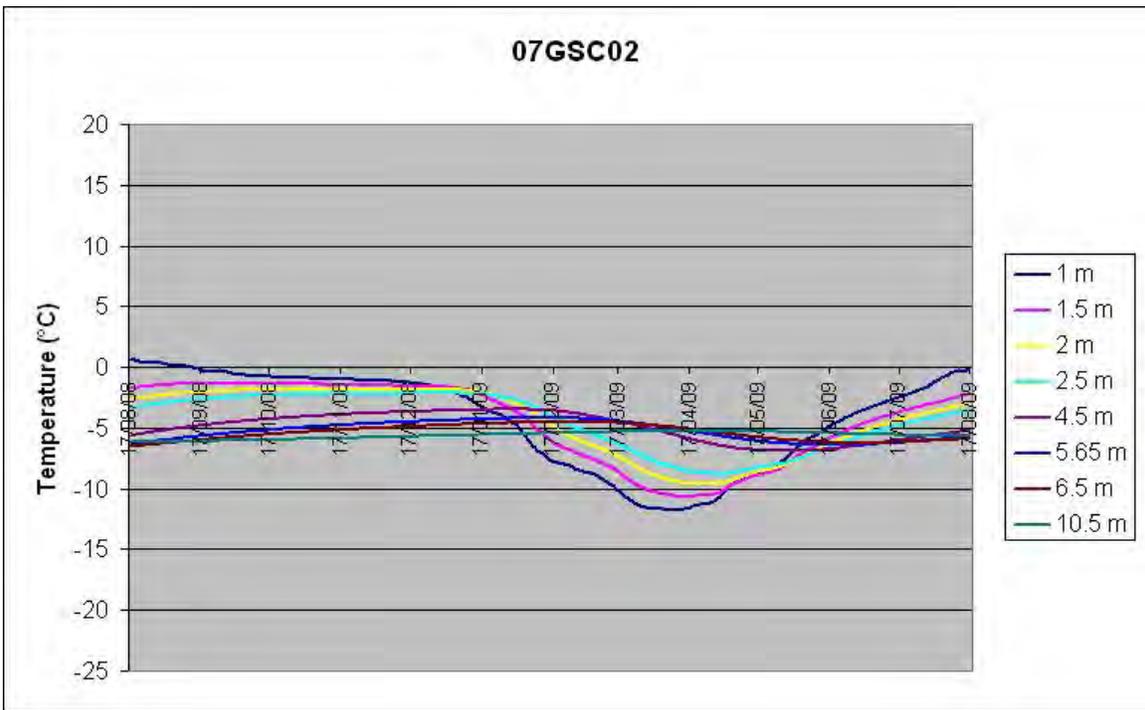
Figure 11: Record of annual temperatures at each measured depth below ground surface in 07GSC02 showing that surface thawing at this site was less than 1.5m.

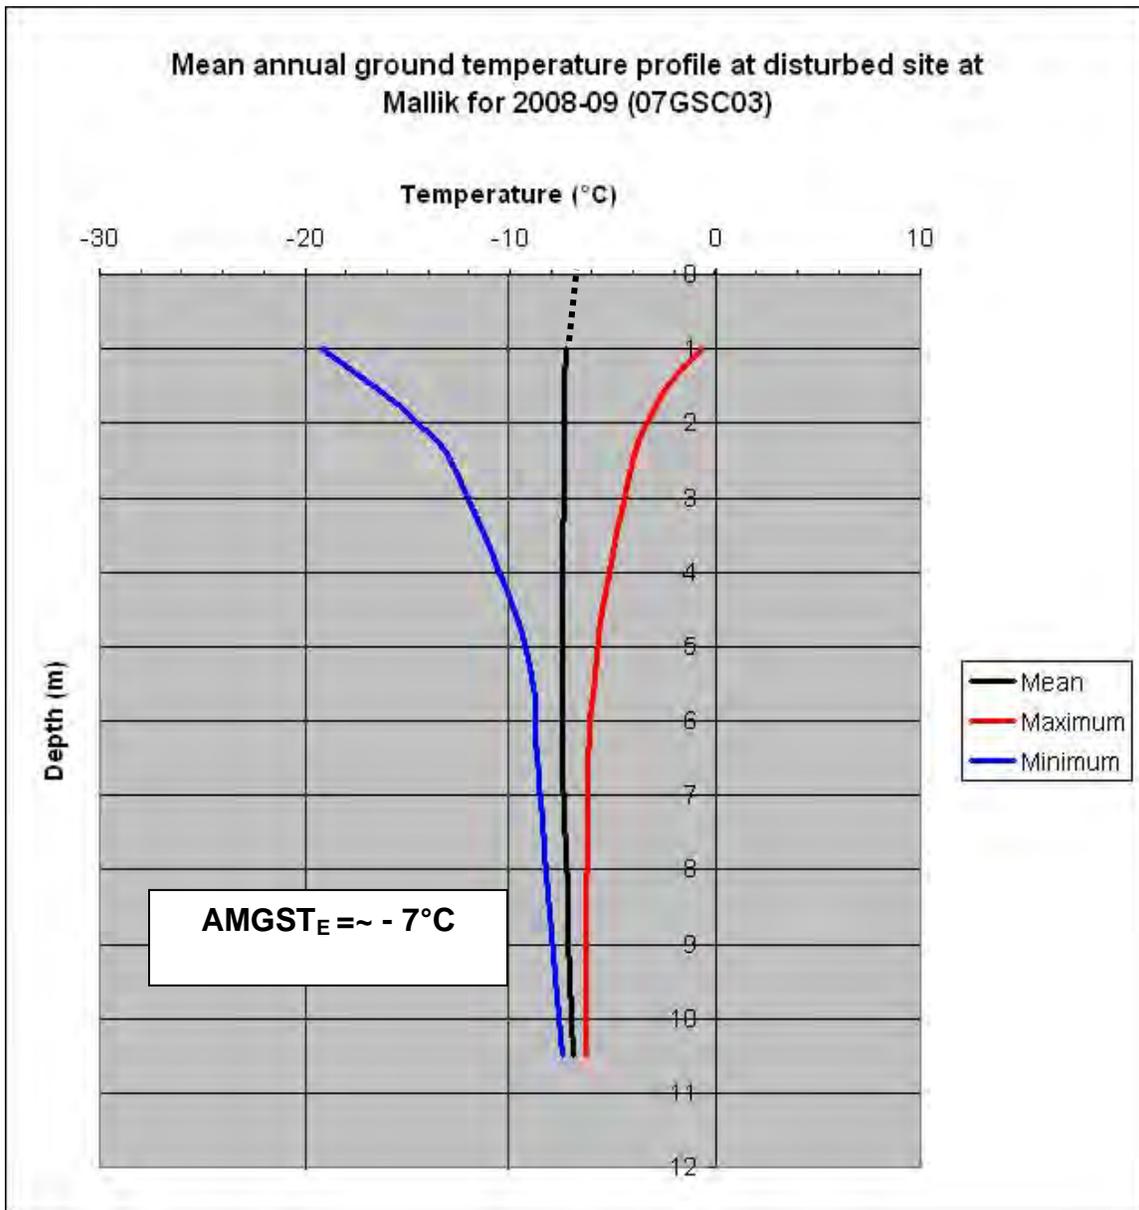
A summary of the 2009 ground temperature conditions is given in Figures 8-15. The estimated mean annual ground surface temperature at the Mallik 2002 sump was -7°C which is colder than the estimated mean annual temperature at the undisturbed sites that varied from -4 to -6°C . This is consistent with the design goals of a sump which are to raise the ground elevation and lower the mean annual ground surface temperature regime. A comparison of the 2008/2009 air and ground temperature at the index site is shown in Figure 16.

Figure 12: Trumpet curve of permafrost temperatures for 07GSC03 site located in Mallik 2002 sump. Mean annual ground surface temperature at this site is approximately -7°C.

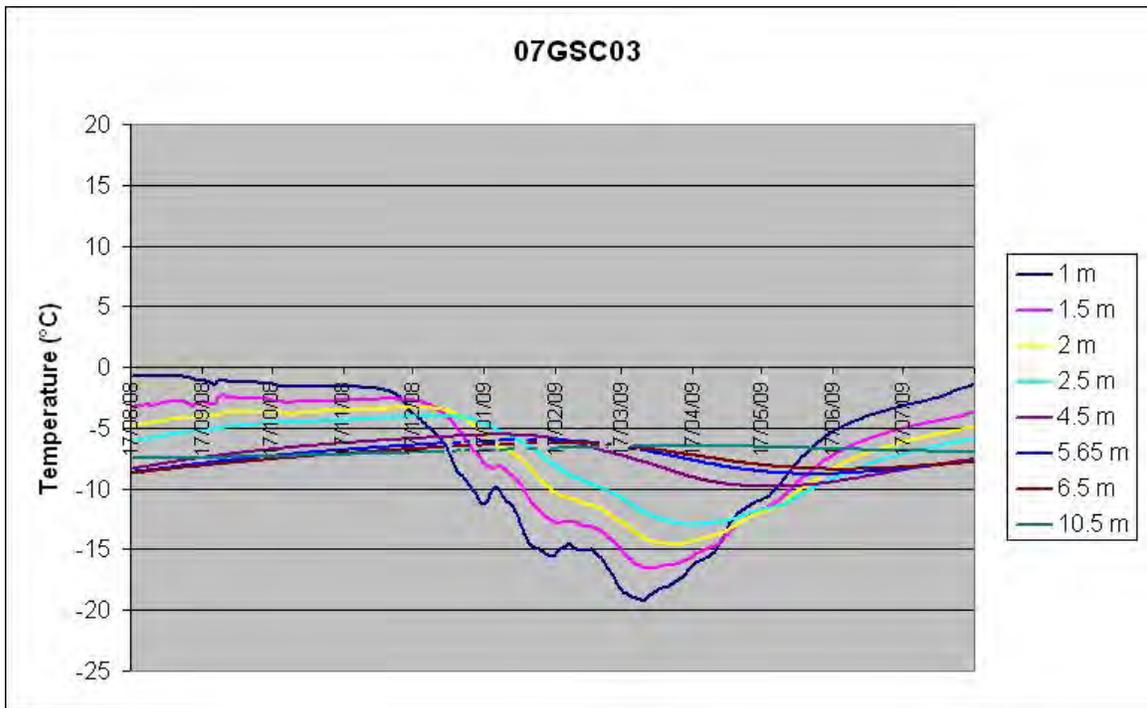
Figure 13: Record of annual temperatures at each measured depth below ground surface in 07GSC03 showing that surface thawing at this site was less than 1.0m.

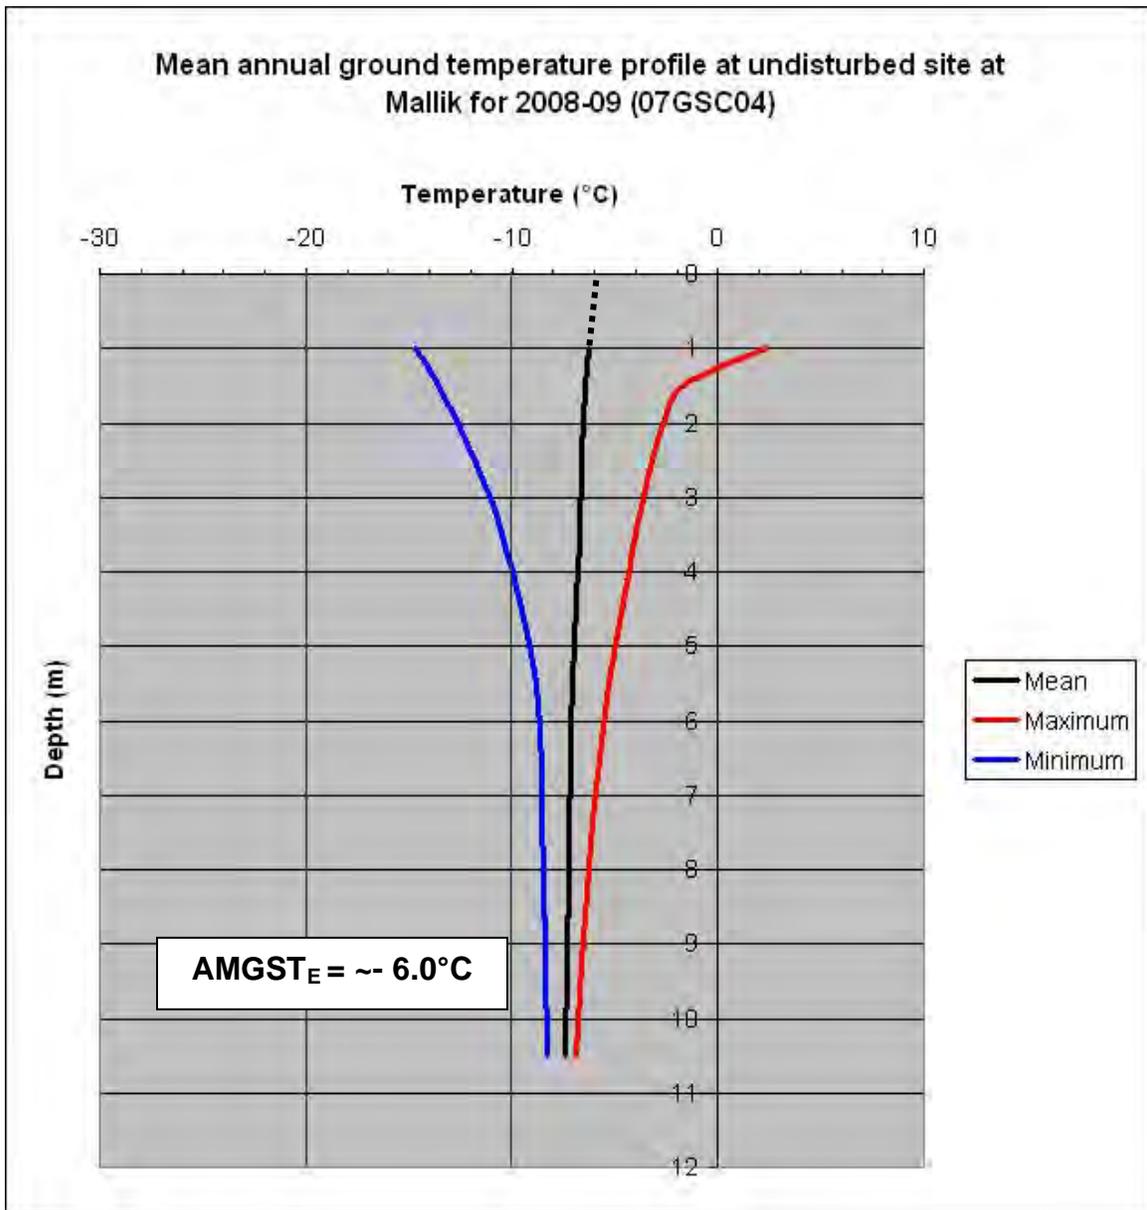
Figure 14: Trumpet curve of permafrost temperatures for 07GSC04 site located in an undisturbed site with sparse to bare ground cover. Mean annual ground surface temperature at this site is approximately -6°C.

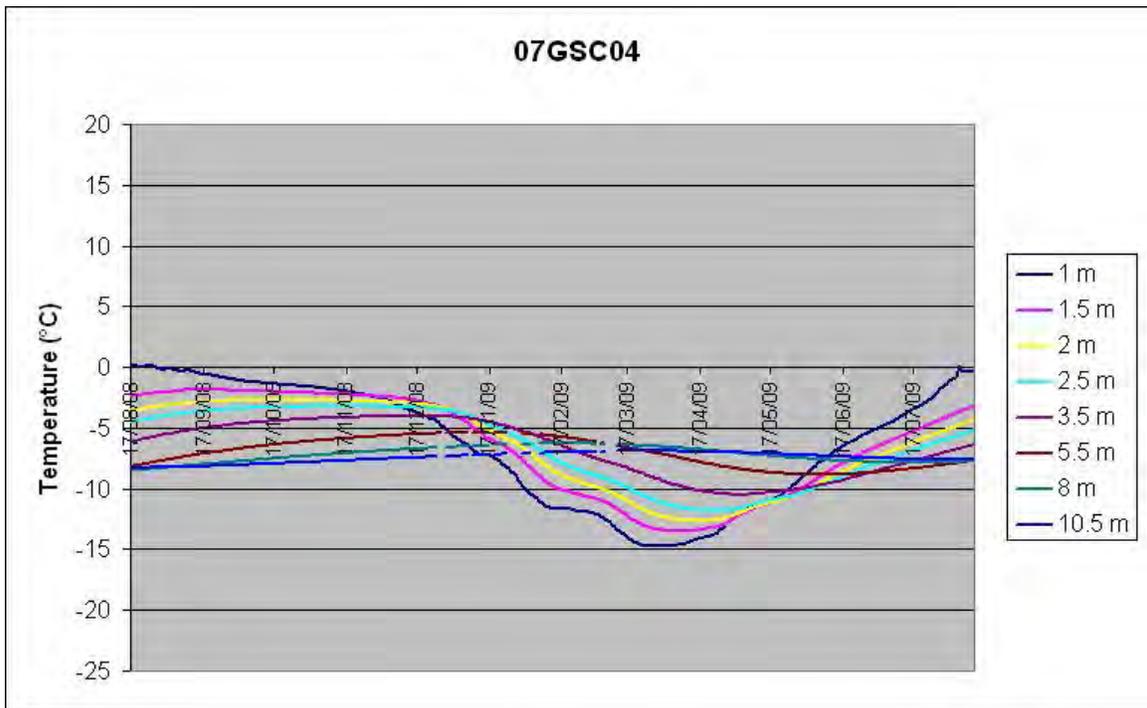
Figure 15: Record of annual temperatures at each measured depth below ground surface in 07GSC04 showing that surface thawing at this site was less than 1.5m.

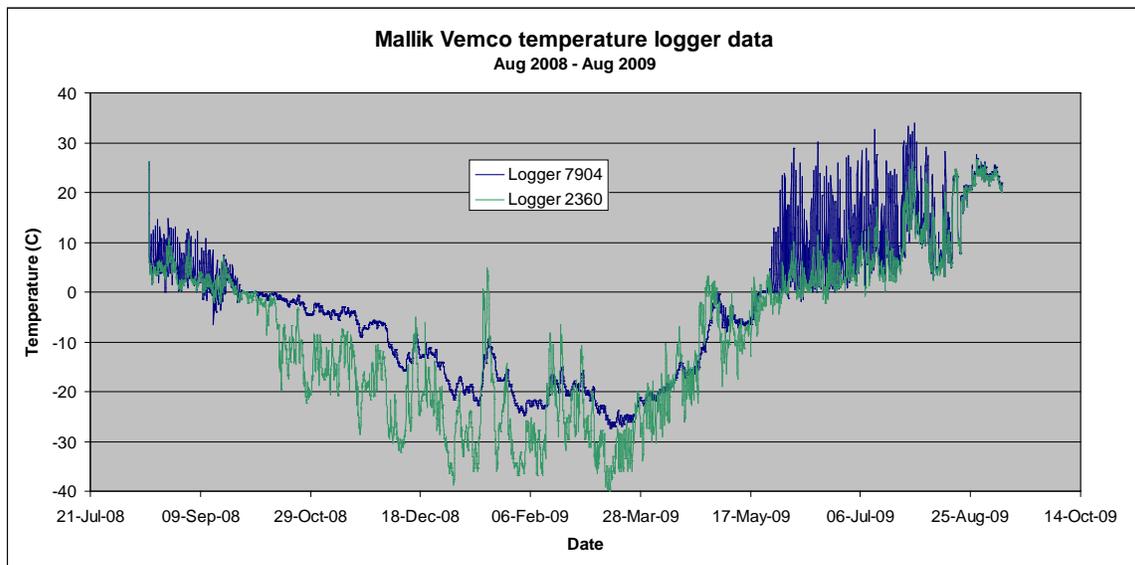
Figure 16: Air temperature record (green) and ground temperature data (blue) for the index site. Note the air temperature station was knocked down during the field season. By the change in the trend of the two records it is likely this occurred near the beginning of April.
