**RE: Industrial Water Use N7L1-1817
CLASS B - INDUSTRIAL
Swan Channel - Mackenzie River**

INDUSTRIAL WATER USE INSPECTION REPORT

LICENCE #:	N7L1-1817	EXPIRY DATE:	November 30, 2016
LICENCEE:	Aurora Research Institute	PREVIOUS INSPECTION:	August 28, 2008
COMPANY REP:	Pippa Seccombe-Hett	INSPECTION DATE:	August 24, 2011

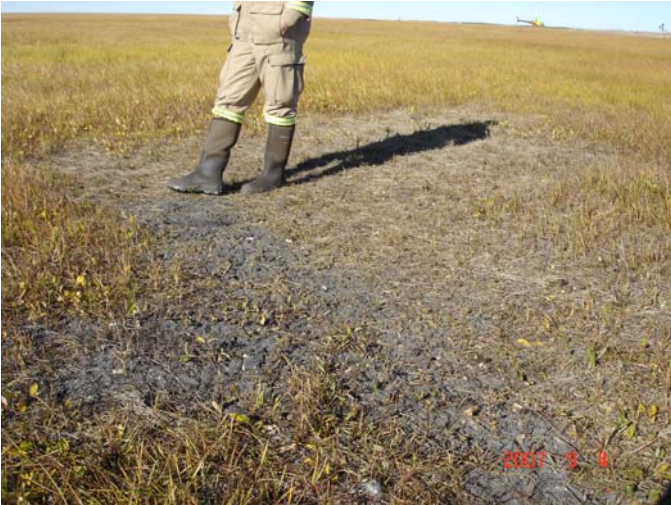
Figure 1
Cuttings and affected area from the March 2, 2007 spill with cuttings. Photo taken September 4, 2007.

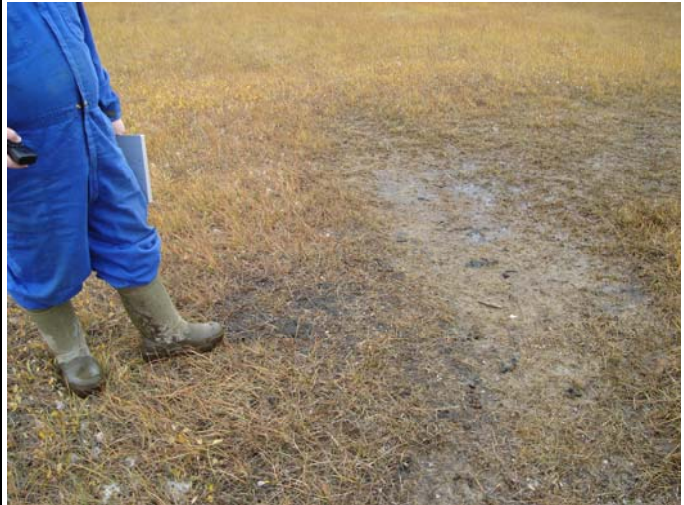
Figure 2
Cuttings significantly reduced from previous spill. Photo taken August 28, 2008.

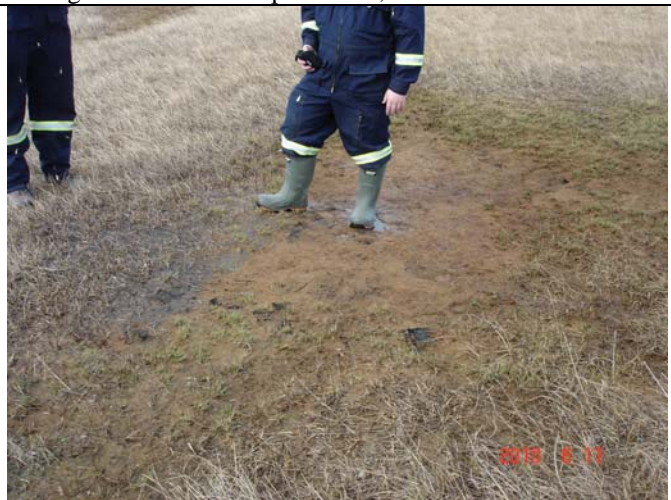
Figure 3
Cuttings spill area - photo taken June 17, 2010.

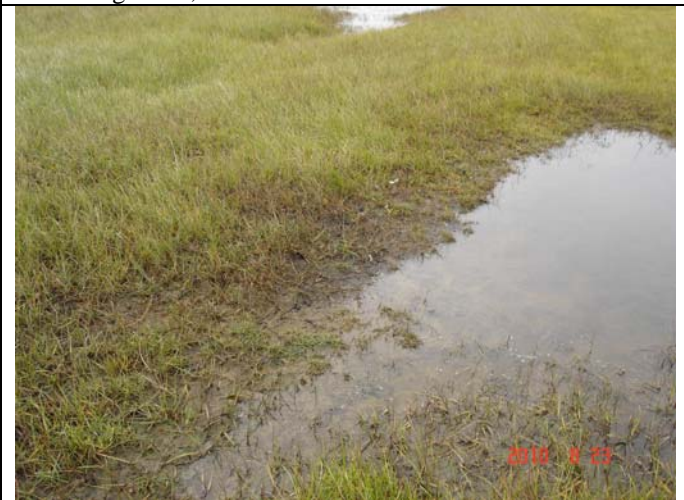
Figure 4
Cuttings spill area - photo taken August 23, 2010.

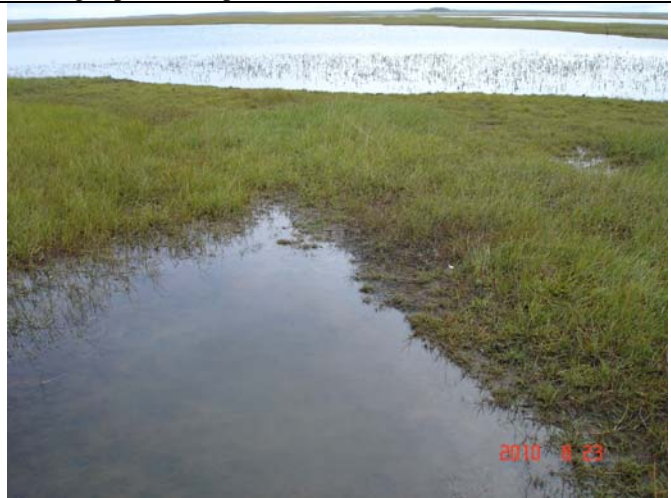
Figure 5
Surrounding vegetation in vicinity of cuttings spill – photo taken August 23, 2010.

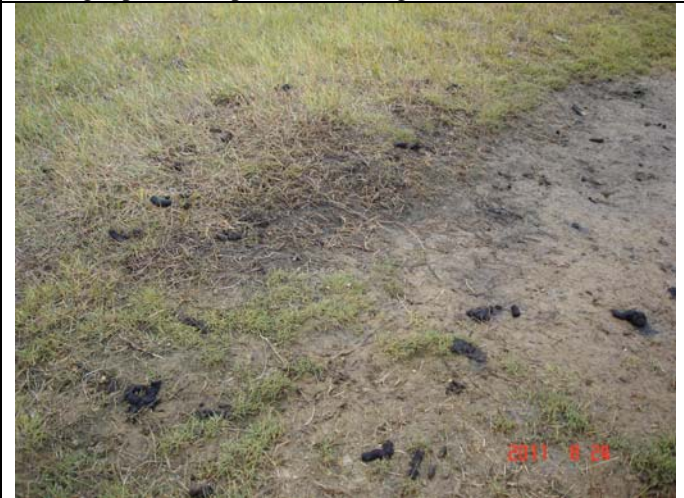
- Cuttings location (N 69° 27' 32.9" W 134° 39' 44.7") from the March 2, 2007 spill with cuttings is barely detectable when compared to the previous inspections dated September 4, 2007 and August 28, 2008. Site visits during June 18, 2010 and August 23, 2010 during the summer months shows the area looking acceptable and it has had no lingering effects from the spill incident. The whole surrounding area has recovered without any problems. During further inspections of the Mallik area it is recommended to continue monitoring the spill area. (see the Inspection Images section)
- The effects from the Mallik Gas Hydrate Production Research Project have been minimal on the surrounding area and the sumps that are present. There seems to be no issues noted from its having taken place.
- Solid waste associated with the project has been removed and the site appears acceptable.

Figure 6
Cuttings spill area - photo taken August 24, 2011.
