**RE: INDUSTRIAL Water Use N7L1-1817  
CLASS B – INDUSTRIAL  
Mallik  
Swan Channel - Mackenzie River**

## INDUSTRIAL WATER USE INSPECTION REPORT

<b>LICENCE #:</b>	<b>N7L1-1817, Mallik</b>	<b>EXPIRY DATE:</b>	<b>November 30, 2016</b>
<b>LICENCEE:</b>	<b>Aurora Research Institute</b>	<b>PREVIOUS INSPECTION:</b>	<b>October 02, 2012</b>
<b>COMPANY REP:</b>	<b>Pippa Seccombe-Hett</b>	<b>INSPECTION DATE:</b>	<b>August 26, 2013</b>

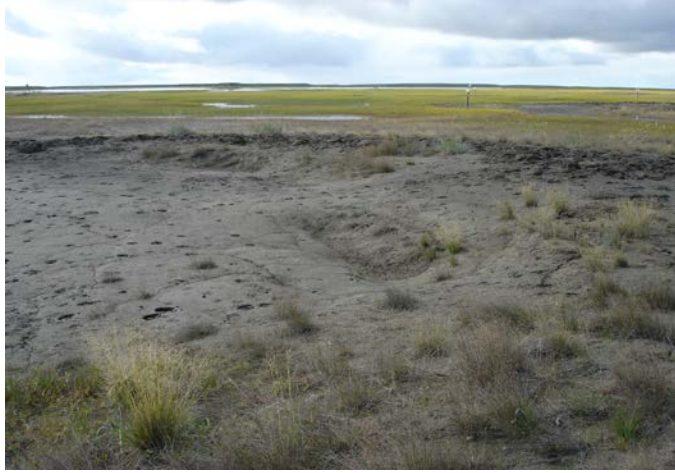
**Figure 1**  
1998 Flare Pit at northend, subsidence present.

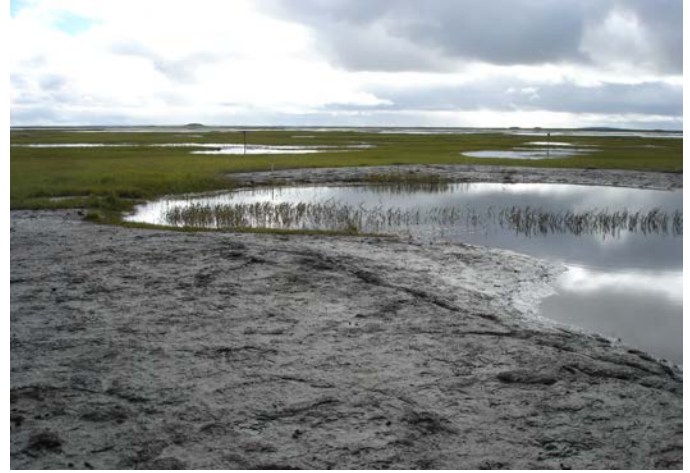
**Figure 2**  
1998 Camp Sump subsidence and ponding at east end.

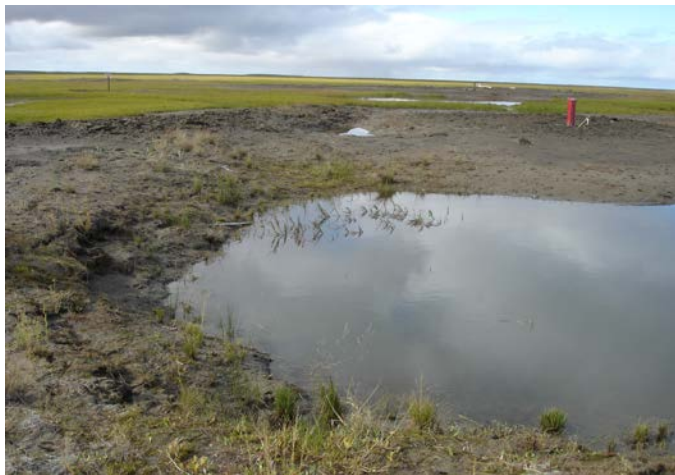
**Figure 3**  
1998 Drill Sump subsidence and ponding at east end and throughout.

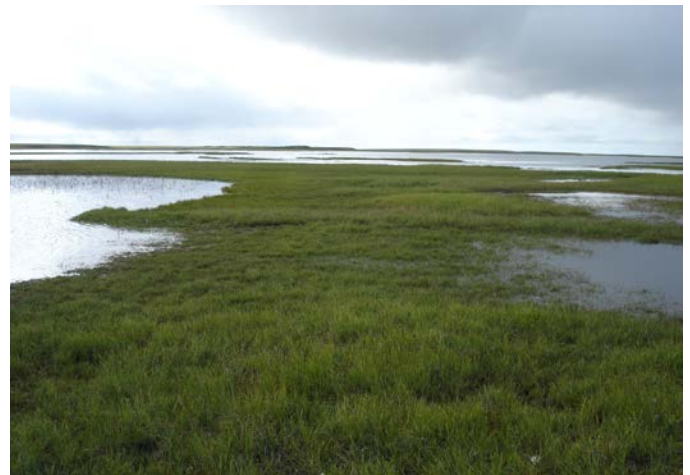
**Figure 4**  
March 2, 2007 cuttings spill area. No cuttings seen and no sign of impacts.

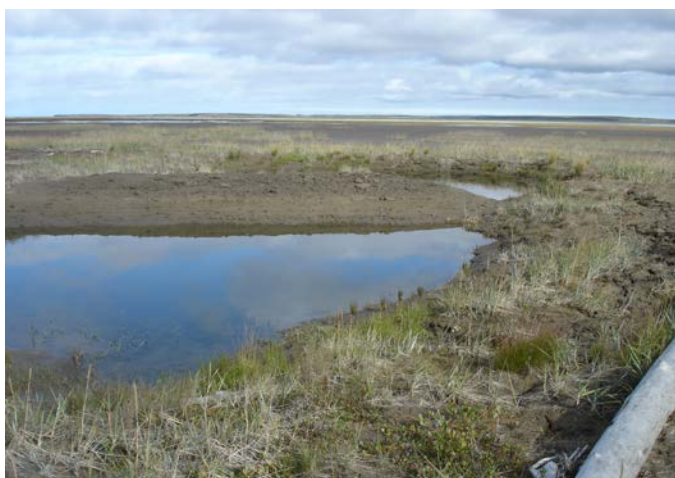
- Subsidence similar to before.
- Ponding occurring in subsided areas.
- Large cracks present on 2002 camp sump.

**Figure 5**  
2002 Camp Sump subsidence at southend.

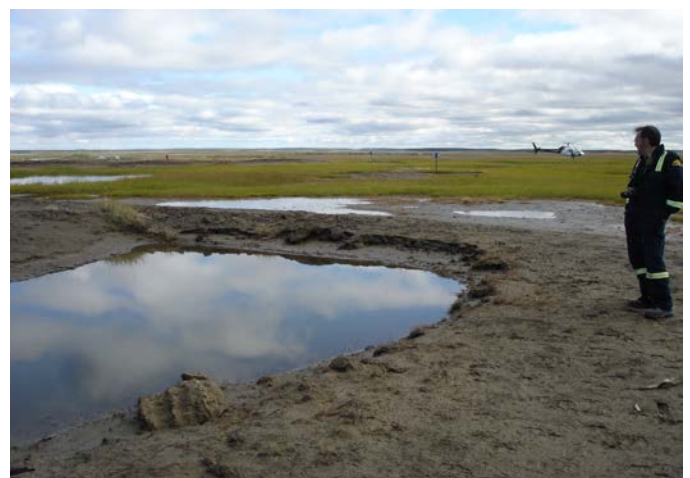
**Figure 6**  
2002 Drill Sump subsidence at southend.
