RE: Industrial Water Use (N7L1-1817)

INDUSTRIAL WATER USE INSPECTION REPORT

DATE:	August 28, 2008	COMPANY REP:	Pippa Seccombe-Hett
LICENCEE:	Aurora Research Institute	LICENCE #:	N7L1-1817

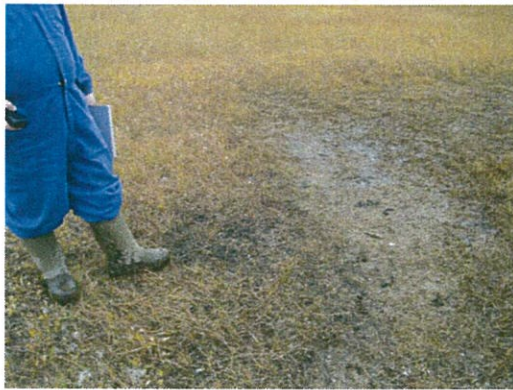
1. Small amount of cuttings is still present at location(N 69° 27' 32.9" W 134° 39' 44.7") from the March 2, 2007 spill with cuttings. It is evident that the amount of cuttings have been reduced from the previous inspection dated September 4, 2007. Surrounding area looks acceptable but follow up inspection is needed during summer months to confirm the area's recovery from the spill (see Figure 1 from August 28, 2008 and Figure 2 from September 4, 2007)

Figure 1
Cuttings from previous spill. Photo taken August 28, 2008.

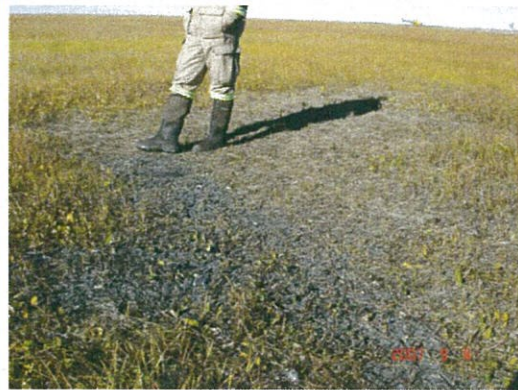
Figure 2
Cuttings from previous spill and affected area. Photo taken September 4, 2007.
