**RE: FEBRUARY 14, 2007 INSPECTION OF WATER LICENCE N7L1-1817  
MALLIK GAS HYDRATE RESEARCH PROJECT**

## INDUSTRIAL WATER LICENCE INSPECTION REPORT

<b>DATE:</b>	February 14, 2007	<b>COMPANY REP:</b>	Mike DeVisser
<b>LICENSEE:</b>	Aurora Research Institute	<b>LICENCE #:</b>	N7L1-1817

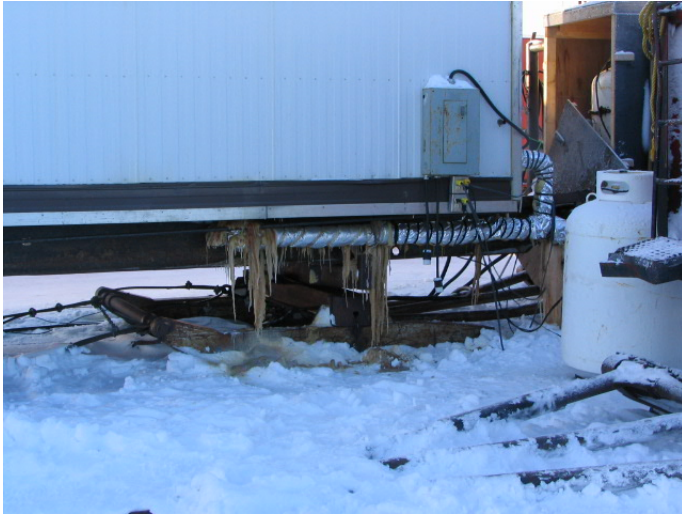
2. The conveyance lines are acceptable for the Mallik Site but there was sewage leaking (as frozen icicles) from the conveyance lines (Figure 1) and the sewage holding tank (Figure 2) at the Grubens Sleigh Camp. This was mentioned to Mike DeVisser and instructions were given to remove the frozen sewage, use drip trays and complete the necessary repairs. There was sewage spillage from the sewage holding tank at the Mallik site when it was being transferred to the vacuum truck. It was mentioned that the frozen spilled sewage was to be cleaned up and a drip tray was to be used during the transfer of sewage to the vacuum truck.

**Figure 1. Sewage leaking from conveyance lines at the Grubens Sleigh Camp.**

- The spilled sewage at the Grubens Sleigh Camp needs to be entered into the Spill Log in addition to being cleaned up.

1. Due to leaking sewage from the Conveyance Lines and the sewage holding tank at the Grubens Sleigh Camp there needs to be better maintenance of equipment like conveyance lines and sewage holding tanks. When there are spills consistently coming from certain equipment, this equipment needs to be better maintained.
2. There were records of water usage but there were not specific records pertaining to the areas (lease pad, access road to pad, camp use, rig and drilling use) covered by the Water Licence. In order to properly measure water usage there needs to be specific records kept and instructions were given to Mike DeVisser on the kind of water usage record expected. There was a

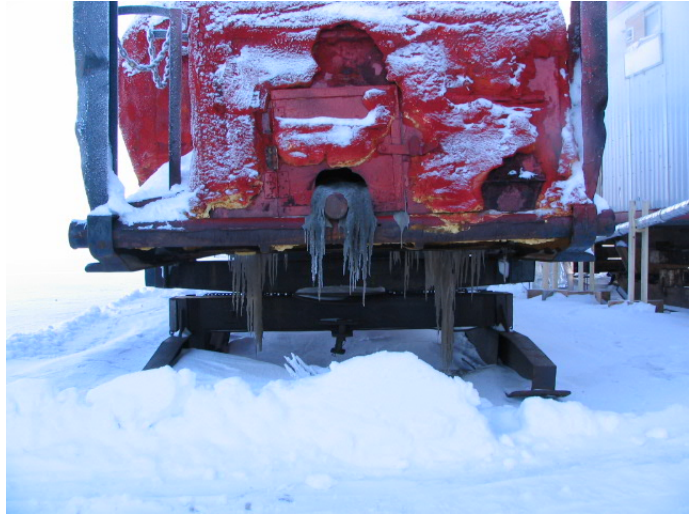
**Figure 2. Sewage leaking from the sewage tank at the Grubens Sleigh Camp.**
