**RE: INDUSTRIAL Water Use N7L1-1835
CLASS A - INDUSTRIAL
ITH South End**

INDUSTRIAL WATER USE INSPECTION REPORT

LICENCE #:	N7L1-1835	EXPIRY DATE:	December 11, 2023
LICENCEE:	Government of the Northwest Territories - Department of Transportation	PREVIOUS INSPECTION:	March 20, 2015
COMPANY REP:	Dean Ahmet, Senior Program Manager	INSPECTION DATE:	January 20, 2016

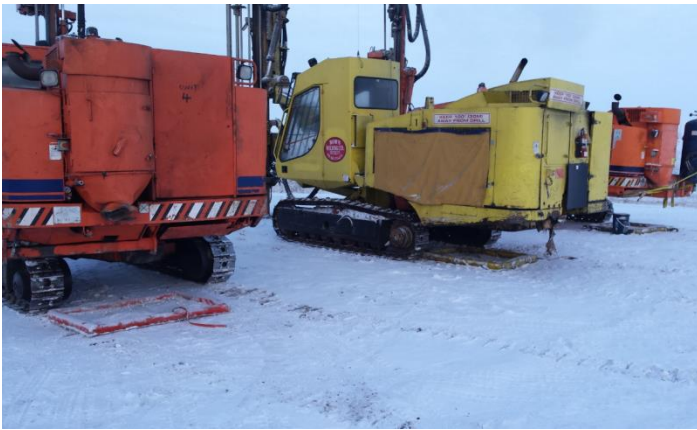
Figure 1

- At the time of the inspection of the south end, crews were working out of Source PW10. All aspects were satisfactory; drip trays were placed under parked vehicles (see Figure 1), chemical products were stored on drip trays (see Figure 2), spill kits could be found where required, storage tanks were in good condition and kept clean, and all areas inspected were clear of debris and well maintained. Please ensure that drip trays do not get windblown and that they are properly cleaned as needed.

Drip trays in use at the time of the inspection.

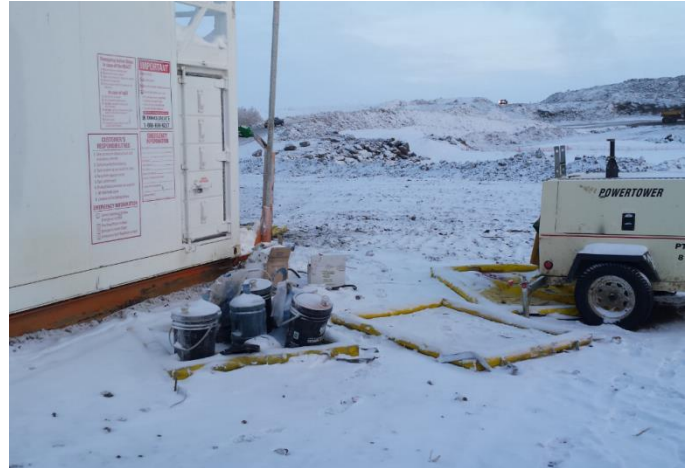
Figure 2

Chemical products temporarily stored on drip trays.

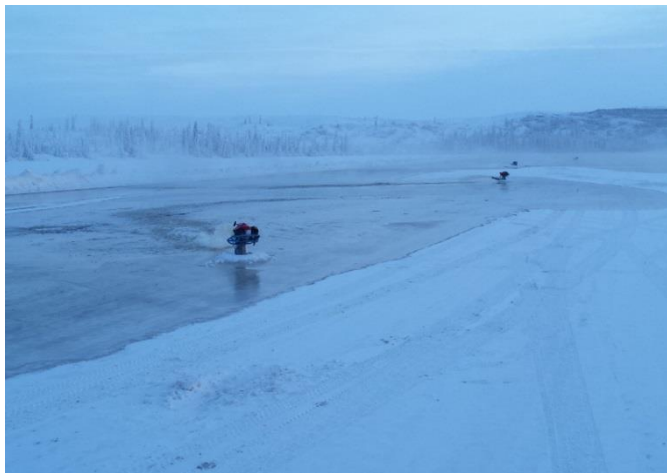
Figure 3

- A section of the access road to PW10 was being flooded at the time of the inspection (see Figure 3). All pumps were equipped with screens as required and operators regularly inspect pumps and screens for general maintenance and condition. Access road was clear of debris and in good condition.

Routine flooding of Source PW10's access road.
