**RE: INDUSTRIAL Water Use N7L1-1835  
CLASS A - INDUSTRIAL**

**RE: INDUSTRIAL Water Use N7L1-1835  
CLASS A - INDUSTRIAL  
ITH South End**

## INDUSTRIAL WATER USE INSPECTION REPORT

<b>LICENCE #:</b>	N7L1-1835	<b>EXPIRY DATE:</b>	December 11, 2023
<b>LICENCEE:</b>	Government of the Northwest Territories - Department of Transportation	<b>PREVIOUS INSPECTION:</b>	January 20, 2015
<b>COMPANY REP:</b>	Dean Ahmet, Senior Program Manager	<b>INSPECTION DATE:</b>	February 4, 2016

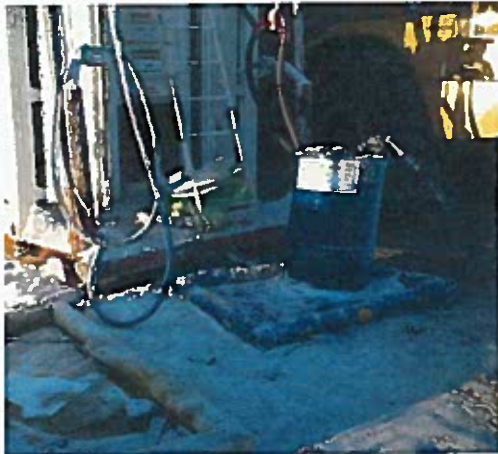
**Figure 1**

- No environmental concerns were evident at the time of inspection.
- Fueling areas were satisfactory (see Figure 1).

Fueling area near Burrow Source PW10.

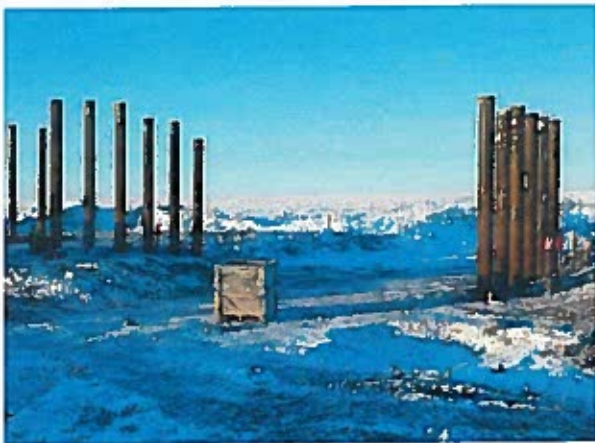
**Figure 3**

- Crews were working on installing bridge pilings at KM 26 (see Figure 3). No flowing water or spills observed.
- No activity observed around Burrow Source GSC4 and Jimmy Lakes other than a small access road being flooded further down at the time of the inspection, off the current entrance to Jimmy Lakes past the camp by KM 28 (see Figure 4).

Bridge pilings recently installed at KM 26.

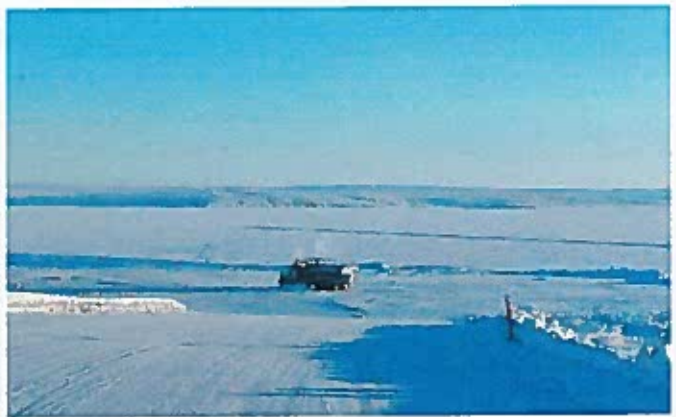
**Figure 4**

Access road to Jimmy Lake out of camp by KM 28 (parked water truck on break).
