**RE: INDUSTRIAL Water Use N7L1-1835
CLASS A - INDUSTRIAL
ITH South End**

INDUSTRIAL WATER USE INSPECTION REPORT

LICENCE #:	N7L1-1835	EXPIRY DATE:	December 11, 2023
LICENCEE:	Government of the Northwest Territories - Department of Transportation	PREVIOUS INSPECTION:	February 4, 2016
COMPANY REP:	Dean Ahmet, Senior Program Manager	INSPECTION DATE:	February 25, 2016

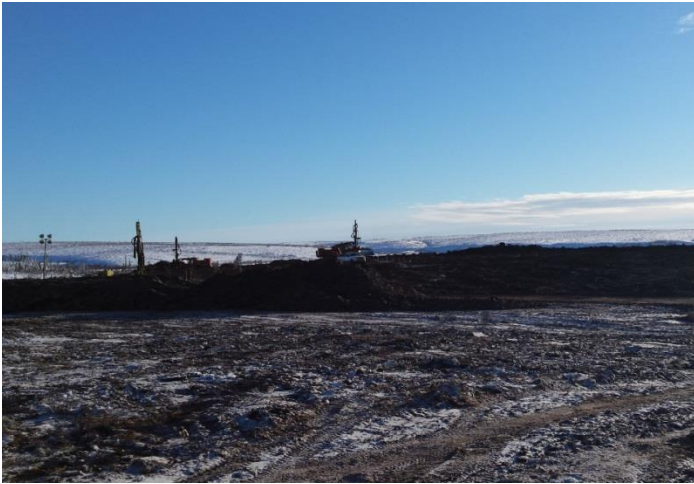
Figure 1

- Lands Resource Management Officer Manager Donald Arey and ENR Water Resource Officer Philippe Thibert-Leduc inspected GSC4 on February 25, 2016. Development work had just begun at the time of the inspection and crews were getting ready for blasting (see Figure 1).

Drills on site at Burrow Source GSC4 prepping for blasting.

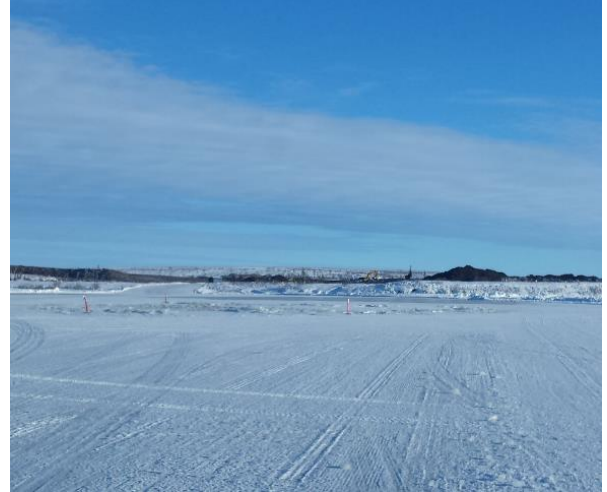
Figure 2

- Access road on Jimmy Lake was clean looking, some overflow observed in front of GSC4 access (see Figure 1). Licensee is working on an overland access contouring the southern side of Jimmy Lake.

Overflow in front of GSC4 access from Jimmy Lake access road.

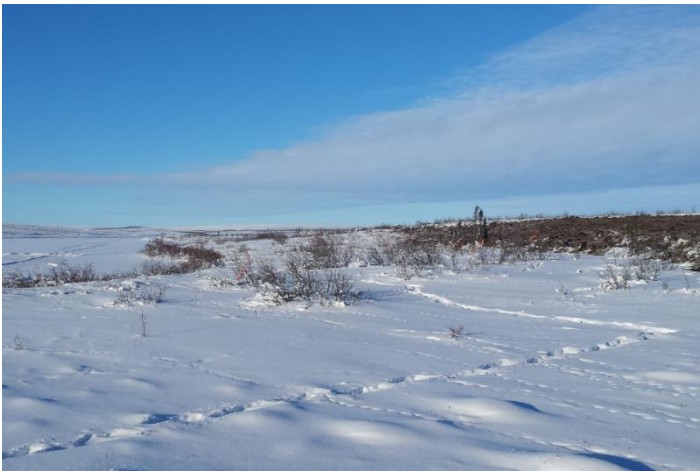
Figure 3

Jimmy Lake on the left off of access to GSC4, excavation/terrain disturbance on the right. Some markers are in place.

- Please ensure no excavation or terrain disturbance activities are carried out within a 50 m setback of any waterbody and that extraction activities at Burrow Source GSC4 occur more than 100 m from Jimmy Lake and more than 50 m from pre-identified creek east of the GSC4a deposit area, as per Subsection 4.1.2 of the approved PDP for GSC4 (see Figure 2). Please ensure that the buffer zone is closely monitored and properly marked for operators.

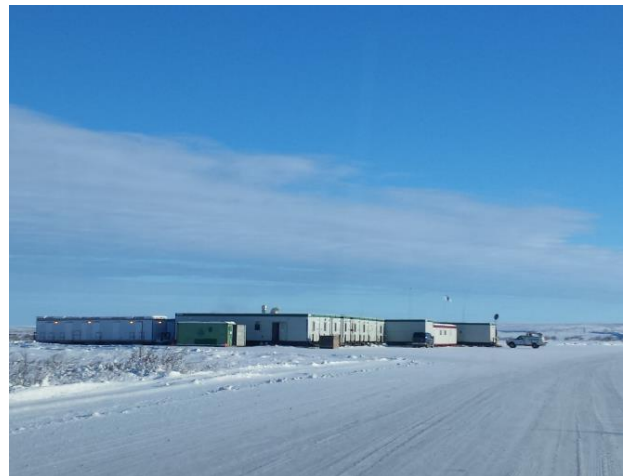
Figure 4

- Camp area by GSC4 was tidy looking with little activity going on at the time of the inspection; no concerns to report (see Figure 3).
- ¹No water withdrawal observed at the time of the inspection. For future weekly progress report, please note which approved water sources have been used that week, if any.

Camp by Burrow Source GSC4.
