**RE: INDUSTRIAL Water Use N7L1-1835
CLASS A - INDUSTRIAL
ITH North End**

INDUSTRIAL WATER USE INSPECTION REPORT

LICENCE #:	N7L1-1835	EXPIRY DATE:	December 11, 2023
LICENCEE:	Government of the Northwest Territories - Department of Transportation	PREVIOUS INSPECTION:	February 12, 2016
COMPANY REP:	Dean Ahmet, Senior Program Manager	INSPECTION DATES:	March 4, 2016 / March 9, 2016

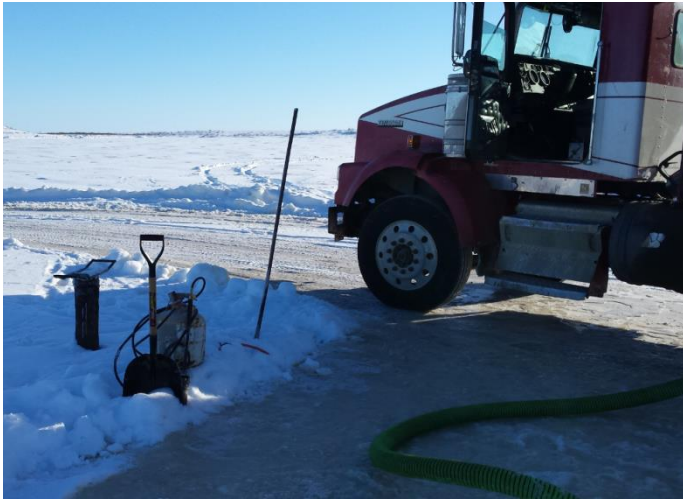
Figure 1

- ¹At the time of the ground inspection on March 4, 2016, a water truck was withdrawing out of Approved Water Source KP61. Drip tray was missing and various materials were being stored long-term on the ice (e.g. propane, spare parts for hose, shovels, etc.) (Figure 1). The operator on site was notified and asked to follow best management practices.
- On March 9, 2016, culverts and other materials were observed on the surface of KP 61 (Figure 2).
- As of March 9, 2016, Approved Water Sources KP61 and KP82a are in use.

Water truck at KP61 without drip tray on March 4, 2016.
Various materials stored on site.

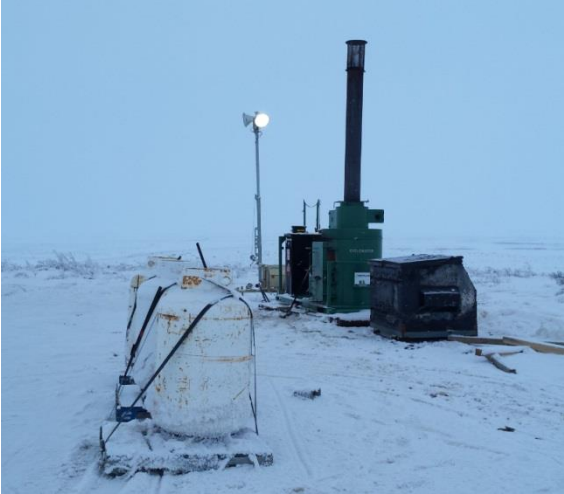
Figure 3

- A second incinerator (same model) was inspected at mobile camp 312 at the time of the aerial survey on March 9, 2016 (Figure 3). No concerns to report.

Incinerator at the mobile camp by Borrow Source 312.

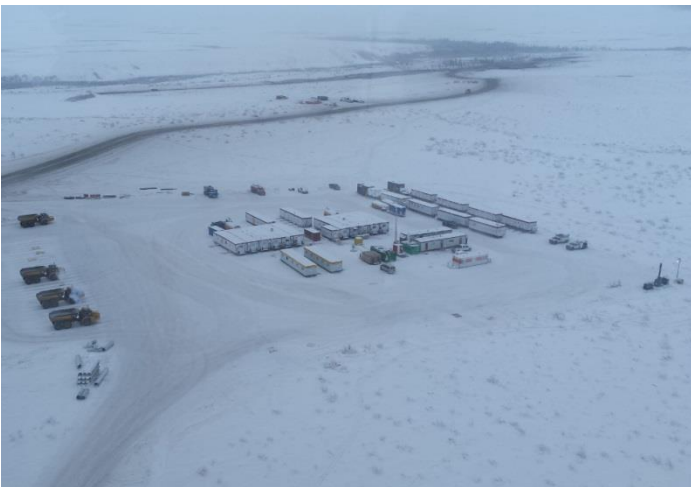
Figure 5

- Overall, camps at 174 and 312 appeared to be clean and tidy (Figures 4 and 5). No environmental concerns to report with regards to storage of fuel and sewage.

Mobile camp by Borrow Source 312. Lots of activity.

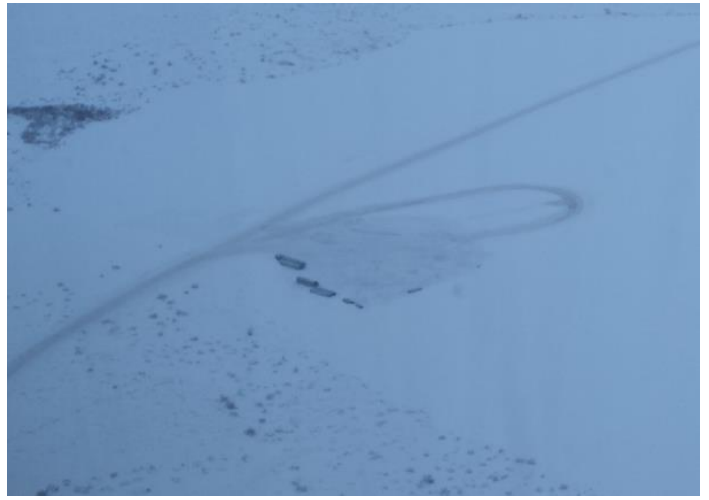
Figure 2

View of access to KP61 as seen on March 9, 2016. Culverts and other materials stored on the ice. Previously flagged materials removed.

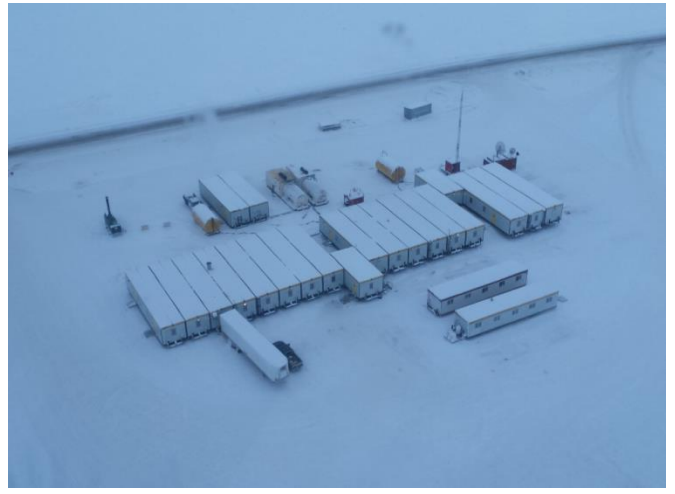
Figure 4

- As of March 9, 2016, there is limited activity out of Borrow Source 174 and the mobile camp. The end of the spread was marked at approximately KM 56 (Figure 6).

Mobile camp by Borrow Source 174. Limited activity.

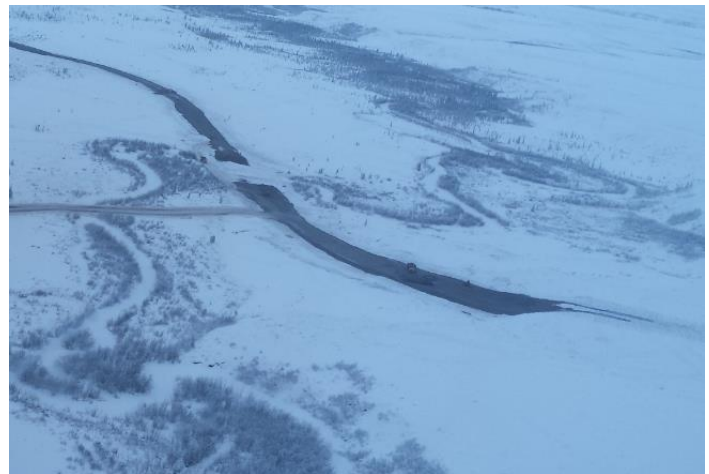
Figure 6

End of spread as of March 9, 2016. Approximately KM 56.
