**RE: INDUSTRIAL Water Use N7L1-1835
CLASS A - INDUSTRIAL
ITH North End**

INDUSTRIAL WATER USE INSPECTION REPORT

LICENCE #:	N7L1-1835	EXPIRY DATE:	December 11, 2023
LICENCEE:	Government of the Northwest Territories - Department of Transportation	PREVIOUS INSPECTION:	March 4, 2016 / March 9, 2016
COMPANY REP:	Dean Ahmet, Senior Program Manager	INSPECTION DATES:	April 12, 2016

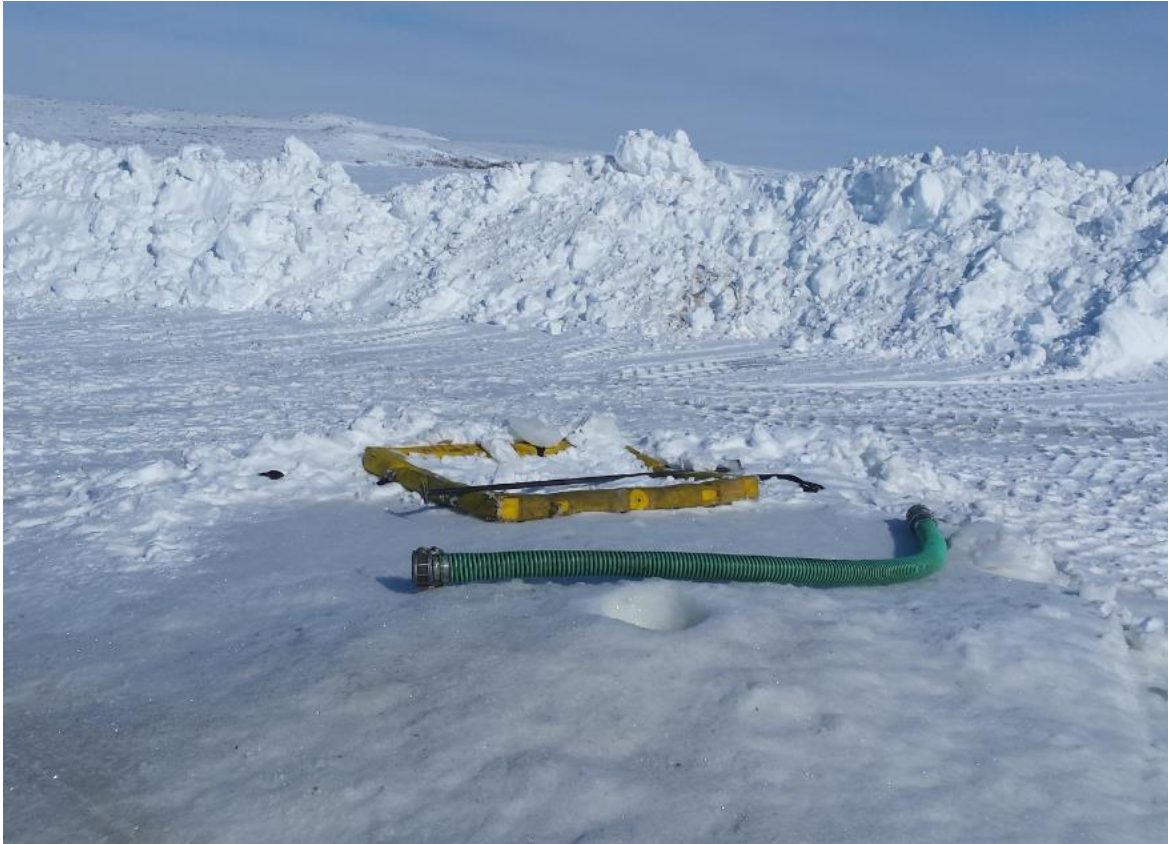
Figure 1

- There were no water withdrawal operations observed at the time of the inspection. There are still flooding operations at 312 and 174 access roads but none could be observed at the time of the inspection.
- Approved Water Sources KP61 and KP82a were inspected. Some materials were left behind at KP82a (see Figure 1). Please ensure that nothing is stored on the ice as things can move around easily due to weather and get lost. KP61 appears to be clean and tidy, and fairly inactive (see Figure 2).

Materials left on the ice at Approved Water Source KP82a.

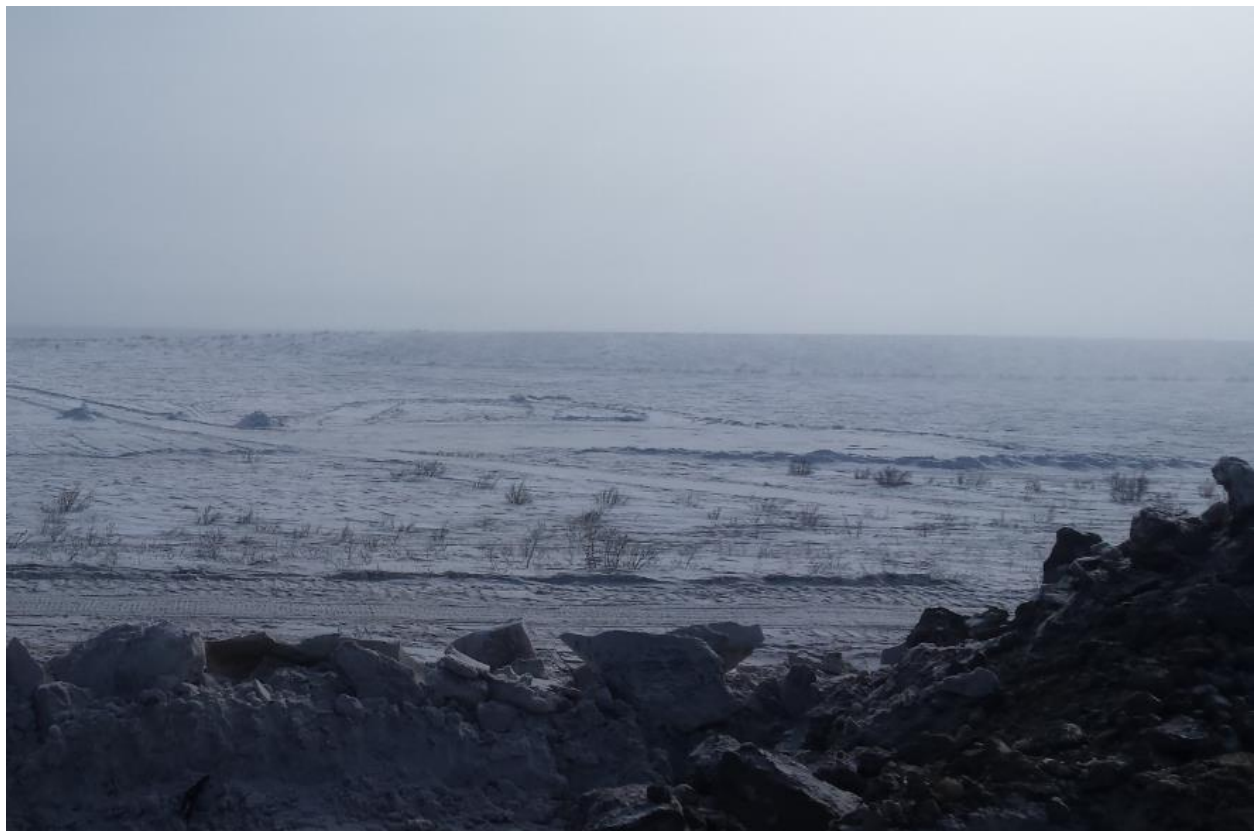
Figure 2

Overview of Approved Water Source KP61.

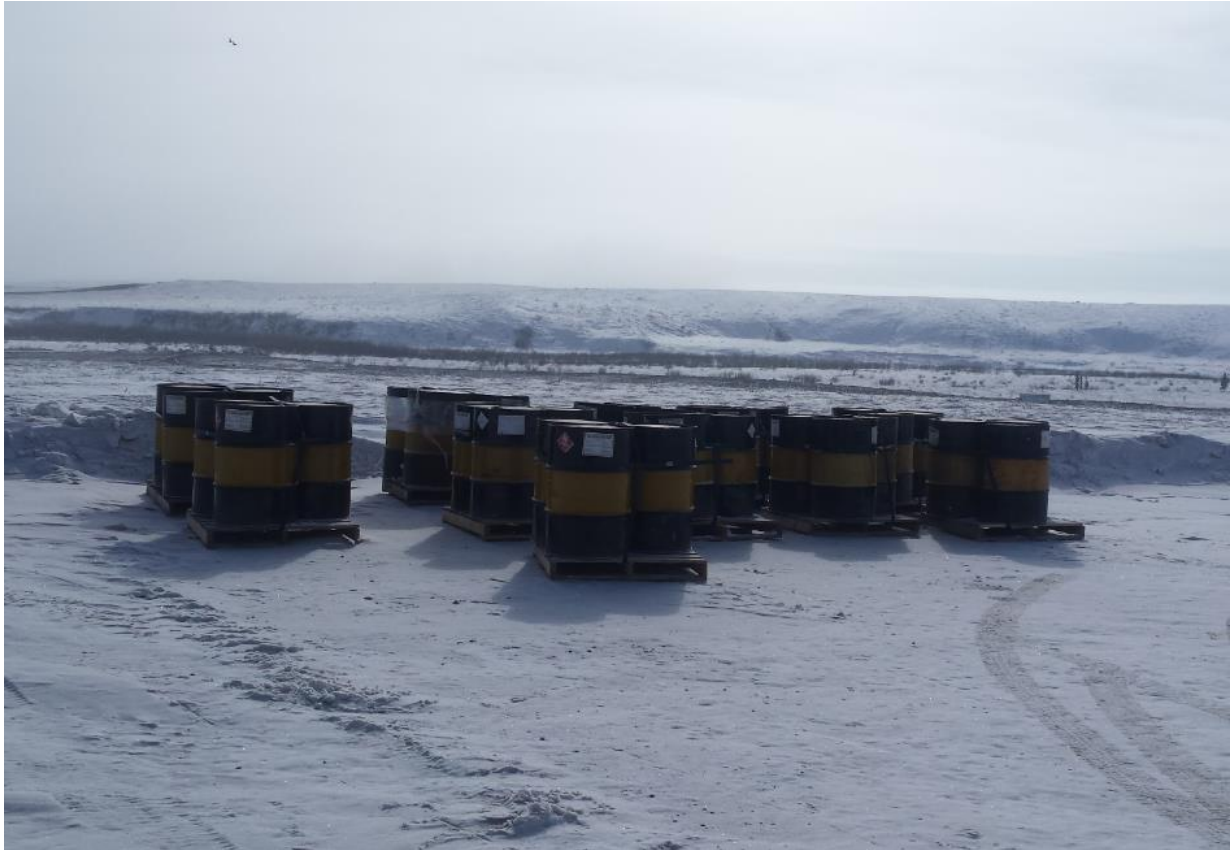
Figure 3

- Approximately 33 fuel drums were observed at the explosive pad that is marked on the now withdrawn amendment request to Pit Development Plan for Borrow Source 312 (see Figure 3). No immediate environmental concerns to report, however this site is uphill of Hans Creek, and currently there is no secondary containment being used. Please ensure that the drums are in impeccable condition and that secondary containment is used if the drums are to be stored at the site for some time.

Fuel drums stored at the explosive pad near Borrow Source 312. Drums are sitting on wood pallets but lack secondary containment.

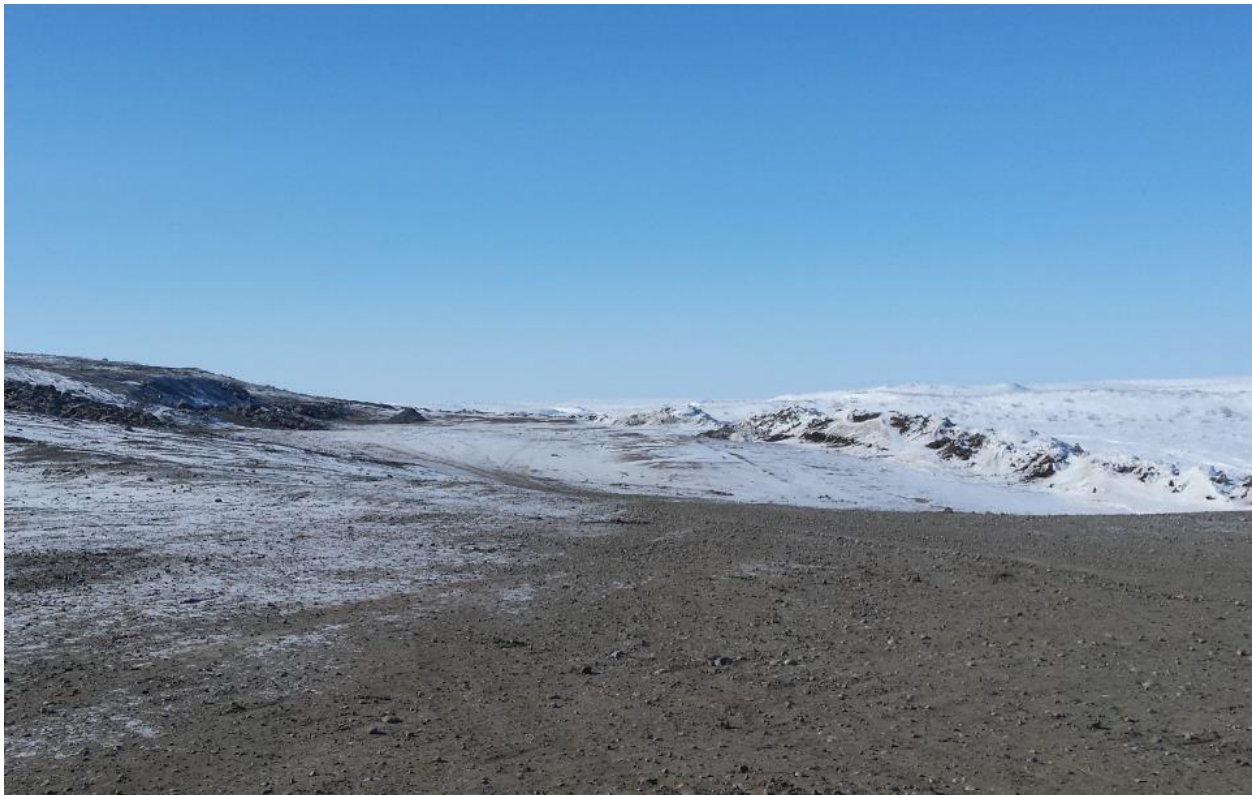
Figure 4

- A ground inspection of the north end was conducted by Water Resource Officer Philippe Thibert-Leduc and Environmental Protection Officer Rolland Malegana on April 12, 2016. At the time of the ground inspection, crews were still working out of Borrow Sources 174 and 312. Borrow Sources 170 and 177 were not inspected, however both sites are in the process of being reclaimed according to the Weekly Progress Report for March 31, 2016 to April 7, 2016. Partial reclamation efforts are ongoing at 174 and 312 – i.e. ripping and pushing in overburden, flattening out the surface (see Figures 4 and 5). Both areas will need to be monitored closely during freshet as there are some important water bodies nearby. No immediate environmental concerns to report.

Overview of North West corner at Borrow Source 174 – stockpiles have been pushed in and flattened out.

- Understanding that the construction season is soon coming to an end, please ensure that all stockpiled materials in all Borrow Sources meet the requirements of their respective Pit Development Plan as approved, and that all terms and conditions of the Water Licence are being met.

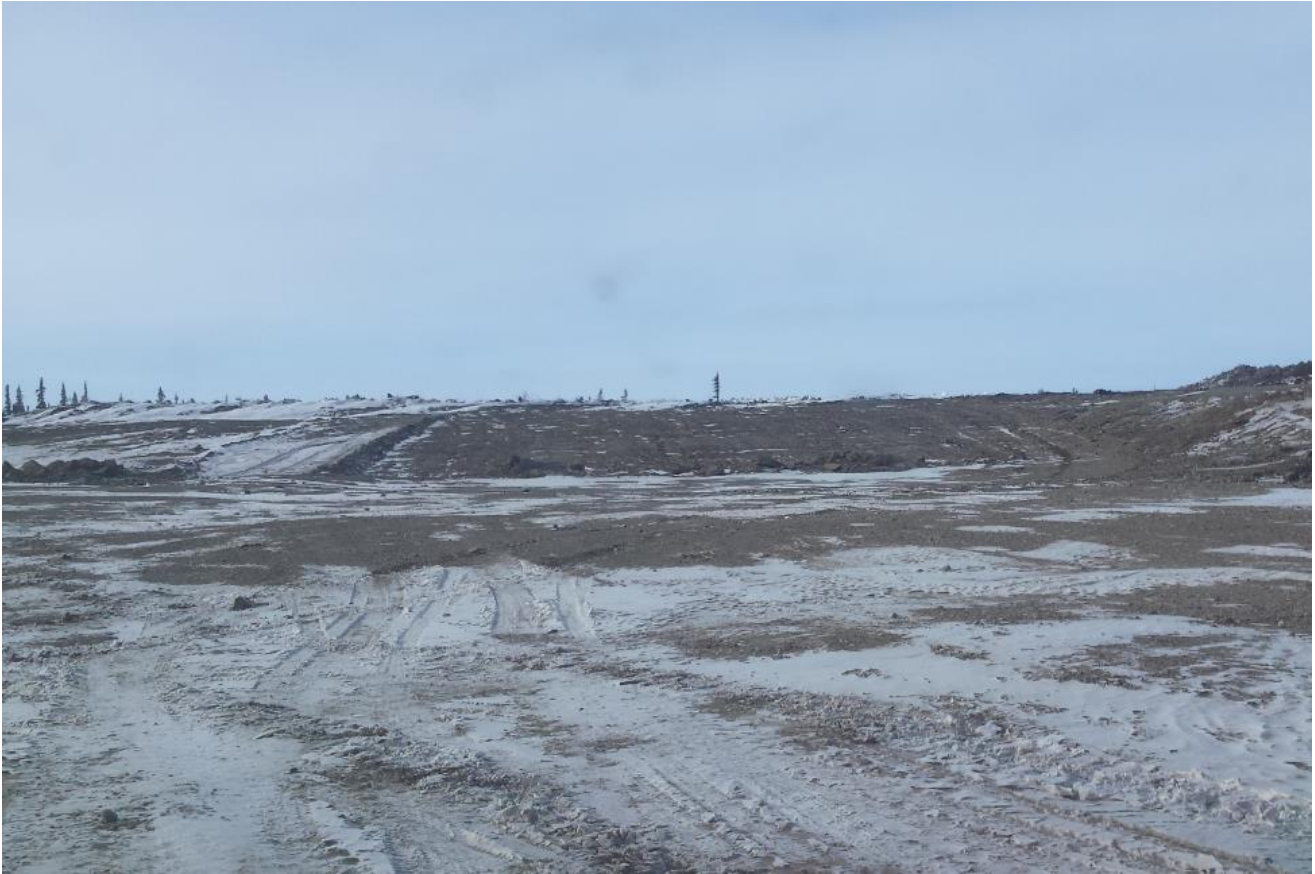
Figure 5

Overview of South West corner at Borrow Source 312 – stockpiles have been pushed in and flattened out.
