File Number N7L1 - 1835
Type of Operation CLASS B - INDUSTRIAL
Location

«INSP_TYPE» WATER USE INSPECTION REPORT

LICENCE #:	N7L1 - 1835	EXPIRY DATE:	December 11, 2023
LICENCEE:	Government of the Northwest Territories, Department of Transportation	PREVIOUS INSPECTION:	March 29, 2017
COMPANY REP:	Dean Ahmet	INSPECTION DATE:	April 18, 2018-2017

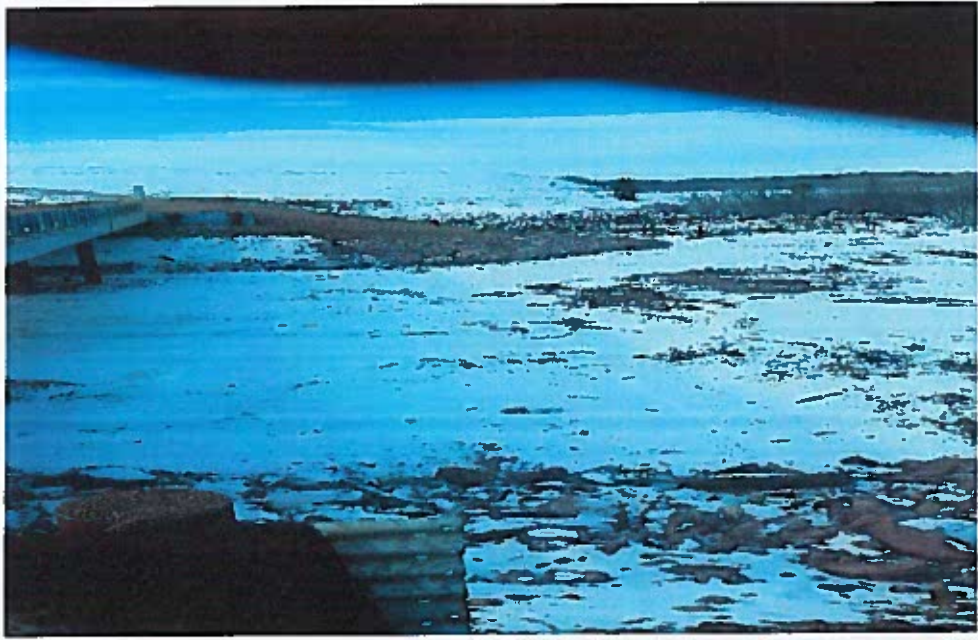
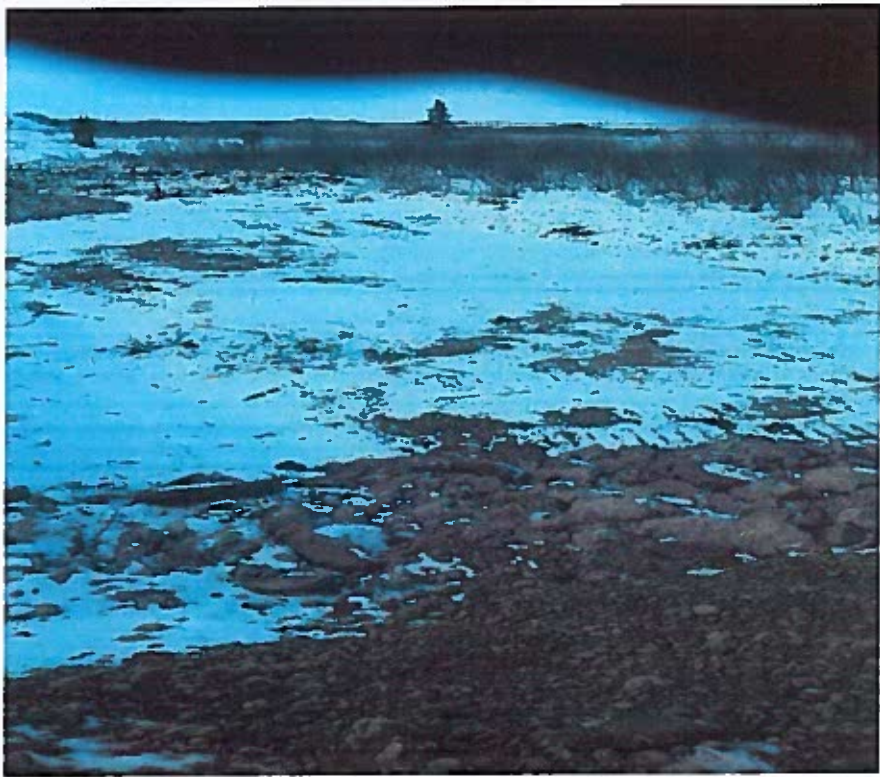
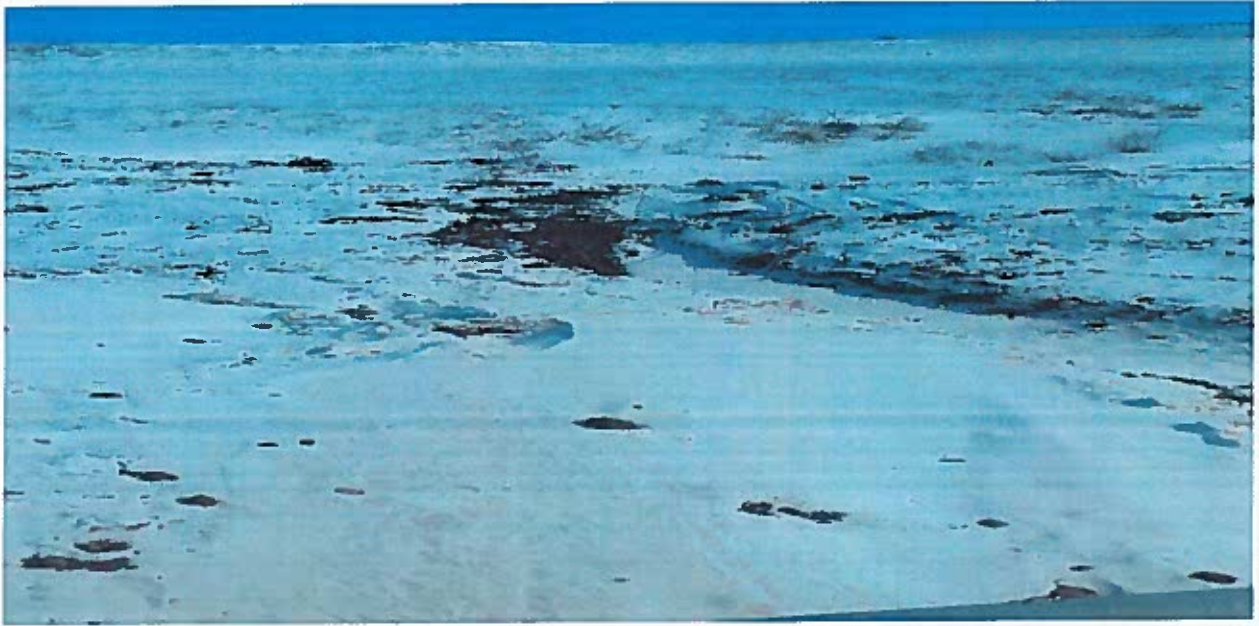
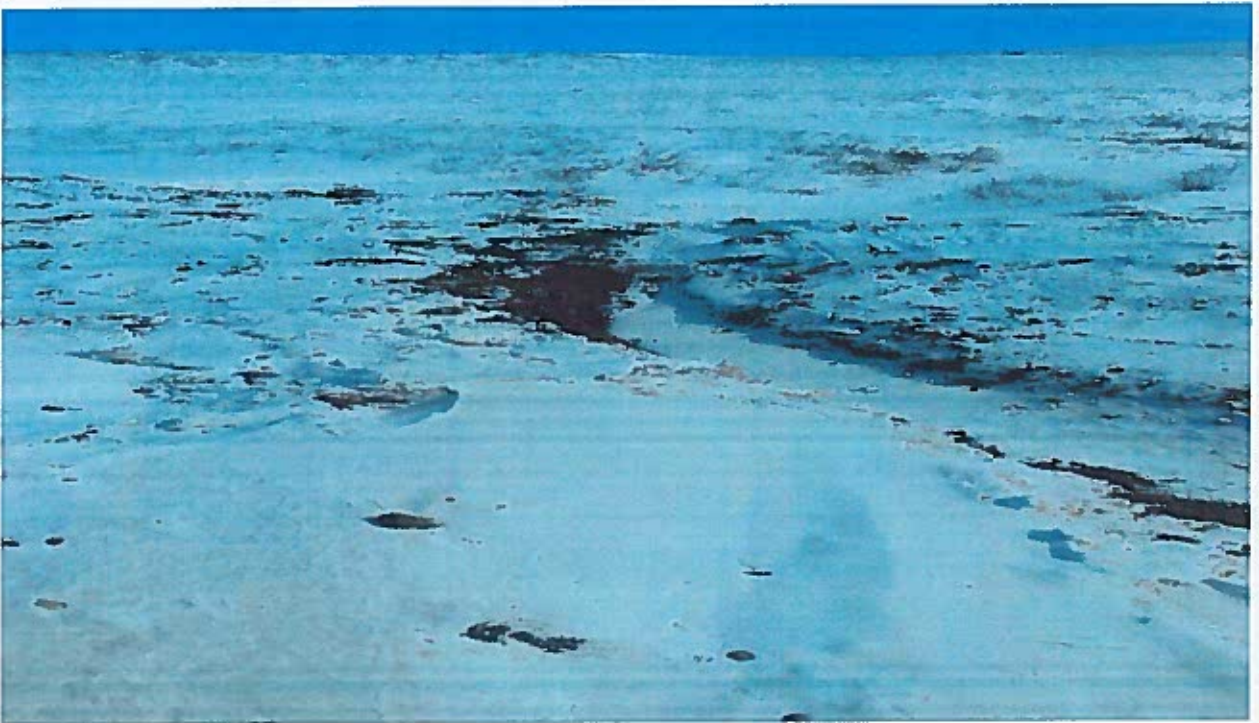
INSPECTION IMAGES

Observations wre made at Trail Valley Creek Crossing, on right hand trench heading north, mud and soil observed middle of trench will be obstructing water flow. These will need to be removed before spring melt

Hans Creek Crossing, gravel observed during inspection was noticed middle of creek water flow. This gravel will require scraped off before spring melt to allow water flow
