**RE: Municipal Water Licence (G99L3-003 and N3L3-0570)**

## WATER LICENCE INSPECTION FORM

<b>DATE:</b>	November 18, 2009	<b>COMPANY REP:</b>	Evelyn Storr
<b>LICENCEE:</b>	Hamlet of Aklavik	<b>LICENCE #:</b>	G99L3-003 and N3L3-0570

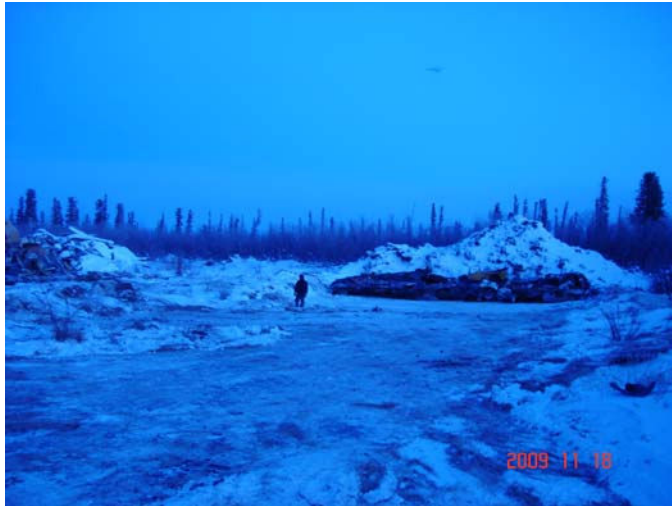
**Figure 1**

3. A lot of work has been done to improve the Solid Waste Disposal Facility(SWDF). Amongst the bulky metal waste area vehicles are being separated and crushed to be put in a designated cell, Hamlet foreman said vehicular fluids have been removed (see Figure 1). There is concern over whether the current cell for vehicle disposal is approved by the Board as per the current Operation and Maintenance Plan and this was expressed to the Hamlet. Vehicles will continue to be separated and crushed but the cell will not be closed. Only upon prior approval is confirmed by the Board will closure occur.

Crushed vehicle cell at bulky metal waste area.

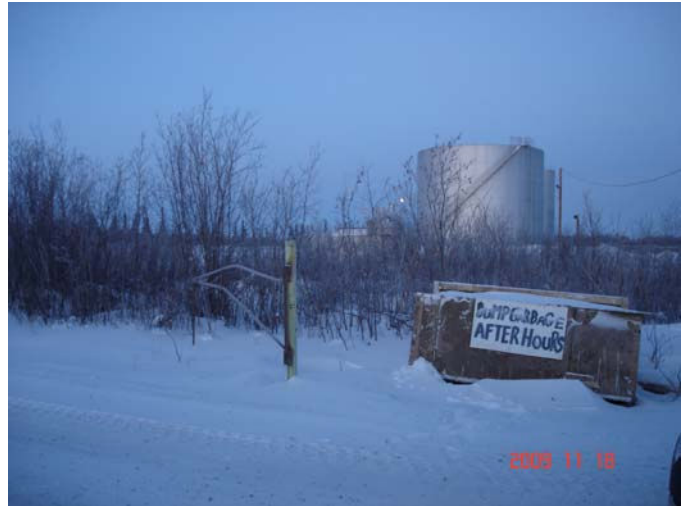
**Figure 2**

- The SWDF has a gated entrance to control access to the facility. After hours there is a drop off bin that allows the public to leave waste. The bin is then able to be picked up by equipment and taken to the designated areas in the SWDF to properly dispose of the waste (see Figure 2).

Gated entrance and after hours drop off bin which allows the public to still leave waste behind.

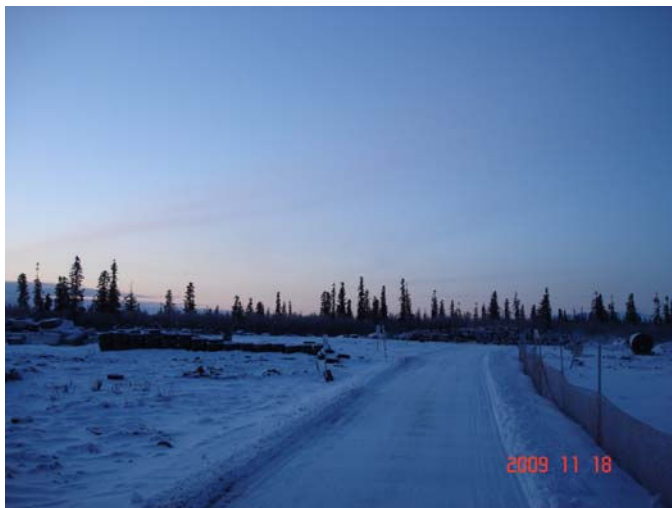
**Figure 3**

5. Many of the current waste cells have been covered over (see Figure 3 and 4). Continue to operate the SWDF so waste cells continue to be properly maintained and capped. The location where the asbestos is buried needs to be on record and noted for future activities .

- Signs and fencing are being used to direct people where to dispose of various waste including household waste. Tires are being used to direct where to put waste appliances (see Figure 3 and 4).

Overall picture of Solid Waste Disposal Facility on south side of access road.

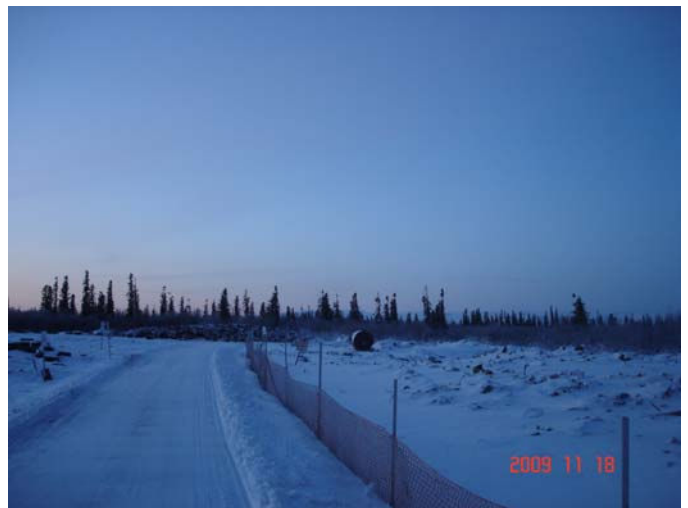
**Figure 4**

Overall picture of Solid Waste Disposal Facility on north side of access road.

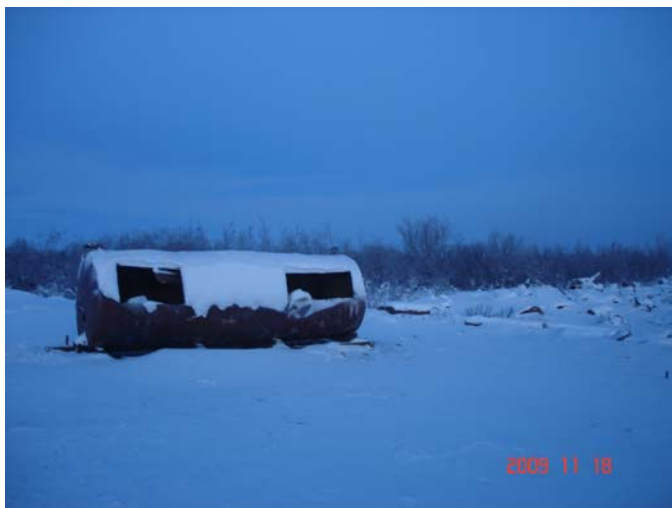
**Figure 5**

- Batteries are taken for storage at the Hamlet including any found at the SWDF.
- No evidence of burning occurring at the time of inspection but the Hamlet has designated a burn bin for burning approved materials. Reminder that municipal solid wastes that are conditionally suitable for open burning are paper products, paperboard packaging and untreated wood wastes according to the document from the GNWT Department of Environment and Natural Resources titled "Municipal Solid Wastes Suitable for Open Burning" (see Figure 5).

Burn bin at Solid Waste Disposal Facility to burn segregated waste- paper, cardboard, and untreated wood.

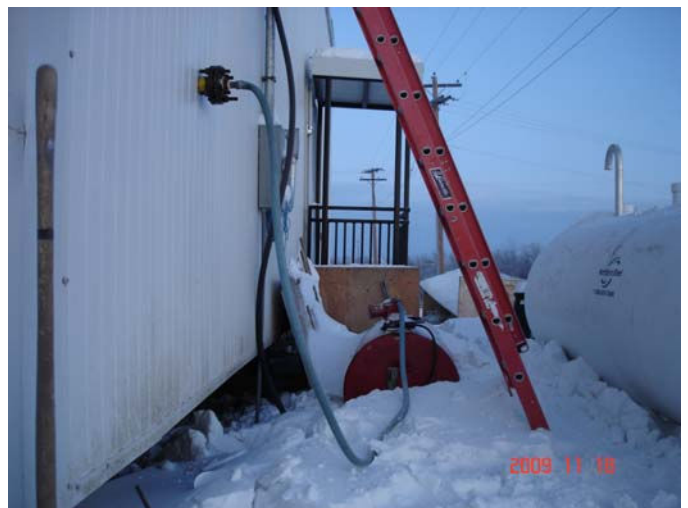
**Figure 6**

1. Flex pipe from old Water Treatment Plant to emergency generator is not straight and is showing signs that movement of buildings and piping is occurring. It is important to observe piping for any further movement that could cause problems/risk of leaks.
2. There was a tidy tank outside the new Water Treatment Plant (WTP) that was being used to supply fuel to the Plant. Safe operation is important as the fuel line is a hose and no secondary containment is present. It is highly recommended that an iced down snow berm be made to include the tank, hose and hook up etc. to allow a proper spill containment (see Figure 6).

Tidy tank connected by a hose the Water Treatment Plant and should have an iced down berm for secondary containment.
