**RE: Municipal Water Licence N3L3-0570
CLASS B – MUNICIPAL WASTE DISPOSAL**

An inspection was conducted of the Municipal Sewage Disposal Facilities on January 27, 2016. Enclosed is a copy of the Municipal Water Licence Inspection Report.

MUNICIPAL WASTE DISPOSAL INSPECTION REPORT

LICENCE #:	N3L3-0570	EXPIRY DATE:	November 30, 2019
LICENCEE:	Hamlet of Aklavik	PREVIOUS INSPECTION:	August 26, 2011
COMPANY REP:	Fred Behrens, SAO	INSPECTION DATE:	January 27, 2016

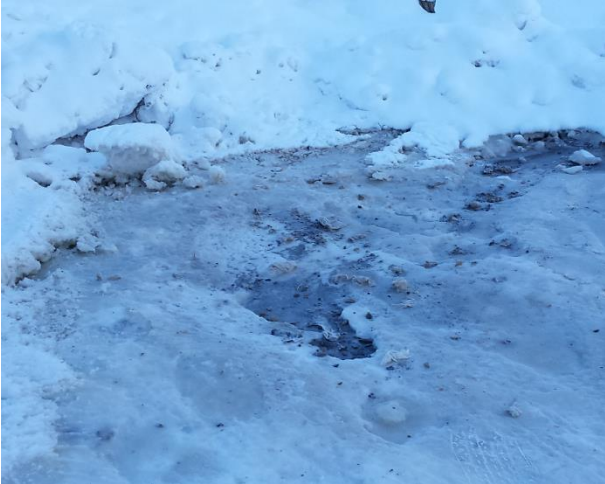
Figure 1

- There is evidence of sewage being discharged outside of the sewage lagoon, near the discharge pad at the Sewage Disposal Facilities (SDF) (see Figure 1). Operator must ensure that that all sewage is discharged into the sewage lagoon as authorized under the Water Licence. Discharging excess or build-up of sewage directly onto the ground is considered an unauthorized discharge of hazardous wastes and cannot continue. If excess sewage cannot be discharged in the chute then it must be contained in a sealed container until it can be disposed properly.

Accumulation of spilled sewage near the SDF.

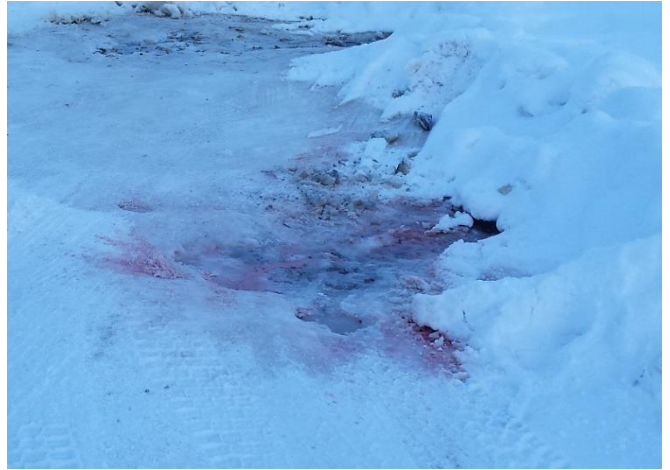
Figure 2

- There is evidence of what appears to be auto transmission fluid (ATF) around the sewage discharge (see Figure 2). Additionally, a number of empty ATF bottles were observed by the discharge chutes (see Figure 3). The sewage truck should not be spilling ATF and should be inspected as soon as possible. The operator is aware that this is ongoing and has agreed to get it checked for general maintenance and possibly repairs.

Spilled ATF near the SDF.

- All spilled ATF will need to be cleaned up as soon as possible and stored in a sealed container until it can be sent for ultimate disposal at a registered receiver of hazardous wastes. Operator agreed to use drip trays/containment when releasing excess sewage and/or ATF generated by the sewage truck and to clean up previous spills.

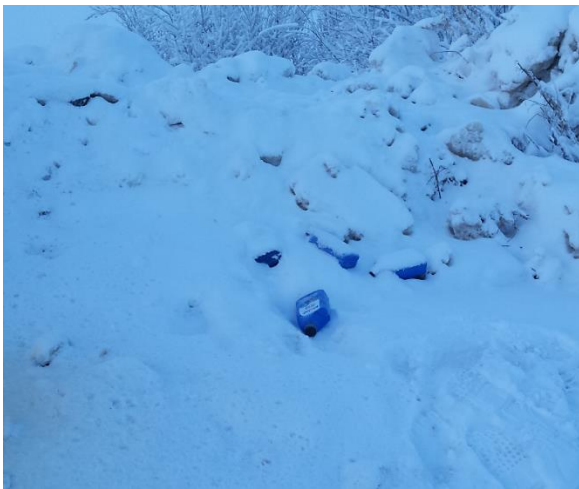
Figure 3

Empty bottles of ATF at the SDF.

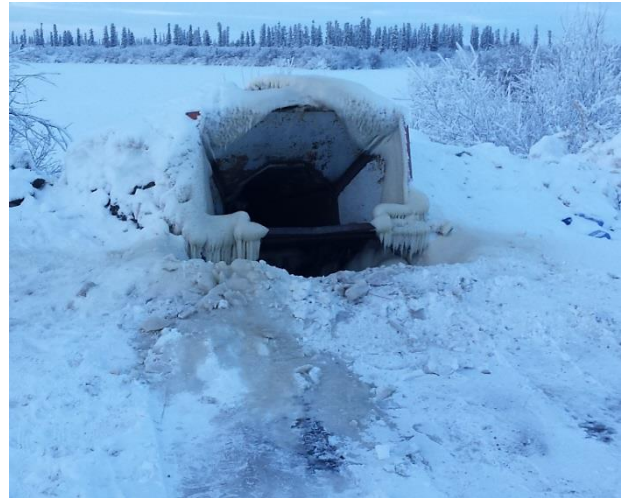
Figure 4

- There is evidence of erosion at the sewage discharge chute that is currently in use. The pad is frozen and covered in snow but there are likely stability issues with regards to the chute and the discharge pad due to sewage pooling and damaging the structure overtime (see Figures 4 and 5).

Accumulation of spilled sewage underneath and around the discharge chute that is currently in use.

- Sewage is being spilled underneath and around the discharge pad. Operator must ensure that all sewage is discharged in the chute and that any spilled sewage is being contained. Recommend adding a catchment basin which can be emptied in the chute when at capacity or on a daily basis during winter season.

- Area will need to be closely monitored during the spring and summer to ensure that any sewage spilled during the off-loading procedure will flow into the sewage lagoon or into a catchment basin (i.e. good drainage).

- Recommend adding or upgrading tire stops for safety reasons and to protect the discharge chute from further damage.

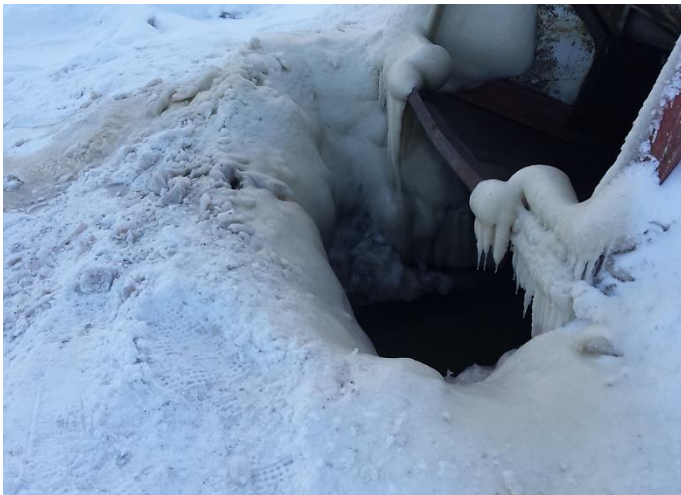
Figure 5

Accumulation of sewage underneath the discharge chute will lead to structural issues overtime. Catchment basin is recommended. Discharge pad needs to be remediated to allow for good drainage and prevent any pooling of sewage.
