Regarding: Hamlet of Tuktoyaktuk Water Licence – Part D-34; Impact Analysis

Assessing the Impact of the Landfill on the Adjacent Bay

TERMS OF REFERENCE

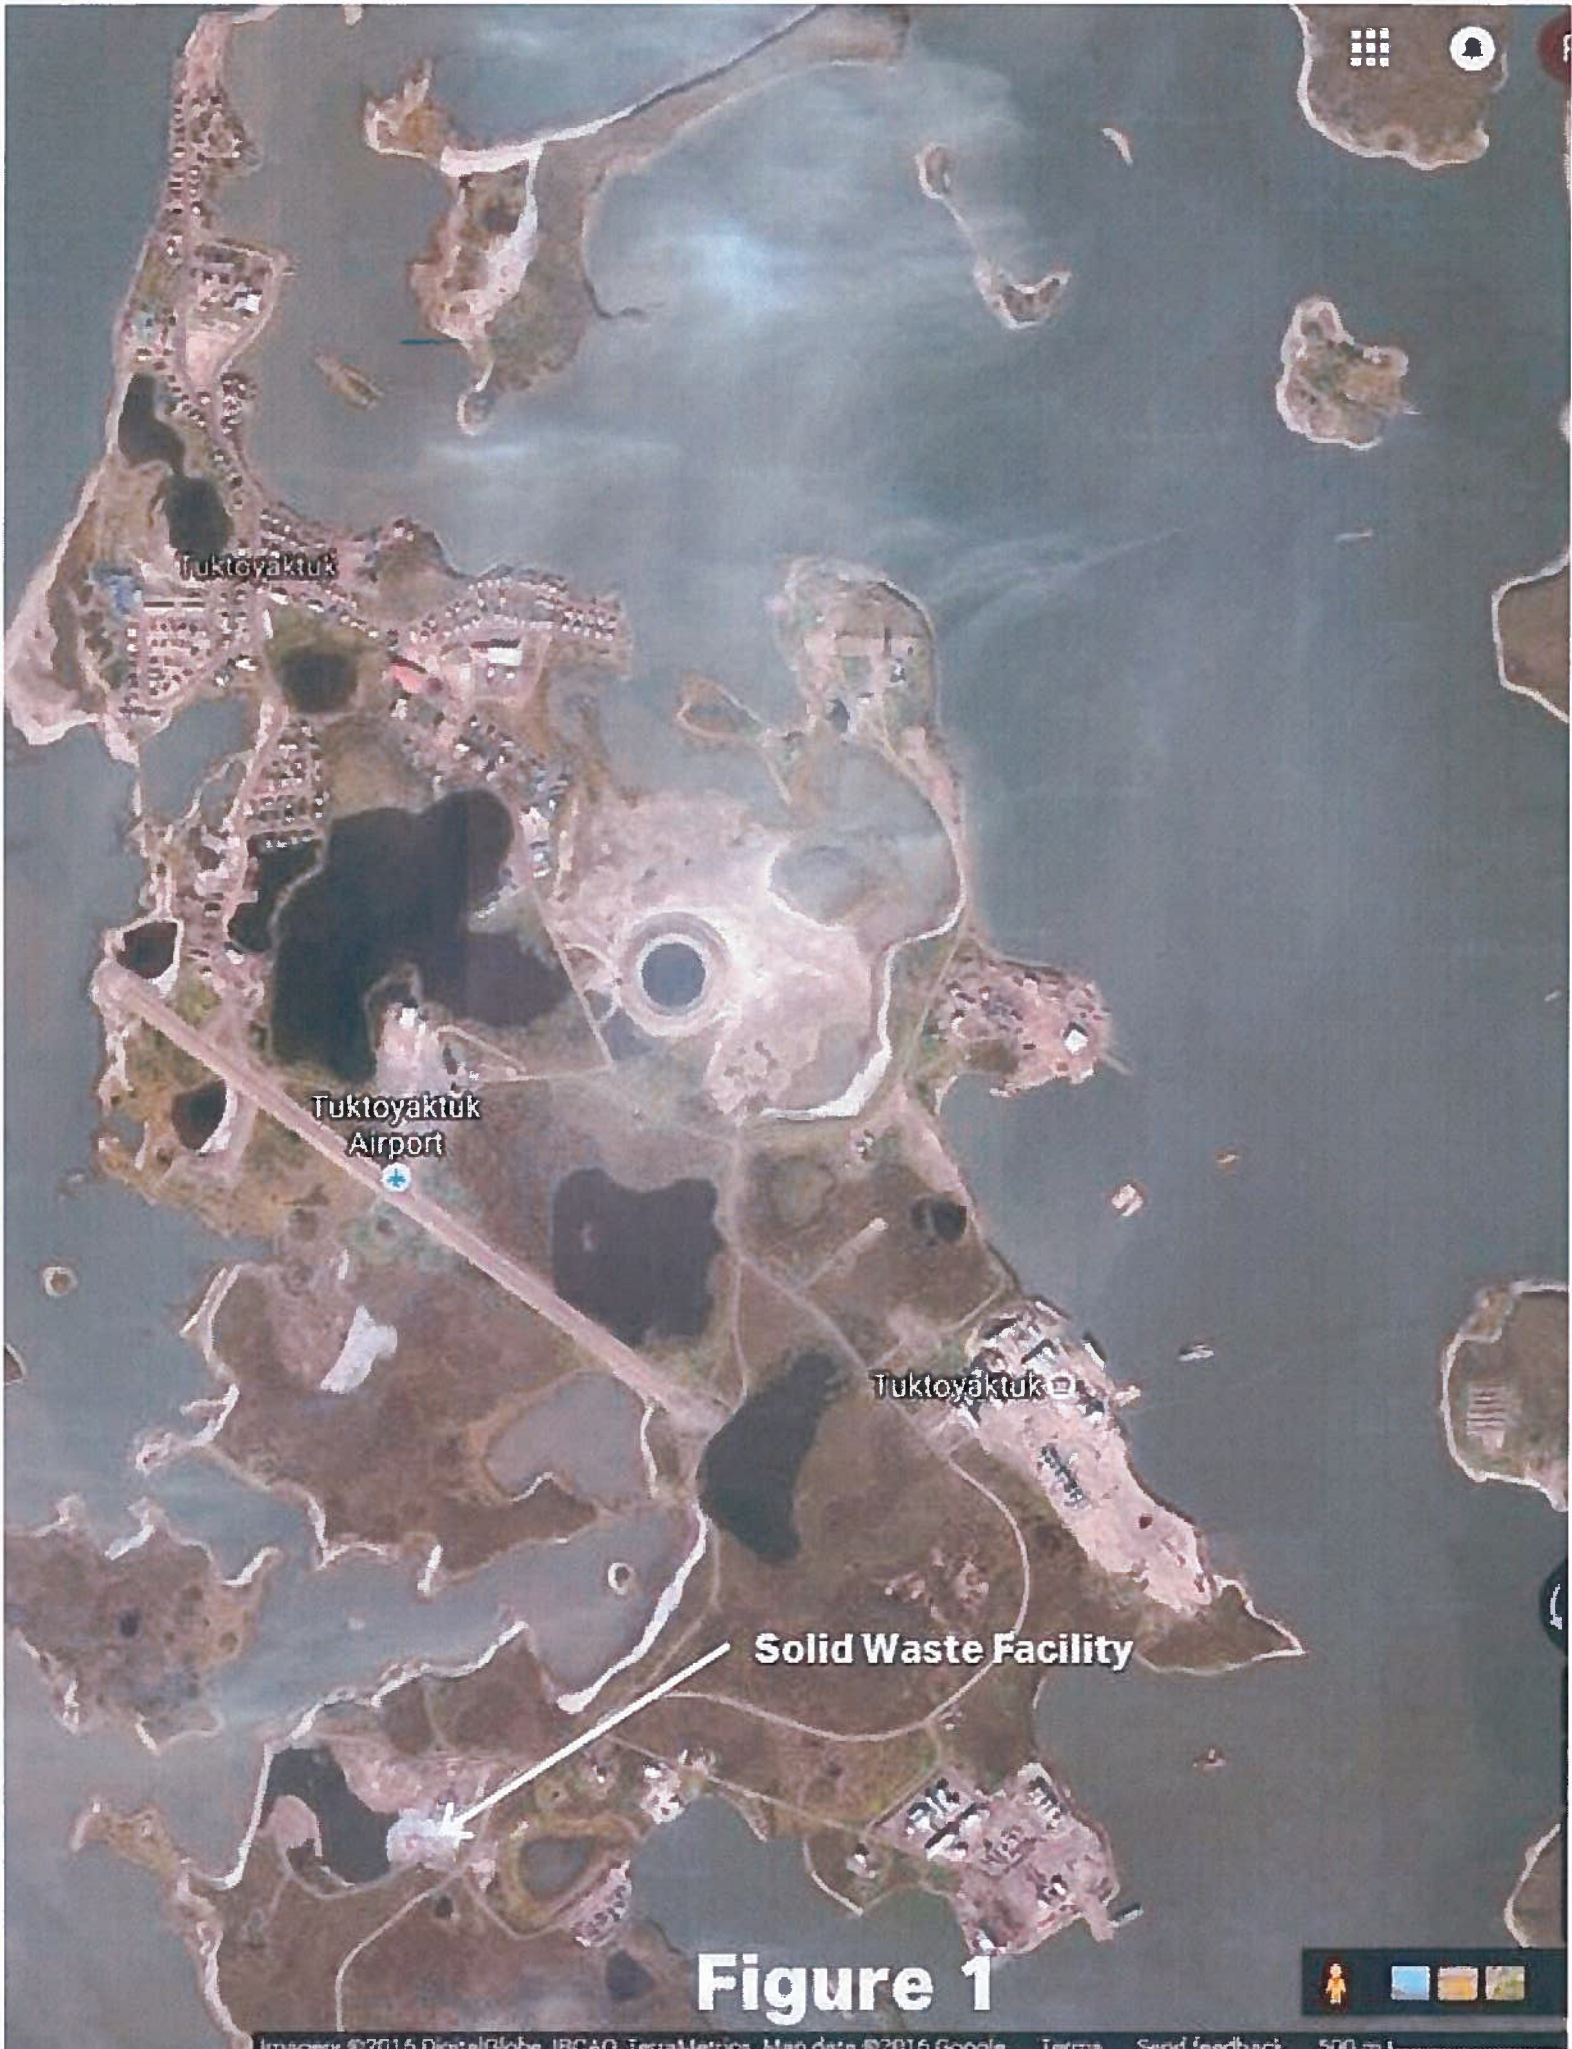
Figure 1

Tuktoyaktuk
Airport

Solid Waste Facility

Tuktoyaktuk's Solid Waste Disposal Facility (landfill) is located approximately 3 km south of the Hamlet along the all-weather road to Reindeer Point. This site has been in operation since the early 1970's. It was developed in a bay of the Beaufort Sea after the bay was isolated from the ocean by construction of a 250 m long, clay and gravel dyke, as illustrated in Figure 1. The site forms a containment that retains water, which becomes contaminated from contact with the waste. The berm does not have any discharge control structure, so water that accumulates from spring melt and rain is pumped over the berm into the ocean periodically, posing an environmental concern.
