KAVIK-STANTEC

# Technical Memo

To:	Russell Newmark, CEO EGT Northwind Ltd.	From:	Erica Bonhomme, P.Geo. 4910 53rd St. Yellowknife, NT
File:	123511255	Date:	September 8, 2016

**Reference: Assessment of Downslope Permafrost Erosion at Borrow Source 174**

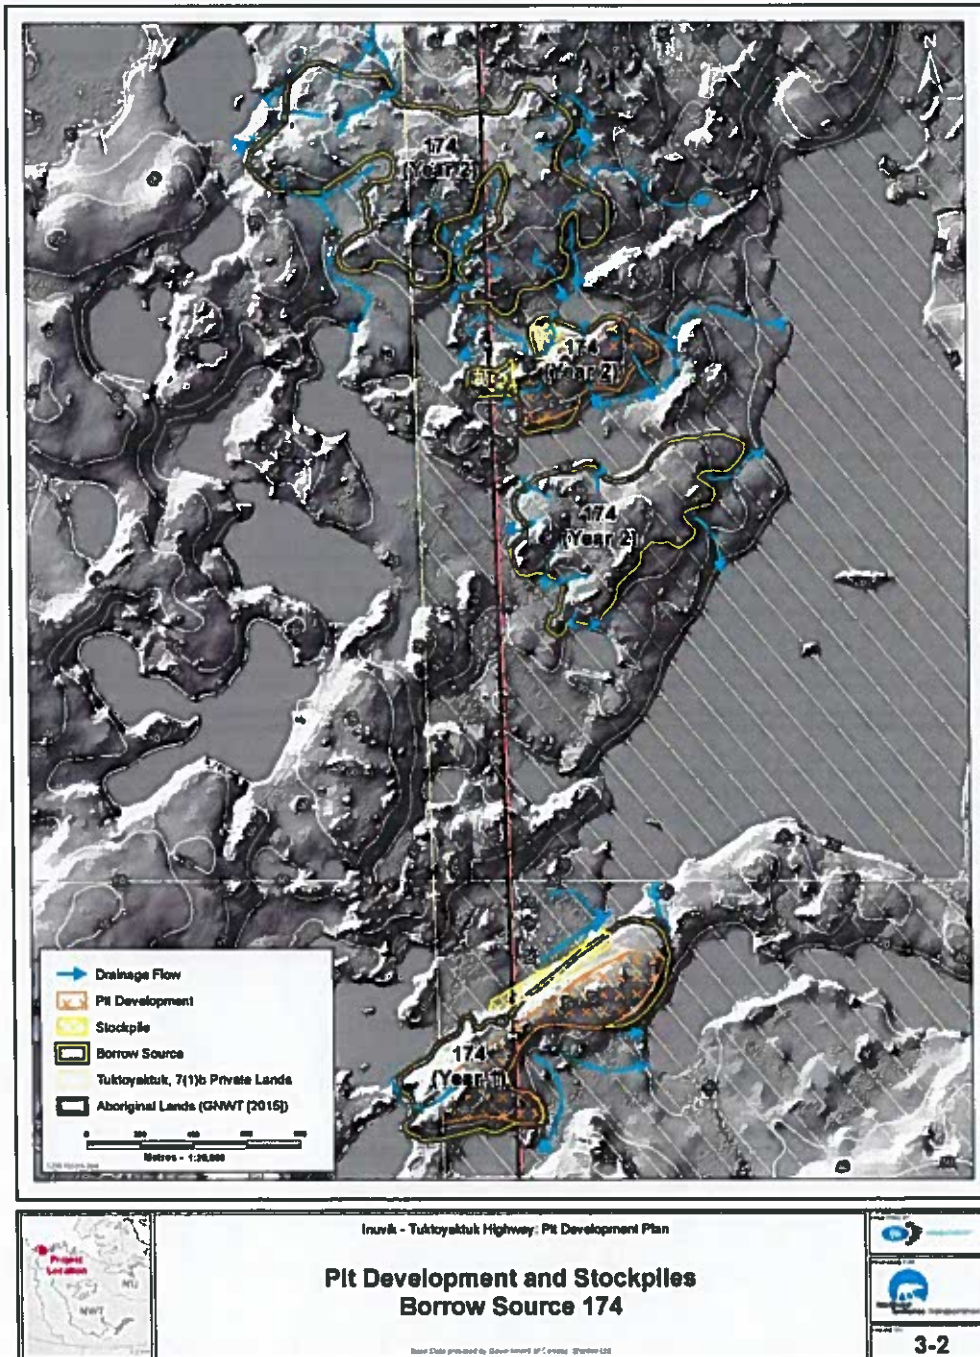
Figure 1: Borrow Source 174 Pit Development Plan – Figure 3-2

Borrow Source 174 is located partly on Inuvialuit Private Lands and partly on Government of Northwest Territories Crown Land (Figure 1- Figure 3-2 from the PDP). Operations at the source are authorized under Quarry Permit issued by the Department of Lands (DOL) and Quarry Licence issued by the Inuvialuit Land Administration (ILA). Both authorizations include a Pit Development Plan, specifying the areas to be developed, methods, quantities, erosion control measures and reclamation (KAVIK-STANTEC, 2014a). Approximately 800,000 m<sup>3</sup> of borrow material from the southernmost polygon of the source was extracted in winter 2014/15 and 2015/2016.

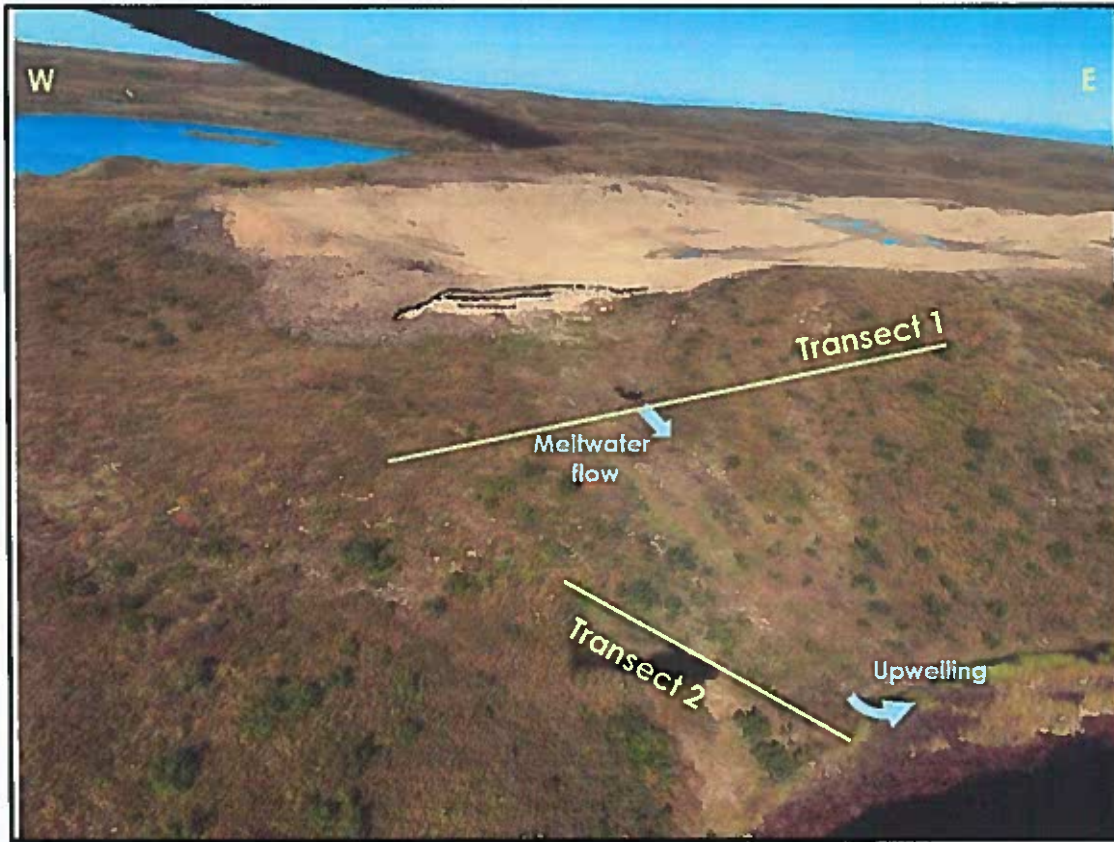
Figure 3: Location of Active Layer Transects in Relation to Borrow Source and Sinkhole

Active Layer Transect 1 is located approximately 50 m from the lake shore, is 100 m long, and is centered on a natural depression between small ridges on either side of the sinkhole area (Figure 3). Two separate active layer depths were recorded every 5 m approximately, using 1 cm diameter steel probe graduated in 20 cm increments. Distance from the base of vegetation to base of active layer was recorded when substrate encountered was determined by feel to be top of permafrost. Detailed location information is included in Attachment A. Due to the coarse nature of the substrate visible at surface in the area (pebbles and cobbles), resistance at depth not due to permafrost was frequently encountered.
