## MUNICIPAL WATER USE INSPECTION FORM

<b>DATE:</b>	September 23, 2004	<b>COMPANY REP:</b>	Debbi Raddi/Peter Nogasak
<b>LICENSEE:</b>	Incorporated Hamlet of Tuktoyaktuk	<b>LICENCE #:</b>	N7L3-0714

## LIST OF FIGURES FOR WATER LICENCE INSPECTION REPORT

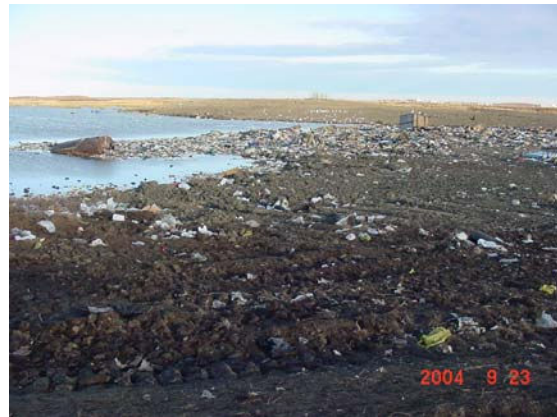
**Figure 11. Waste Disposal.** SWDF north west view with old bulk metal waste storage facility in the background.

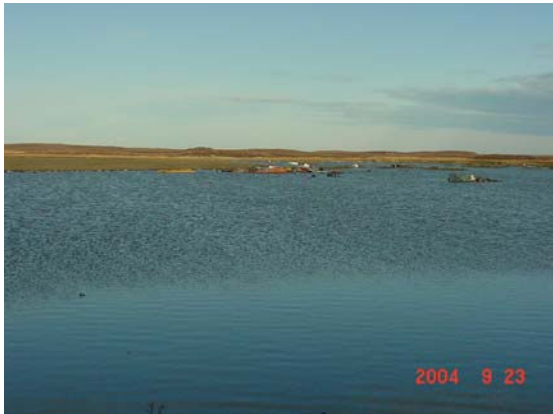
- As indicated last year the SWDF waste oil and hazardous materials area (Figure 12, 13) are becoming permanent storage areas. It is recommended that every effort be made to dispose of these materials at a certified disposal facility. Long term/permanent storage of this material is not recommended. It is only a matter of time before spills occur. It is understood that there is a plan to dispose of this material (waste oil) at Grubens

**Figure 12. Waste Disposal.** SWDF waste oil and hazardous wastes area.
