From: **James C. McDougall, P.Eng.**
Date: March 26, 1999
Pages: 11 Including this cover page
Subject: **Water Board License N3L1-1727 Abandonment and Restoration Plan**

This fax outlines the Abandonment and Restoration Plans for this winters construction activities associated with the Town of Inuvik Gas Project as required under Part H of License Number N3L1-1727.

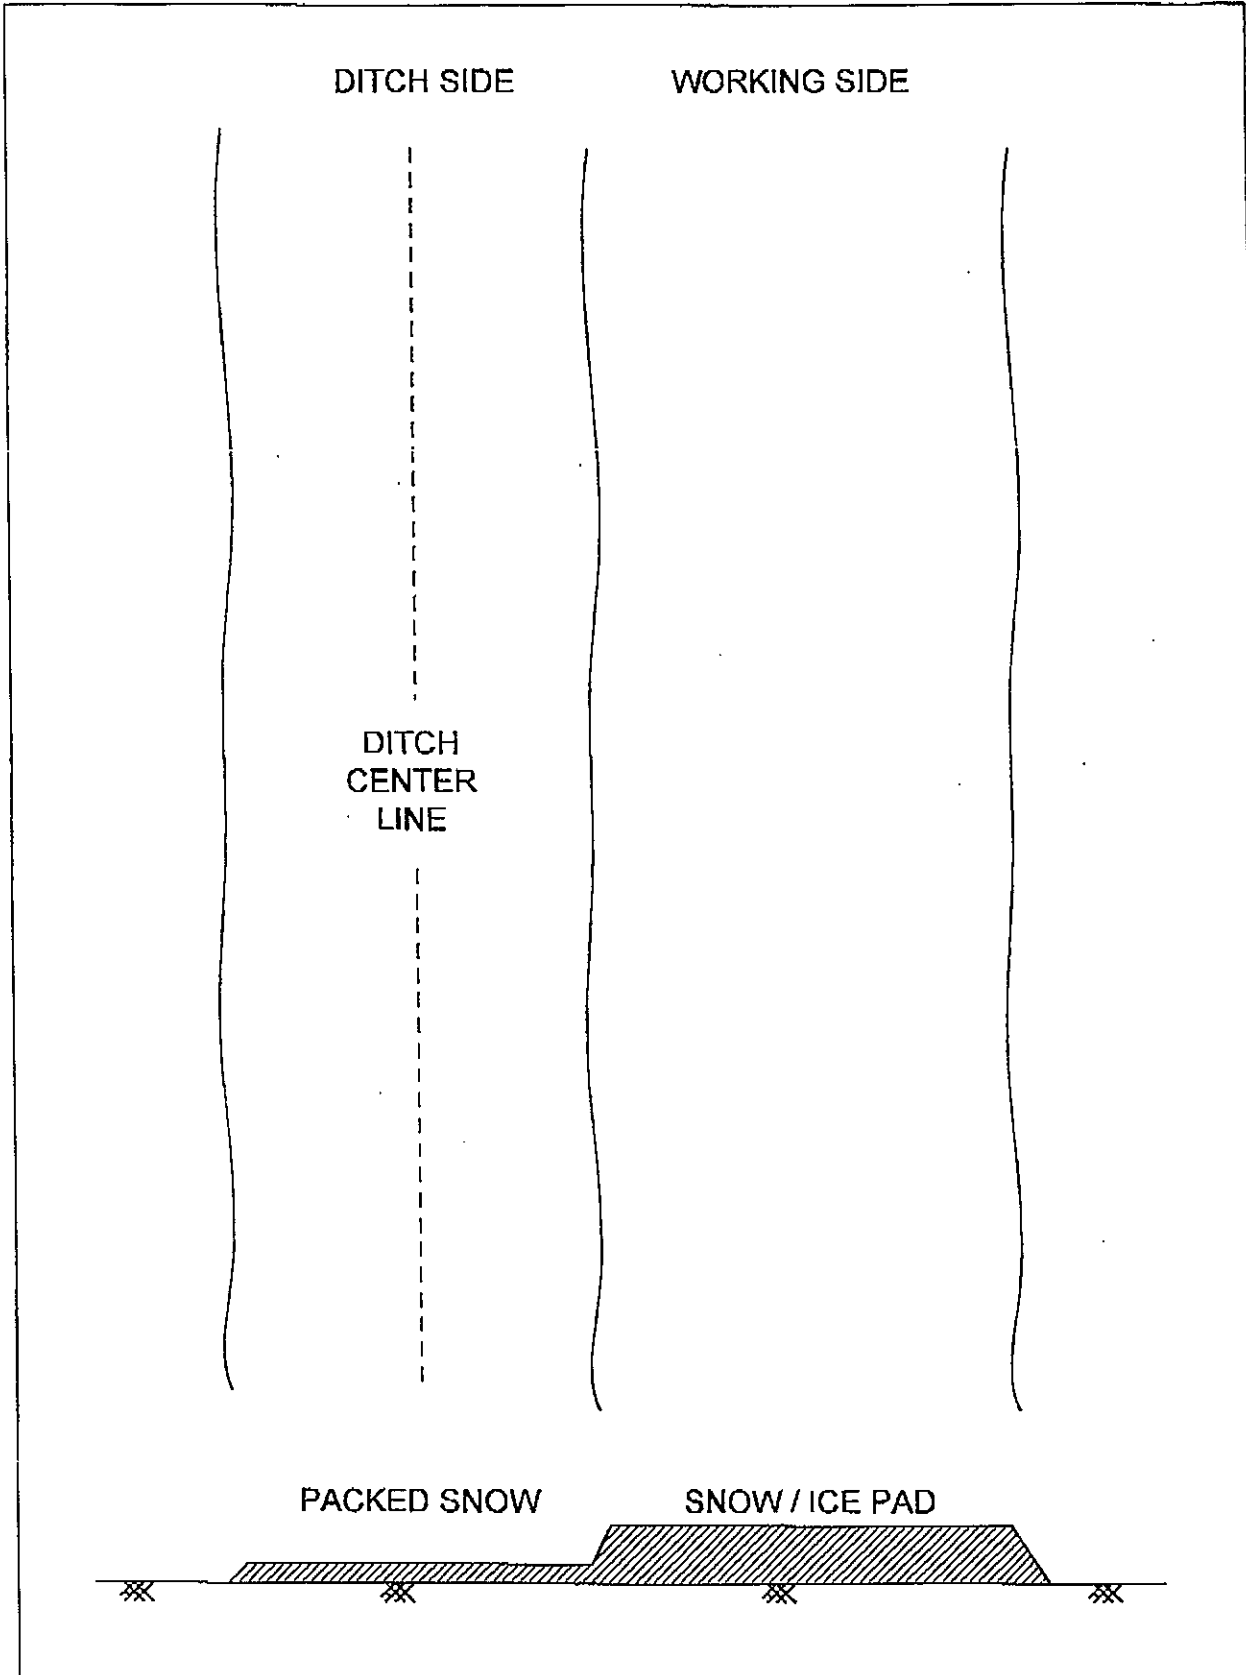
<p>60</p>	<p>North of 60 Engineering Ltd. 2050, 140 4th Avenue S.W. Calgary, Alberta, Canada T2P 3N3</p>		<p>Figure 1 - Snow / Ice Pad</p>	
	<p>By: CWT</p>	<p>Date: 99/03/11</p>		
	<p>Scale: NTS</p>

As shown in Figure 1, a snow / ice pad was constructed on the east side of the right-of-way to provide a working surface for vehicular movement. The snow / ice pad will be allowed to melt in place. There are a number of locations along the ROW where the snow / ice pad may impede cross drainage. In these locations the snow / ice pad will be notched in a manner so as to protect the permafrost before spring break up to facilitate natural water flow. If ponding becomes evident during spring break-up, personnel will be dispatched by snow machine or helicopter to rectify the problem area.

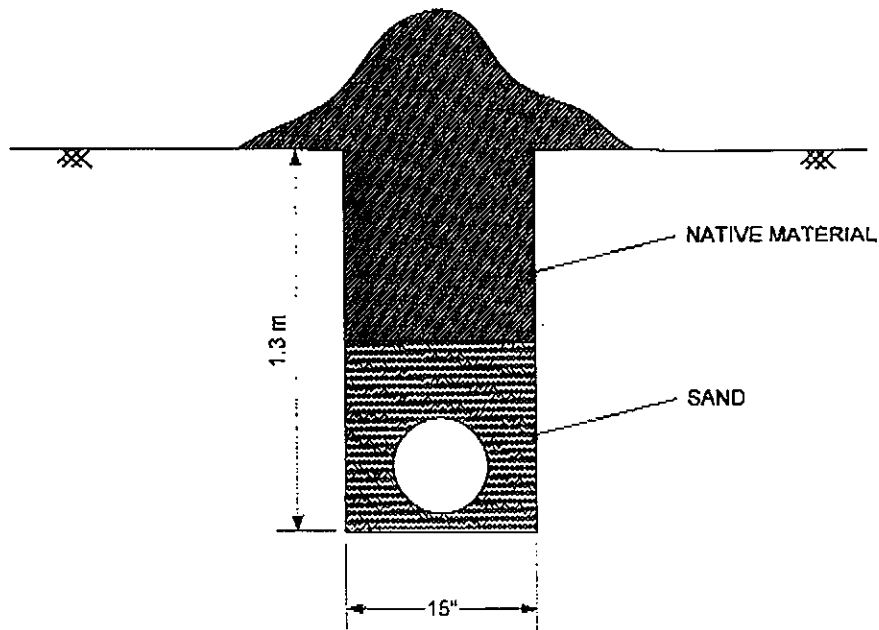
Figure 2 - Ditch Backfill

As shown in Figure 2, the majority of the 50 km 6 inch pipeline was laid in a 15 inch wide ditch that is 1.3 meters deep. The pipe was then covered with 2 feet of sand and the native soil was then placed in the ditch with the excess material roached over ditch. Thaw strain analysis of the native ditch material shows that there will be approximately 50% settlement in the native material when it thaws next summer which will result in a ditch profile similar to that shown in Figure 3a. The restoration plan is to rake or shovel the excess material from the thawed roach on either side of the ditch into the ditch, thus bringing the ditch to grade (Figure 3b). The ditch will then be monitored until the following summer when it will be re-seeded with indigenous grasses if necessary.

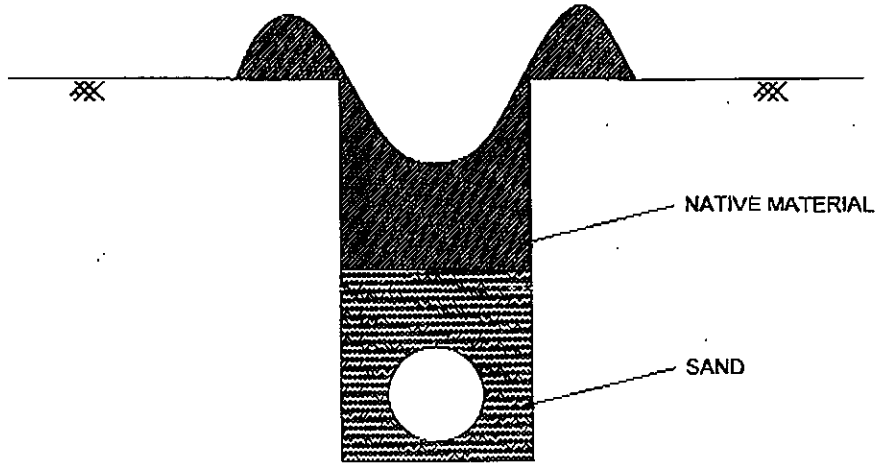
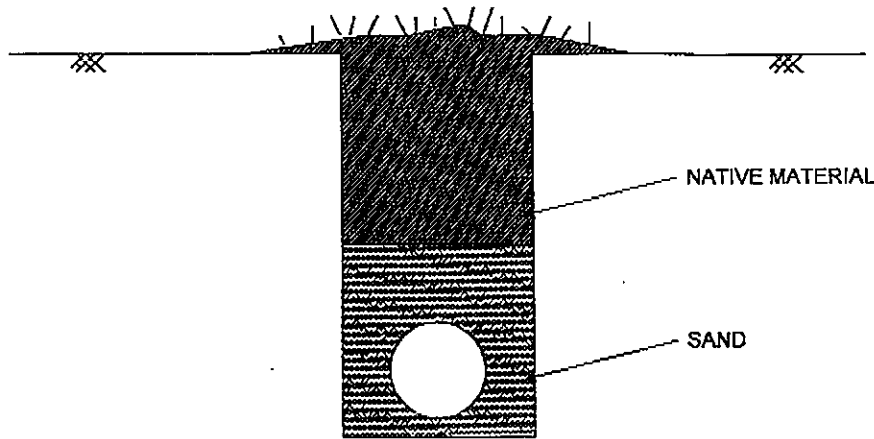
(a) - After First Thaw

(b) - After Restoration

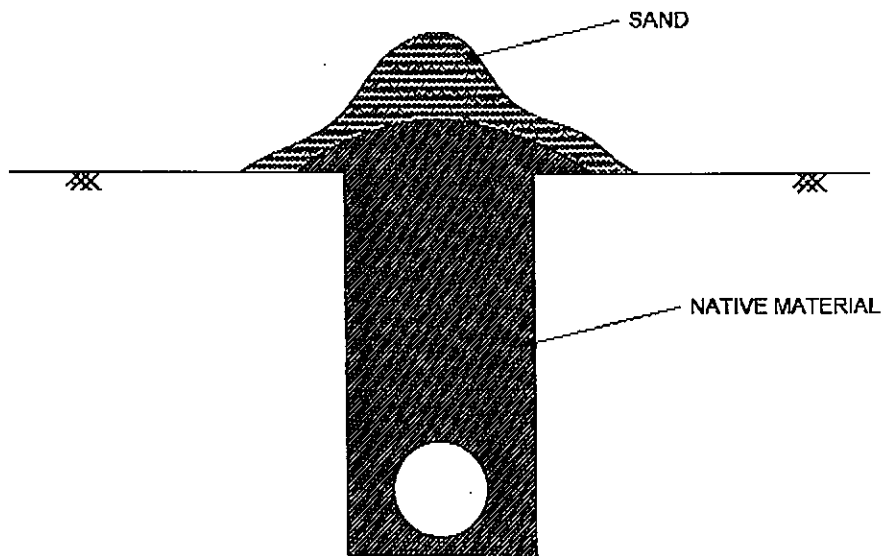
Figure 4 - Ditch Backfill - Sand Roach

Sand padding was not initially available for the first seven kilometers of the ditching and backfilling operation. As a result native material was placed on top of the pipe, and then sand was roached over the ditch line as shown in Figure 4. As described above, we expect about 50% settlement in the native material when it thaws next summer. For this section of line we will be raking a mixture of sand and native silt into the ditch to bring the ditch to grade (Figure 5). The ditch will be monitored until the following summer when it will be re-seeded with indigenous grasses if necessary.

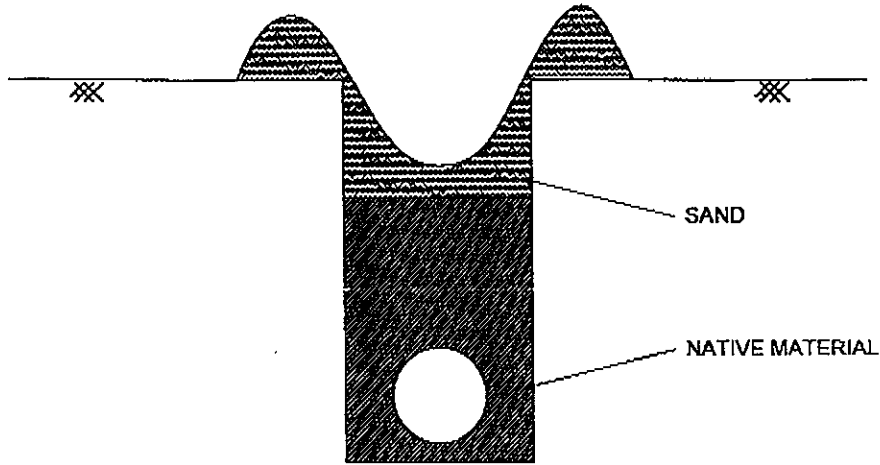
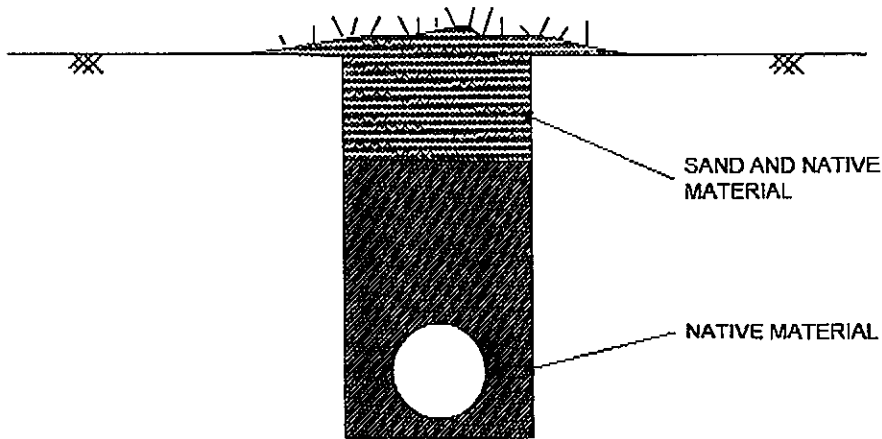
(a) - After First Thaw

(b) - After Restoration

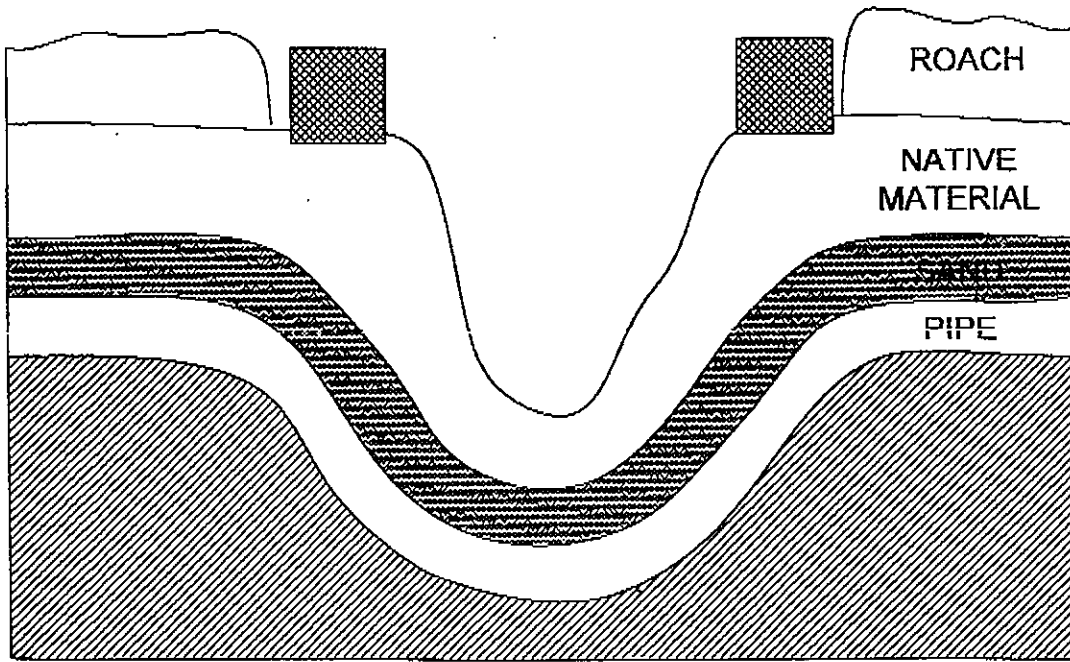
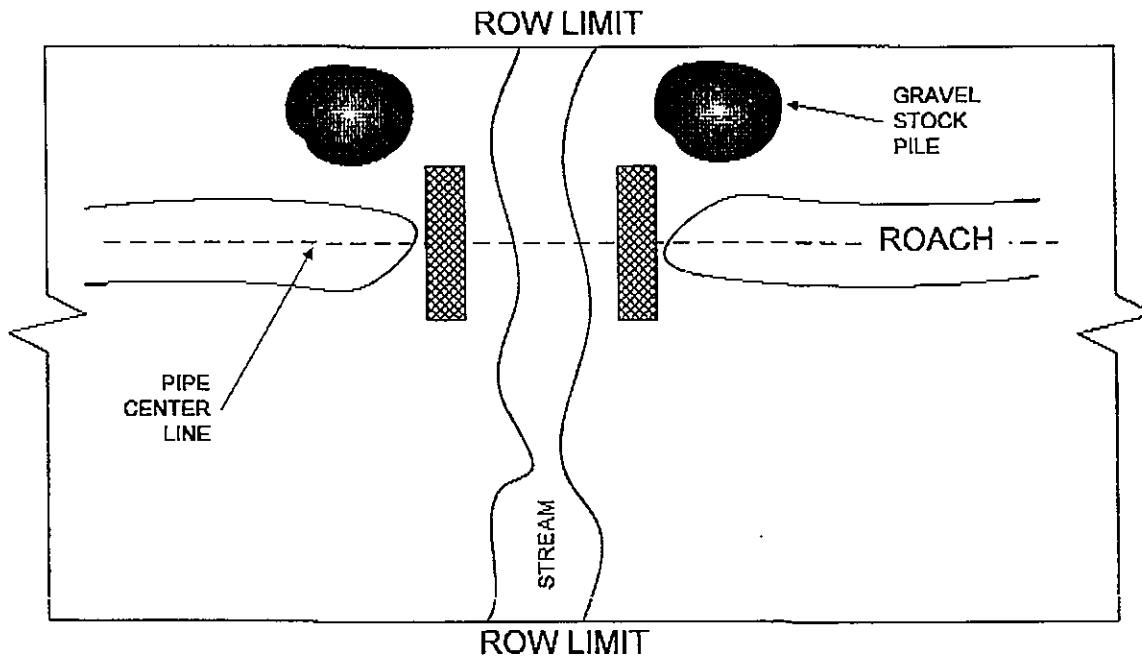
Figure 6 - Ditch at Stream Crossing

The pipeline crosses a total of 15 very small streams, all of which were not flowing during construction. The ditcher or backhoe was used to cut a trench across the streams as shown in Figure 6. After the pipeline was laid, sand was placed on top of the pipe and then native material packed on top of the sand to bring the ditch to surface. Excess material was not roached on top of the ditch as described above. The restoration plan for stream crossings is to ensure that the snow / ice pad on the working side of the ROW is notched or removed before spring break up in order not to impede natural flow. A load of clean coarse gravel will be placed on either side of the stream so that it can be placed on top of the ditch if necessary to prevent any erosion of the ditch material that may cause siltation of the stream. Straw bails will also be placed along either side of the stream above high water, to prevent water from flowing along the ditch and into the stream. This should also mitigate siltation of the stream. This summer efforts will be made to restore the channel and bed of the stream to their original alignment and cross-section.

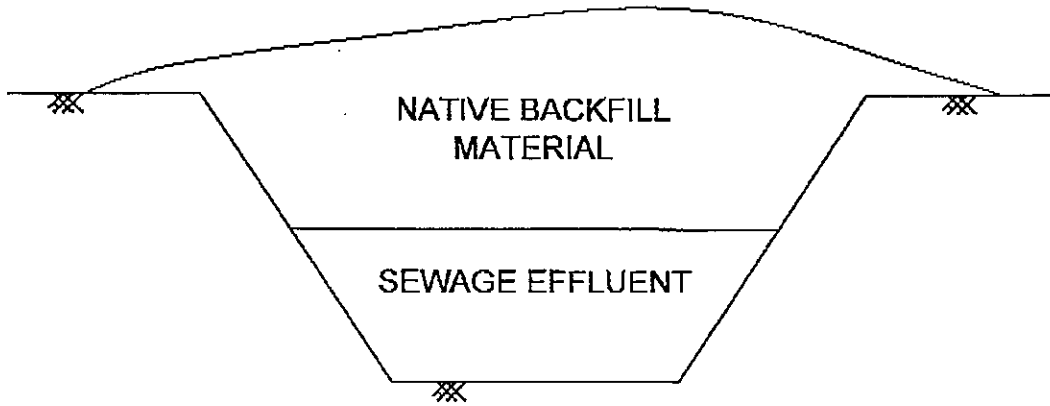
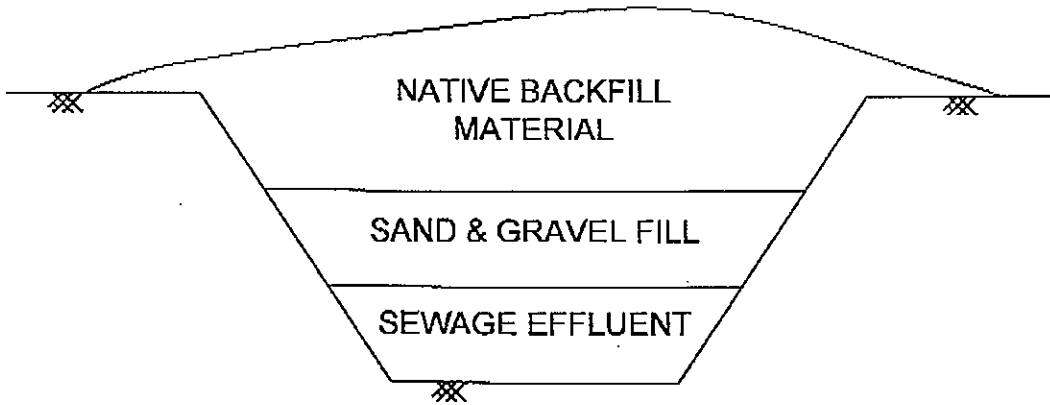
There are two sewage sumps, one at the Douglas Creek camp and the other at the Ikhil camp. As shown in Figure 7 both sumps will be capped with native material and seeded next summer with an indigenous seed mixture. The Ikhil camp sump will be capped with granular material that has been stockpiled nearby prior to capping with native material.

Douglas Creek Sump

Ikhil Sump
